# THE BRIDGES OF NORTH COUNTY CLARE

*An Inventory of Civil Engineering Heritage*

*recorded and compiled by*  
**Lotts Architecture and Urbanism**

*for Clare County Council with the support of The Heritage Council*

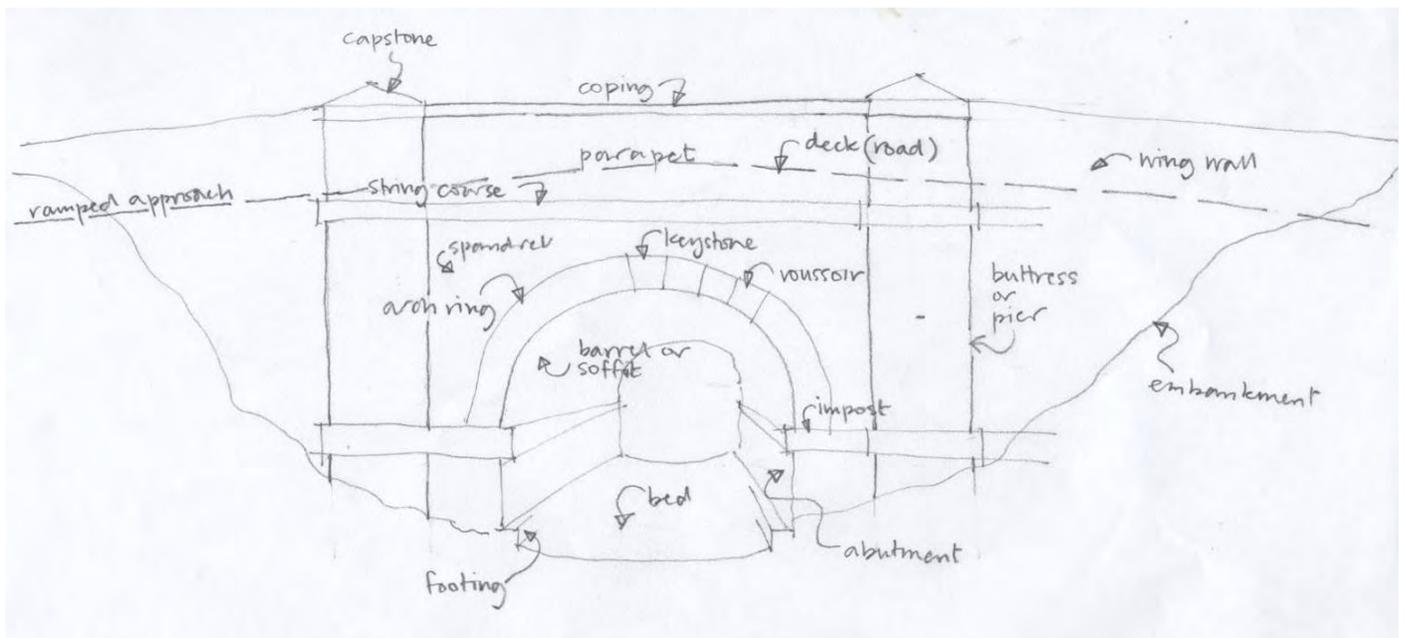
Fig. 2: Principal terms for bridge components used in the inventory

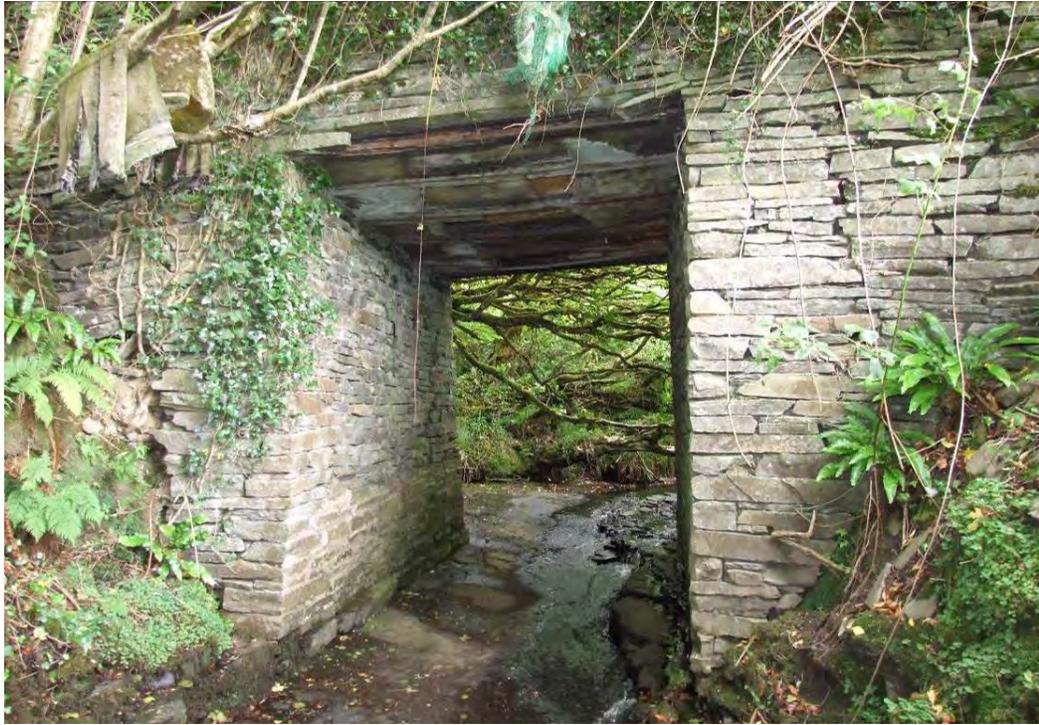
**Fig. 4:** Use of flat stones in abutments and soffit to bridge (65) at Silverhill/Glendine South

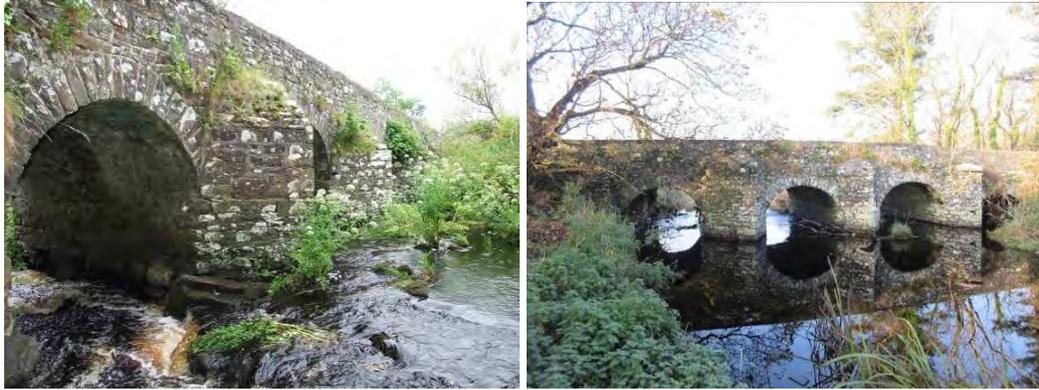
**Fig. 6-7:** Wide piers in bridges (Left: 107 & Right: 162) on the Aughyvackeen River suggesting early date

Bridges of great age do not survive in the county, the oldest multi-arch bridge being the four- and five-arch bridges over the Aughyvackeen River, whose wide piers suggest a date in the early 18th century, if not earlier (107 & 162). Other bridges may incorporate earlier structures altered in part due to replacement of spans or widening works.

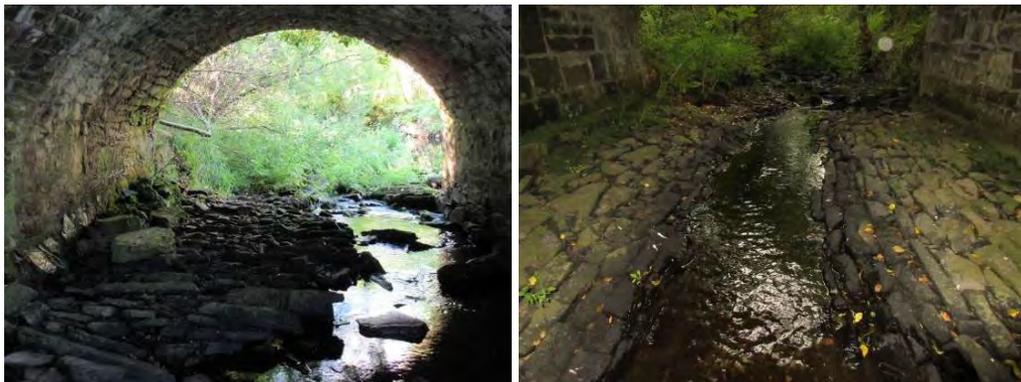
**Fig. 8-9:** Lapped bed stones at Inagh Bridge (24) and bonded pattern at Boola Bridge (20)

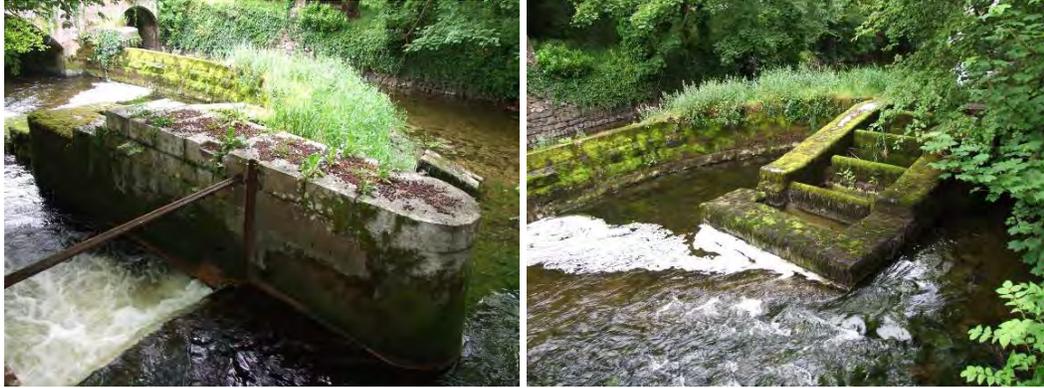
Some bridges are located near or from part of interesting industrial heritage sites such as the bridge at Clifden (7) alongside a former flour mill. This particular bridge is integrated with a ruined mill building, an impressive mill race, weir and salmon leap.

Fig. 10-11: Ashlar weir wall and mill race wall with two-span bridge (7)

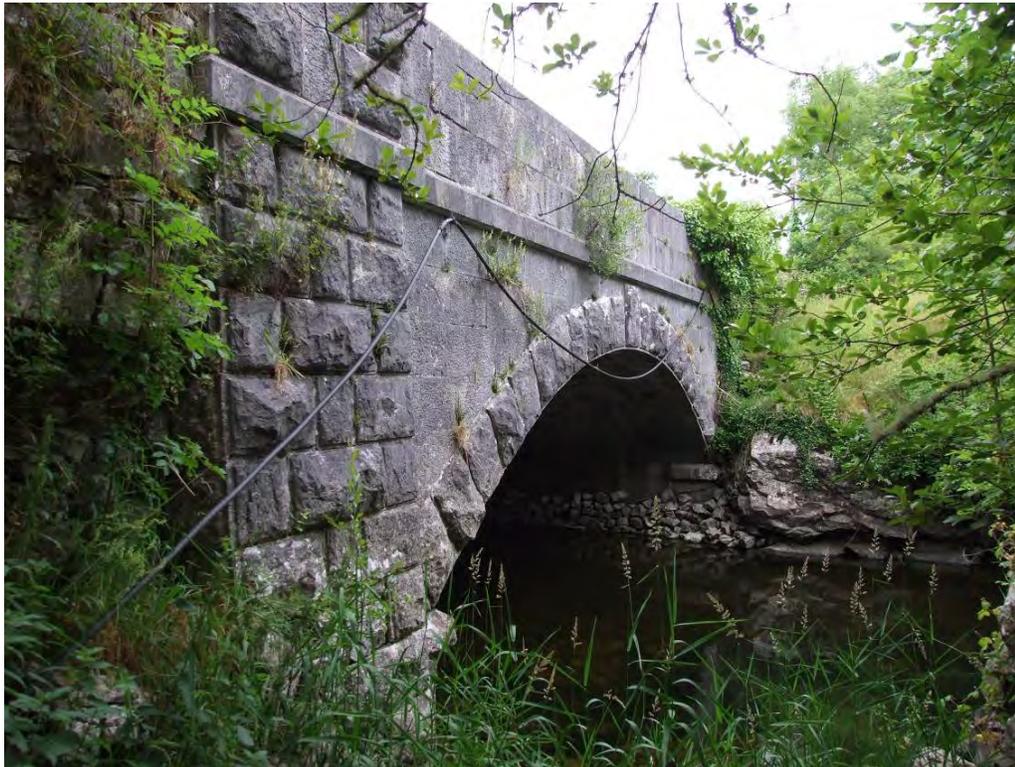
An example of the Arterial Drainage works can be found in townlands of Ballyogan Beg and Loughaunnewelaun. The 6" Ordnance Survey map shows Ballyogan Bridge located in a landscape with no clear river path and with large areas designated as 'liable to floods'. In the later 25" Ordnance Survey map the drainage works have provided for a clear river path that remains in evidence today. Furthermore, a new bridge (151) was built over the river, but at a location to the south of the historic structure, and bearing the same name. The new structure is a substantial one with a wide span to cross the size the new watercourse.

Fig. 25: Ballyogan Bridge (151)

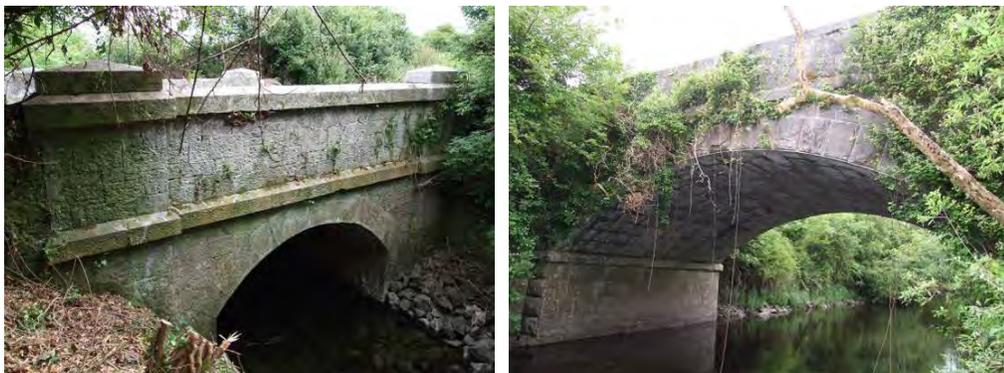
Although many bridges were destroyed, the loss was in part offset by the very high quality of the bridges constructed by the Board of Works in the 1850s and 1860s. Very good examples can be seen at Kells (143), Bealickania Bridge (145), Nutfield Bridge (146), Addroon Bridge (152) and nearby bridge at Carrowkeel More (153). All of these bridges were built to very high standards of architectural design and craftsmanship using ashlar and rock-faced stone. Together this succession of bridges forms a landscape of civil engineering significance, which demonstrates the ambitions and achievements of the drainage scheme and can only be properly understood or appreciated in the group context.

Fig. 26-27: Right: Bridge at Kells (143) & Left: Addroon Bridge (152)

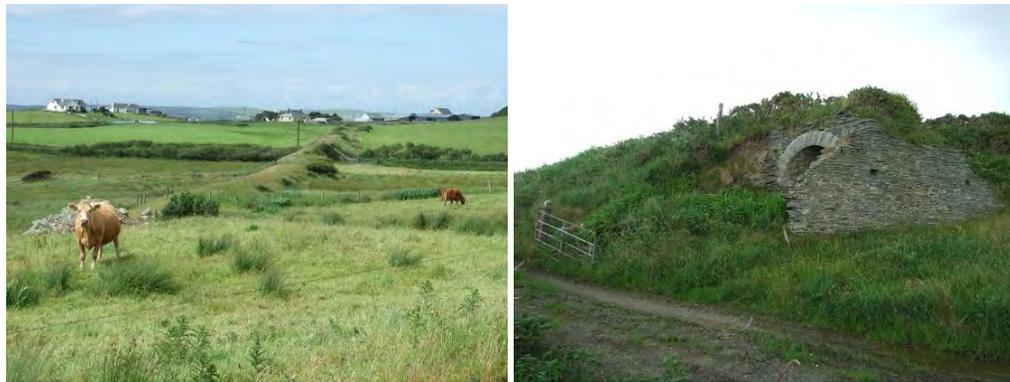
Fig. 30-31: Left: disused railway embankment beside bridge (68) at Fintra More. Right: disused bridge (71) and partially removed embankment at Drummin

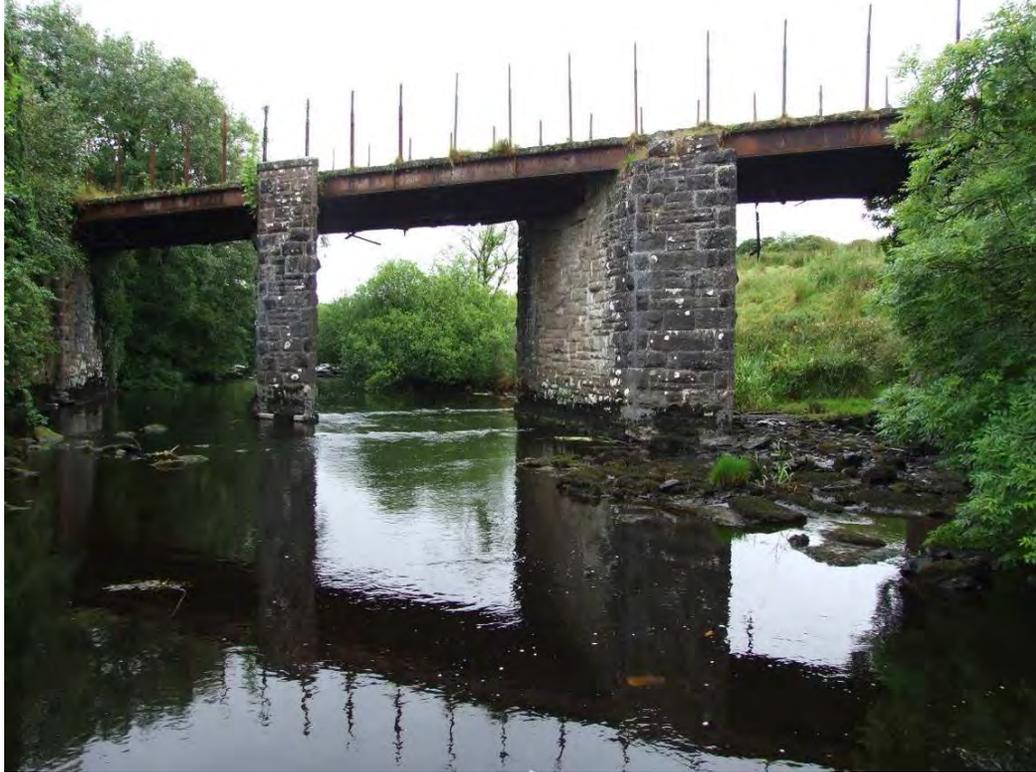
The railway bridges that remain are built of high quality stonework, often with rock-faced ashlar. They are either arched or trabeated with stone abutments supporting riveted cast-iron box sections.

**Fig. 32:** Impressive former railway bridge (83) spanning River Inagh in Ennistimon at skewed angle and having skewed piers and abutments

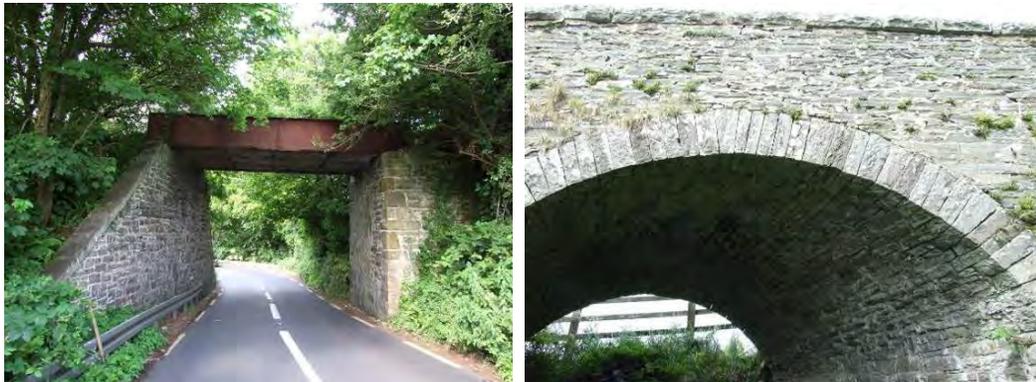
**Fig. 33-34:** Left: disused railway bridge over road (75) at Cullaragh South & Right: Road crossing a disused rail line at Fintra More (68), a stone bridge with a with shewed barrel

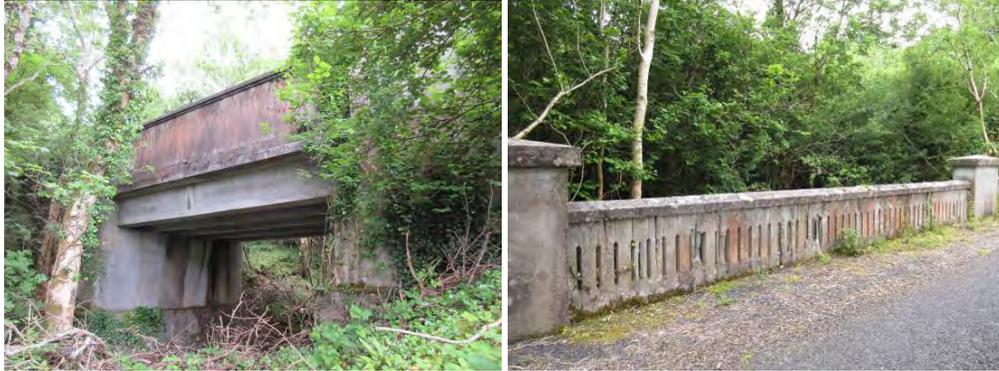
There are no bridges solely of steel in the survey area county. Some of the railway structures have cast-iron sections and an early twentieth-century bridge at Clogher (155). There are some bridges using concrete elements for structural purposes built in the first half of the 20<sup>th</sup> century, but bearing historic references in their appearance. Some samples of such bridges were recorded.

**Fig. 35-36:** Concrete bridge at Gortcurka (12) with concrete beam supports and precast balustrade

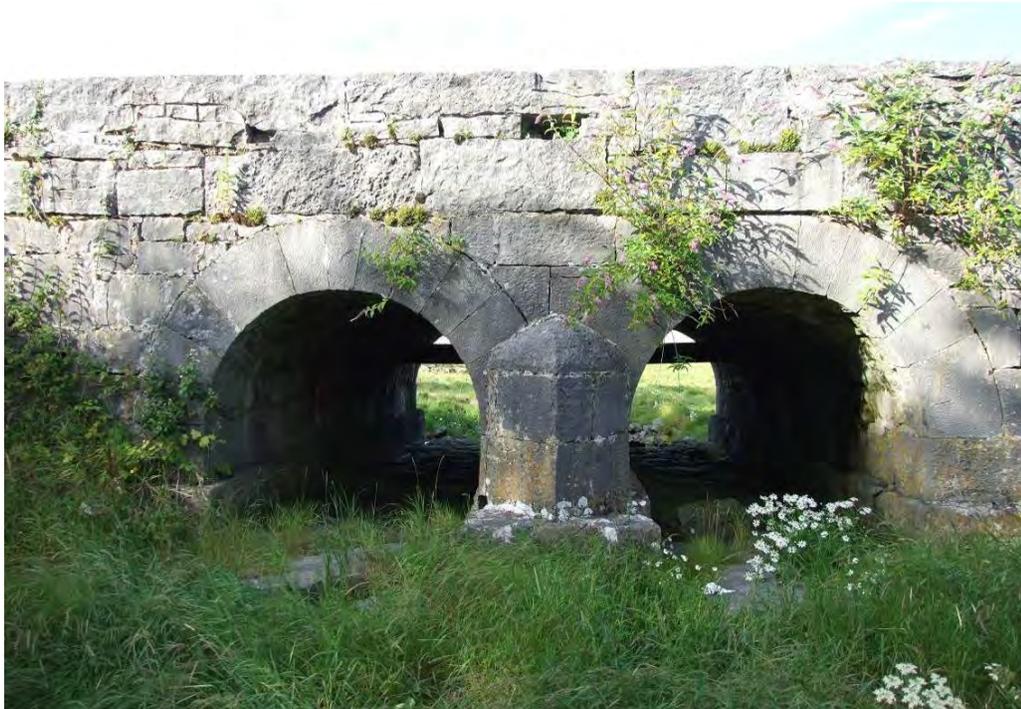
**Fig. 37:** Bridge at Ballyvaghan (132)

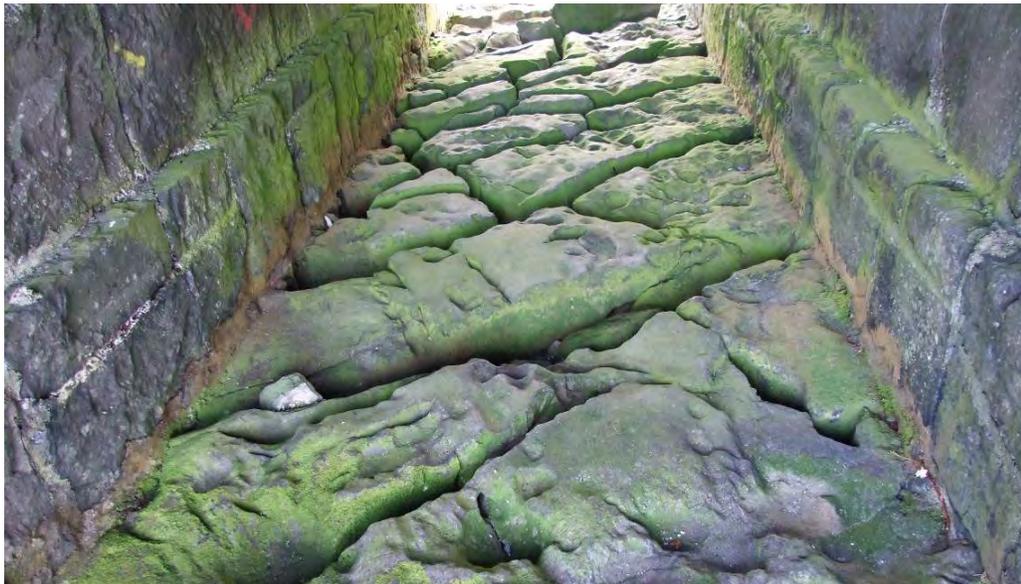
**Fig. 38:** Exposed rock floor in channel of bridge at Ballyvaghan (132)

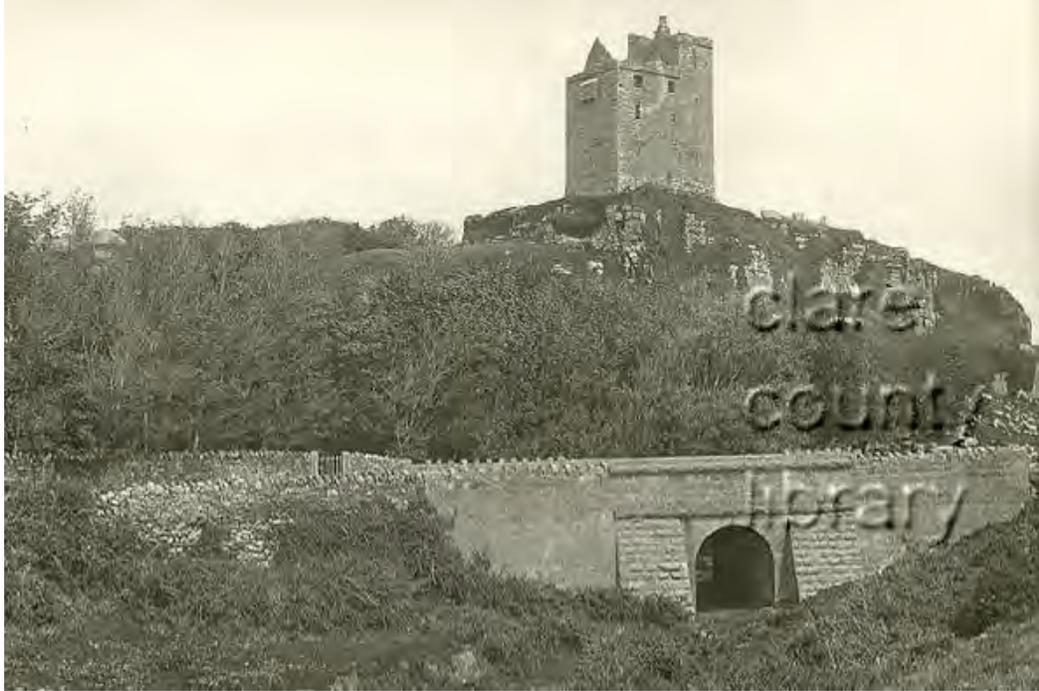
**Fig. 39-40:** Above: Historic view of Ballinalackan Castle with bridge (124) in foreground & Below: structure now overgrown and no longer visible in its landscape setting

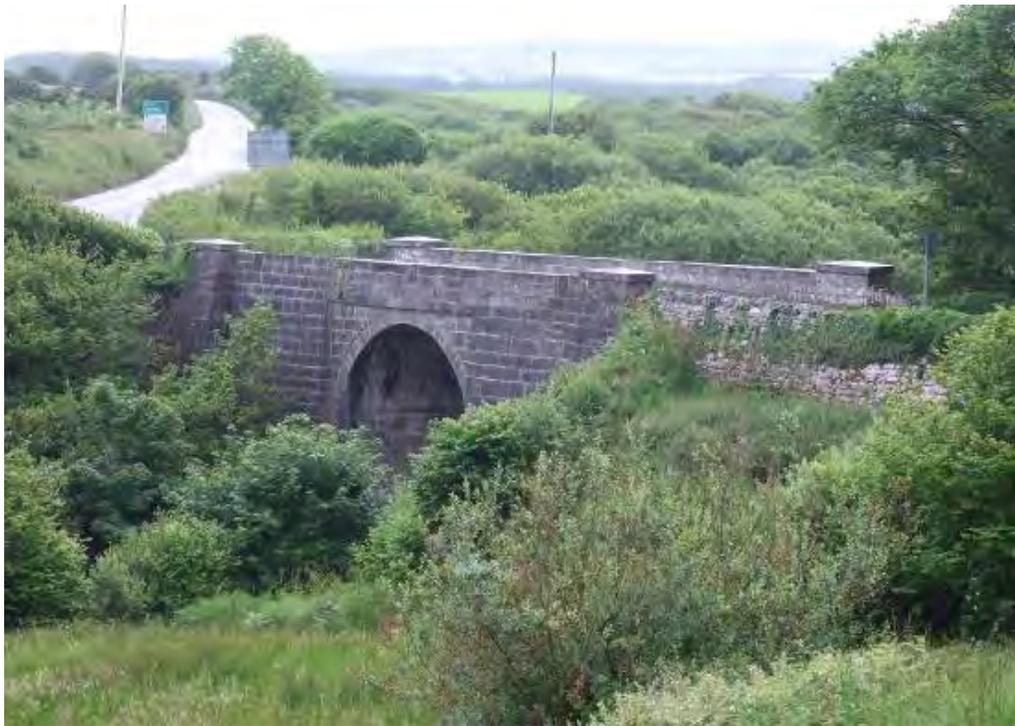
Fig. 41-42: Above: Historic view of the Spectacle Bridge (119) with visitors (source: Archiseek) & Below: much of structure now overgrown and no longer visible or accessible in its landscape setting

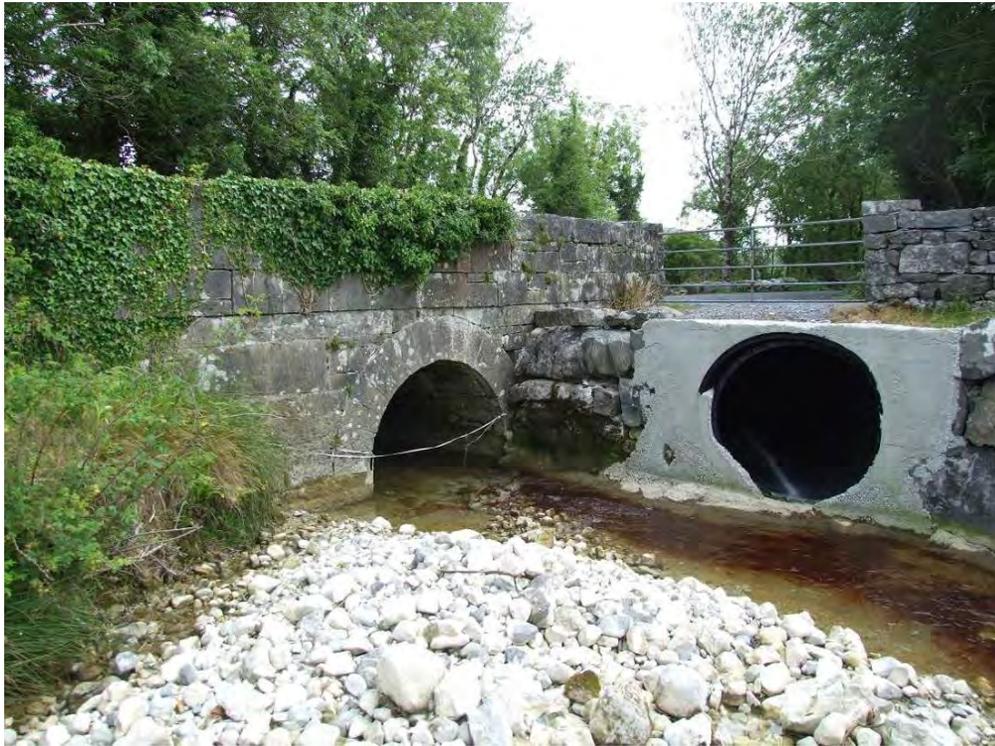
**Fig. 43:** Bridge at Drumbrickaun (134): poor quality alterations adjacent to a fine stone bridge

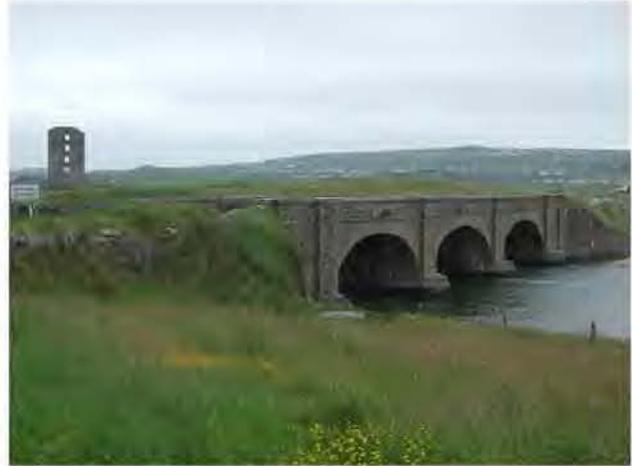
**Description:** Large triple-span elliptical-arched cut-stone road bridge supporting a level deck, dated 1836, spanning River Inagh at right angles. Square stone coping on parapet of coursed square stone above continuous string course. Advanced square piers between spans in full height, twin piers to ends, all of random coursed stone. Spandrels of squared stone, arches with cut-stone voussoirs, barrel of squared stone. Square impost course integrated with V-cutwaters to both faces. Wing walls and splayed abutments of random squared stone and Scotch copings. Damaged inscription stone to parapet on deck side.

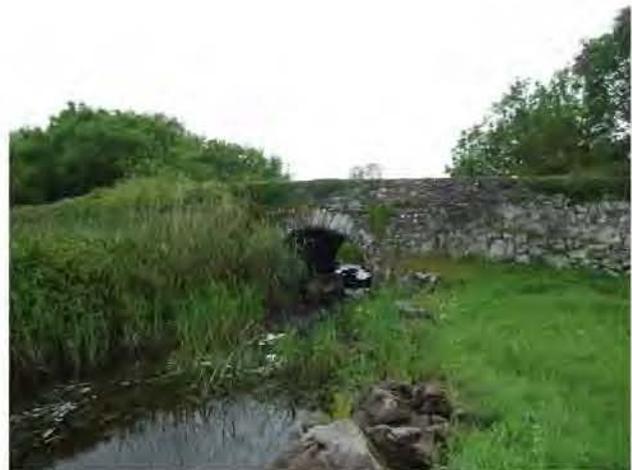
**Description:** Small single-arched stone bridge with semi-circular arch, spanning the Ballycullan Stream at right angles, and supporting a ramped deck. Uncoursed rubblestone parapets with no copings. Rubblestone spandrels and wing walls. Roughly squared arch voussoirs with splayed keystone. Gunned barrel face. Wing walls extending along ramped deck approach. Approach to southeast allows access by cattle to water.

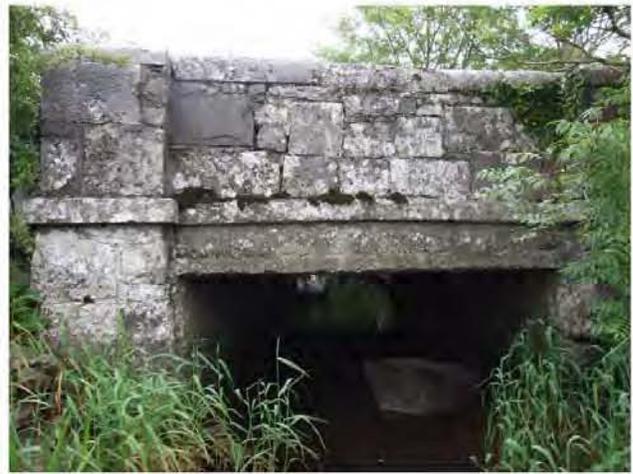
**Description:** Medium sized single-flat span road bridge of stone and concrete, spanning a stream at right angles, supporting a flat deck. Parapets of coursed random squared stone with cut half-round cut stone parapets. Advanced square piers of large random squared stones to both ends with double-round cut-stone cappings. Stone string course above deck level. Flat span of course-faced concrete. Splayed stone abutments with square stone footings in bed.

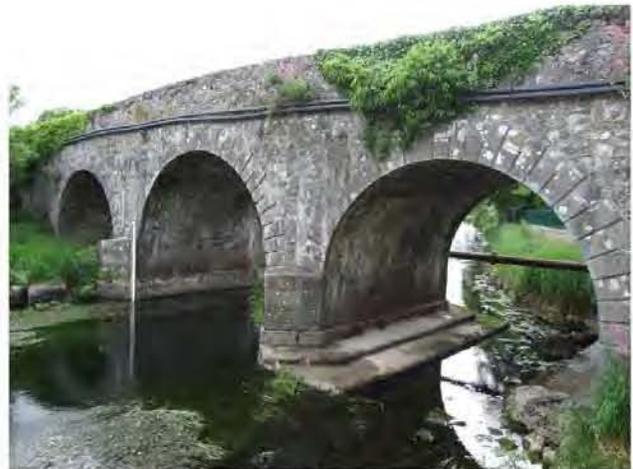
**Description:** Large triple-span semi-circular arched stone bridge with humped deck, built c.1790, spanning River Fergus at right angles. Uncoursed rubblestone parapets and spandrels. Cut arch voussoirs with bevelled edges, every second voussoir half length, rubblestone barrel. Ashlar v-cutwaters and abutments of ashlar stonework. Extensive curved wing walls.

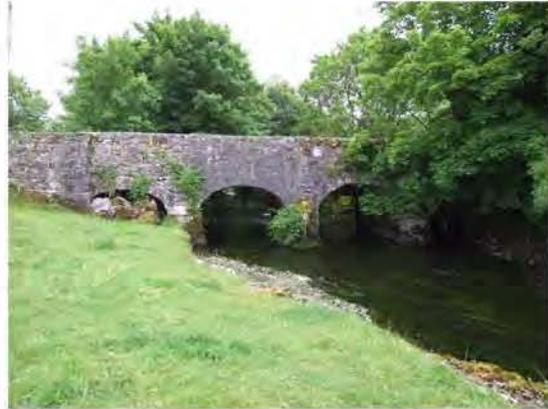
**Description:** Medium sized four-span stone arched bridge, spanning Fergus River at right angles with flat deck. Rubblestone parapets with squared stone top course. Rubblestone spandrels and wing walls. Elliptical arches with two central arches larger than flanking spans. Unequally sized stone voussoirs, barrels of rubble stone. Ashlar abutments and cutwaters. Exposed rock bed. Parallel wing walls extending from bridge, wing wall to northeast curving around corner with integrated stile and steps to floodplain.

**Appraisal** An elegant composition with extensive wing walls giving strong definition to its landscape context. The bridge is highly visible from the nearby crossroad approaches. It demonstrates technical skill employed in bridge structures of this size in this period.

**Condition:** 2: Good. Cement pointing in areas, ivy growth in areas. No access to view barrel.

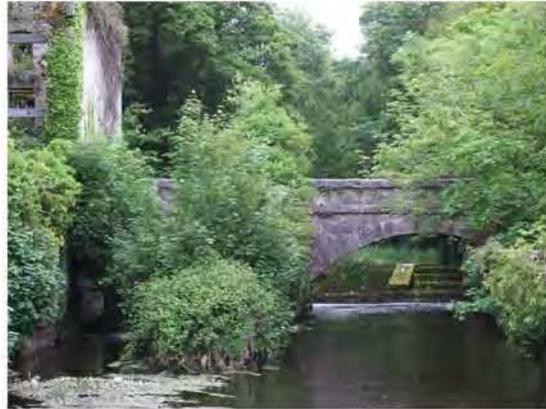
**Registration No.** 7  
**Name of Bridge**  
**Over Bridge** Private road  
**Under Bridge** River Fergus  
**Townland(s)** BAUNKYLE \ CLIFDEN  
**Parish\Barony**  
**Type/OS coord** Road over watercourse  
X: 526538 Y: 689073  
**Estimated Date** 1750 to 1800  
**NIAH Reg. No.**  
**NRA Ref. No.**

**Description:** Large two-span segmental-arched bridge supporting a flat deck, spanning River Fergus at right angles. Larger arch on east side, smaller west arch spanning mill race. Cut-stone coping with profiled copings to end piers, ashlar parapet walls. Square string course above ashlar spandrels, continued as wing walls to ashlar end piers. Cut-stone voussoirs and square stone barrel resting on ashlar abutments. Ashlar cutwater integrated with rock-faced mill wall which extends in curved line to fish leap and sluice. Random-square stone lining to river banks.

**Appraisal** Finely constructed cut-stone bridge as part of an impressive historic ensemble of mill ruin, mill race, fish leap and sluice. The bridge also provides access to Clifden house. It is a good example of fine stonework used in mill constructions from its time.

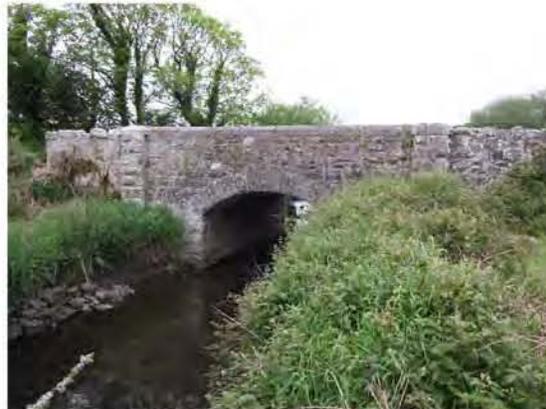
**Description:** Small single-arched stone bridge with segmental arch, spanning the watercourse at right angles and supporting a flat deck. Sloped cut-stone copings with hipped ends over end piers, all on coursed rubble-stone parapets. Coursed rubble-stone spandrels, advanced rock-faced piers. Rock-faced voussoirs with smooth edge. Square-stone abutments. Wing walls of rubble stone.

**Condition:** 4: Poor. Collapse of part of inside of south parapet. Cement pointing. Settlement of abutment stones. Rubble-stone lining of banks collapsed in areas. No access to inspect barrel.

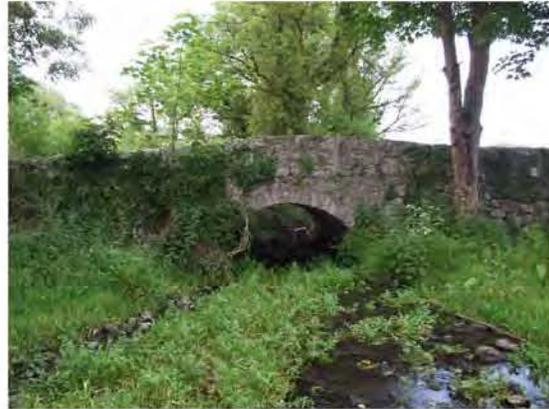
**Registration No.** 9  
**Name of Bridge** Beggar's Bridge  
**Over Bridge** L-1100  
**Under Bridge** Watercourse leading to Lough Ateduan  
**Townland(s)** BALLYKINNACORRA SOUTH \ CREGMOHER \ KILLEEN (INCHIQUIN)

**Appraisal** A rustic structure of strong character extended by wing walls into its setting. It is a good example of construction used in structures of its kind and date.

**Condition:** 3: Fair. Parapets damaged in areas. Cement jointing in areas and to barrel, other pointing requiring repair. Ivy growth. Service pipes attached to bridge faces.

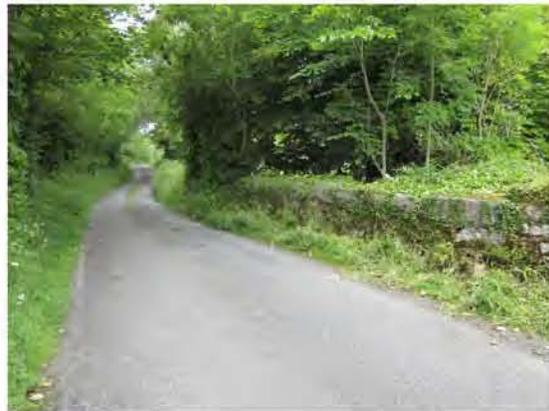
**Registration No.** 10  
**Name of Bridge**  
**Over Bridge** L-8136-0  
**Under Bridge** Stream leading to Loch Bhaile  
**Townland(s)** CARHOO \ DYSERT (INCHIQUIN) \ MOLLANEEN

**Condition:** 3: Fair. Damage to joints. Vegetation cover in several areas. No access to south face

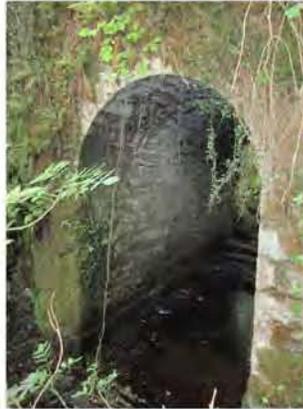
**Description:** Medium-sized single-span tall stone bridge with semi-circular arch, spanning watercourse at right angles and supporting a flat deck. Random-square coping course on random square stone parapets. Random square stone spandrels and wing walls. Cut-stone voussoirs and random-square stone vault. Random square stone abutments with square stone footing. Exposed rock in river bed.

**Condition:** 3: Fair. Joints needing repair. Heavy vegetation and penetrating ivy overgrowth. No access to east face.

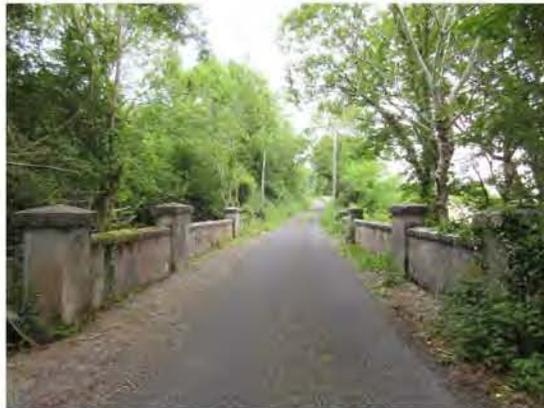
**Description:** Single flat-span concrete bridge, spanning a stream at right angles on steep ground with a flat deck. Sloping rendered coping profile with pyramidal copings on advanced piers flanking a central bay with further piers to both end bays. Parapet in central bay of vertical precast concrete uprights with narrow waist section, parapets to flanking bays of rendered walls. Outward face of piers with recessed line marking central panels. Five board-marked concrete beams spanning opening and resting on rendered abutment walls with stepped footings.

**Condition:** Spalling of concrete cover in precast balustrade.

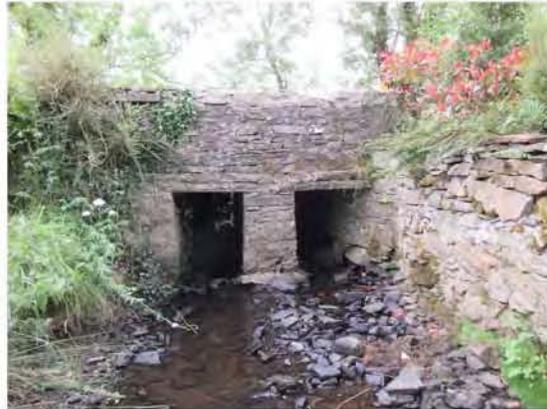
**Description:** Culvert bridge of rubble stone with level deck and orthogonal crossing. Double span and single pier with v-cutwater. Parapet of rubble stone.

**Condition:** 4: Poor. Damaged parapets, some roof stones to spans collapsing, falling abutments.

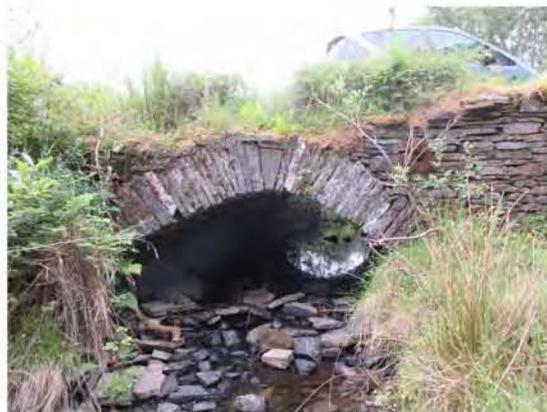
**Description:** Single-span arched stone bridge of flat rubble stone and flat deck. Arch of flat squared stone voussoirs and splayed keystone.

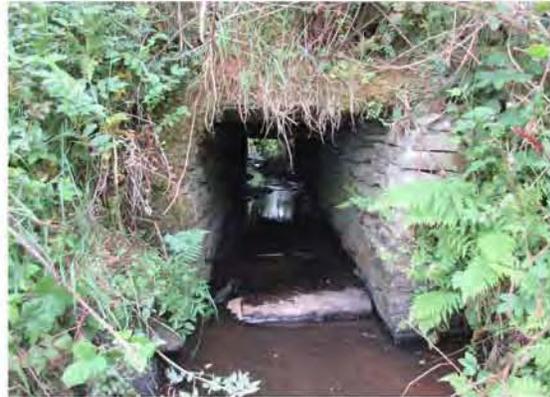
**Registration No.** 15  
**Name of Bridge**  
**Over Bridge** L-8318-0  
**Under Bridge**  
**Townland(s)** BALLYDUFF MORE  
**Parish\Barony**  
**Type/OS coord** Road over watercourse  
X: 524458 Y: 680493  
**Estimated Date** 1750 to 1800  
**NIAH Reg. No.**  
**NRA Ref. No.**

**Description:** Culvert bridge of rubble stone with level deck and orthogonal crossing. Exposed rock floor in bed.  
**Appraisal** A modest structure typically used in crossing small watercourses using local stone with no apparent use of mortar  
**Rating:** Local  
**Condition:** 3: Fair. Vegetation overgrowth especially on west side

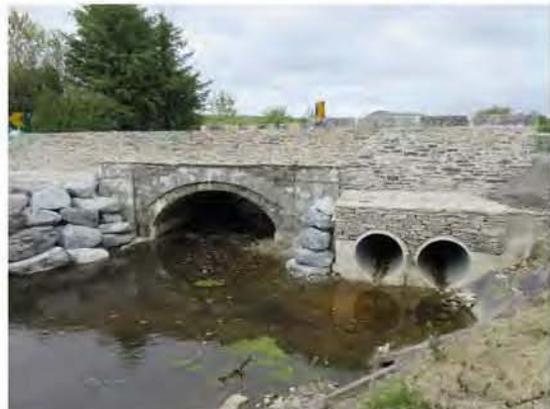
**Description:** Heavily modified medium-sized cut-stone segmental-arched bridge, spanning watercourse at right angles, flat deck. Spandrels of random squared stone, arch of toothed voussoirs. Some squared abutment stones remaining. Flanking battered ashlar buttresses. Modifications include supporting barrel on steel formwork resting on concrete abutments, replacement rubblestone parapets and adjacent precast concrete pipes set in concrete with rubble stone capping.  
**Appraisal** A once elegant and finely composed stone structure now severely compromised by unsympathetic alterations and additions. Location of recent large coping stones not in line with original watercourse and bridge structure.  
**Rating:** Local  
**Condition:** 4: Poor. Low quality additions, poor quality cement pointing

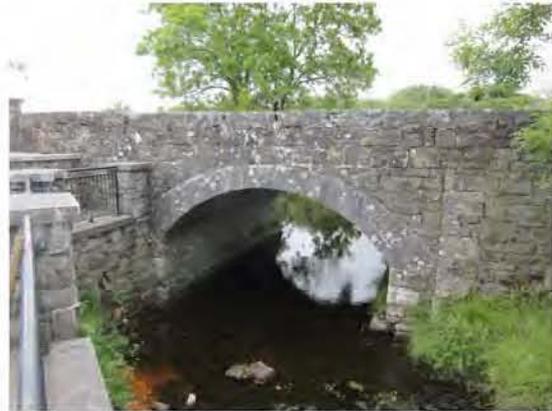
**Description:** Middle-sized single-span stone bridge with segmental arch, spanning watercourse at right angles and supporting level deck. Large random square stone coping course on coursed squared random stone parapets, pandrels of random squared stones. All resting on cut stone arch with voussoirs increasing in depth towards abutments. Barrel of random rubblestone. Abutments of random squared coursed stone resting on projecting stone footings. Splayed buttresses to wing walls of random squared stone.

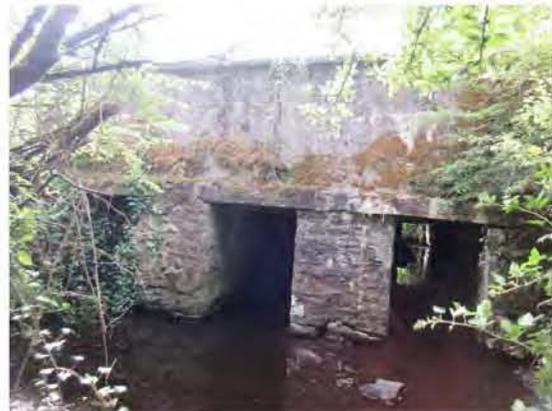
**Description:** Culvert bridge of rubble stone with three spans, level deck and orthogonal crossing. Recent rendered parapet. Rock floor exposed in river bed.

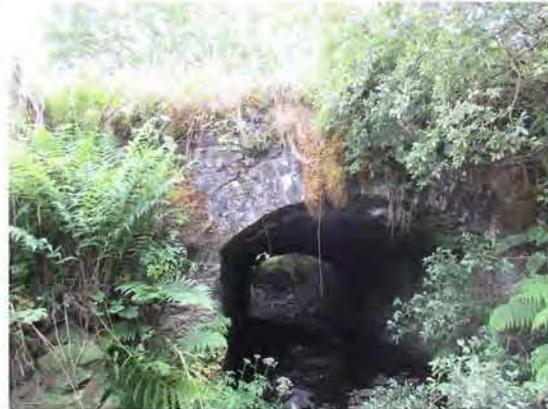
**Description:** Small-sized single-arch bridge with segmental arch, spanning watercourse at right angles and supporting a level deck. No parapet, spandrels of rubble stone. Voussoirs of rough equal sized stones. Abutments of random squared stones.

**Condition:** 4: Poor. Heavy vegetation to both sides. Cement pointing throughout. Collapsing abutment to south side.

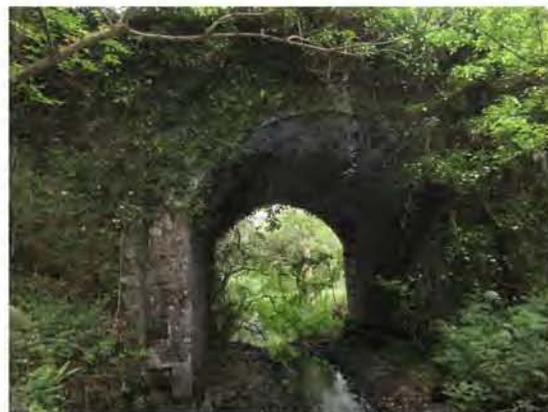
**Description:** Medium-sized single-span segmental-arched stone bridge, spanning watercourse at right angles and supporting a level deck. Raised road embankment to the south. Large squared cut-stone parapet course with rounded upper edge on coursed random square stone parapet. Random square stone spandrels, even voussoirs to arch, barrel of random square stones. Random squared stone abutments. Battered buttresses of random coursed squared limestone and sandstone. Stone dressed bed to beneath span.

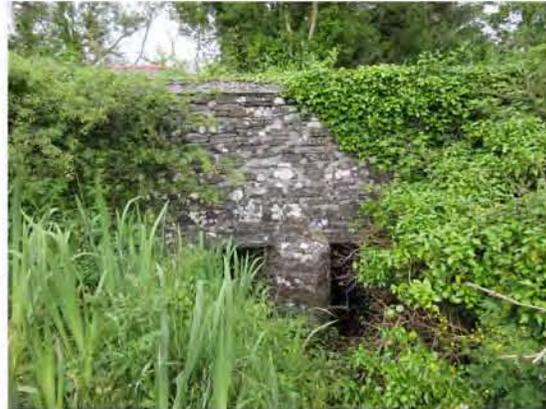
**Description:** Culvert bridge of rubble stone with two spans and v-cutwater, level deck and orthogonal crossing. Recent concrete coping. Rock floor exposed in river bed.  
**Appraisal** A modest structure typically used in crossing small watercourses using local materials.  
**Rating:** Local  
**Condition:** 3: Fair. Cement coping and cement pointing throughout

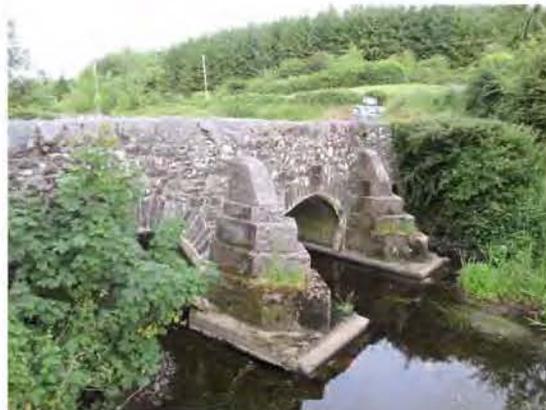
**Description:** Medium-sized three-span stone bridge with segmental arches, spanning watercourse at right angles and supporting a level deck. Rubble-stone coping course on rubble-stone parapet. Rubble-stone spandrels, arch of roughly squared voussoirs. Gunnitted abutment and barrel, concrete casing to east face of south span carrying altered road path. Stepped concrete v-cutwaters/butresses flanking west side of central span. Wing walls of rubble stone.

**Rating:** Local  
**Condition:** 4: Fair. Various alterations such as gunnitting, cement pointing, steel restraints have taken place to the structure and others to the approach road. These have for most part have been carried out in an unsympathetic manner.

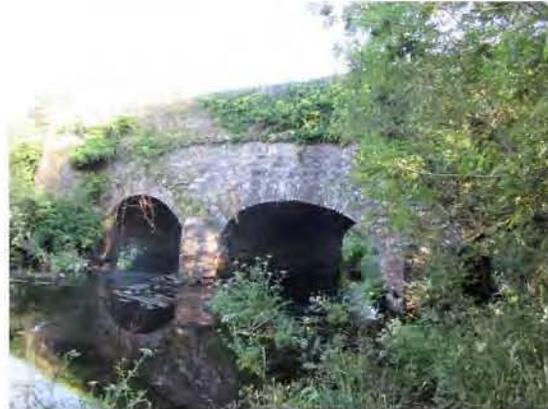
**Description:** Large three arched bridge, spanning the Inagh River at right angles and supporting a ramped deck. Scotch coping to rubble-stone parapet walls with square string-course below. Spandrels of rubble stone. Arch voussoirs of roughly squared stones, barrel of rubble stone. Central elliptical over widest span, side arches semi-circular. Abutments of rubble stone with v-cutwaters to both sides. Lapped stone dressing to river bed below spans. Wing walls of rubble stone.

**Condition:** 3: Fair. Heavy vegetation including ivy in areas. Cement pointing in areas.

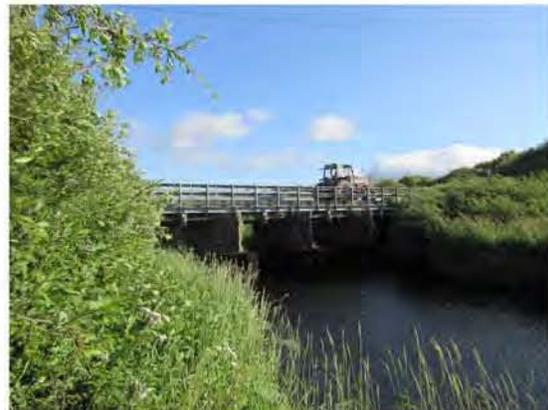
**Description:** Altered four-span bridge with remaining rubble-stone piers with v-cutwaters to south side. Arches replaced by steel structure supporting a flat deck. Concrete pads to stone piers supporting steel structure, large concrete encasing footings to piers at water level.

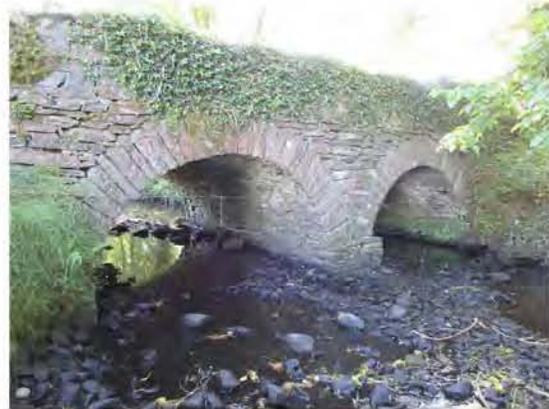
**Description:** Medium-sized two-span stone bridge with semi-circular arches, spanning a watercourse at right angles and supporting a level deck. Low rubble-stone parapets. Rubble-stone spandrels and roughly squared voussoir stones to arches with no apparent mortar in joints. Barrels of roughly squared rubble stone. Abutments also of squared rubble stone with v-cutwater to one side.

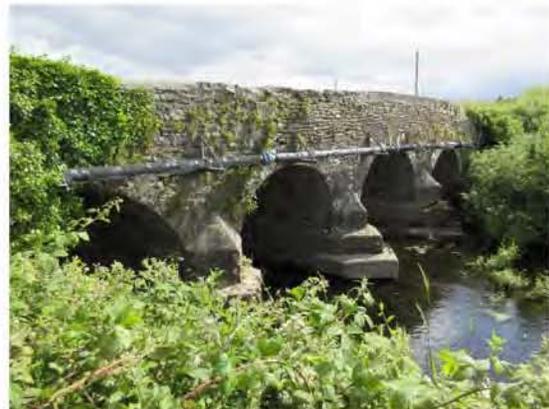
**Description:** Medium-sized four-span semi-circular arched bridge, spanning watercourse at right angles and supporting a ramped deck. Rubble-stone parapet and copings. Rubble-stone spandrels. Rough unequal stone voussoirs to arches. Larger arch to second span from east end. Random squared barrels. Abutments encased in concrete with concrete encased stepped v-cutwaters. Exposed rock floor to river bed.

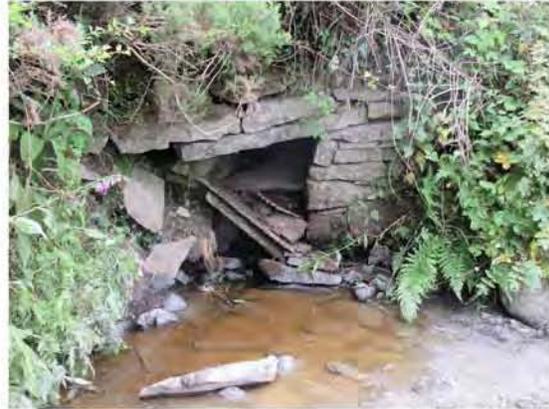
**Registration No.** 28  
**Name of Bridge**  
**Over Bridge** L-1084  
**Under Bridge**  
**Townland(s)** ILLAUNBAUN  
(CORCOMROE) \  
KNOCKACULLEA SOUTH

**Condition:** 4: Poor. Collapsed end to east side. Heavily overgrown and no access to west side.

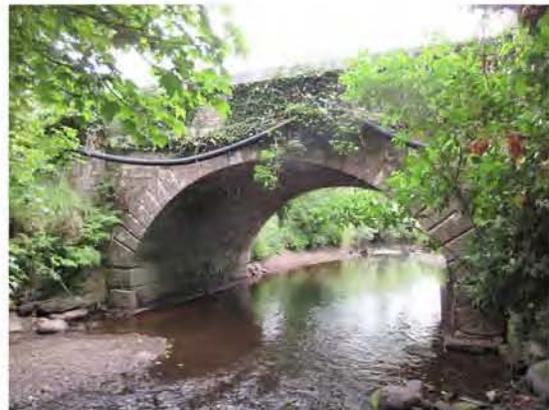
**Registration No.** 29  
**Name of Bridge** Derrymore Bridge  
**Over Bridge** L-1084  
**Under Bridge** Watercourse leading to  
Drumcullaun Lough  
**Townland(s)** CLOONTYSMARRA \  
ILLAUNBAUN  
(CORCOMROE)

**Condition:** 2: Good. Some stones to spandrel and abutment coming loose. Some parapet stones replaced by concrete, these stones lie in the river bed. Vegetation, including ivy in several areas. Service pipe attached to west elevation.

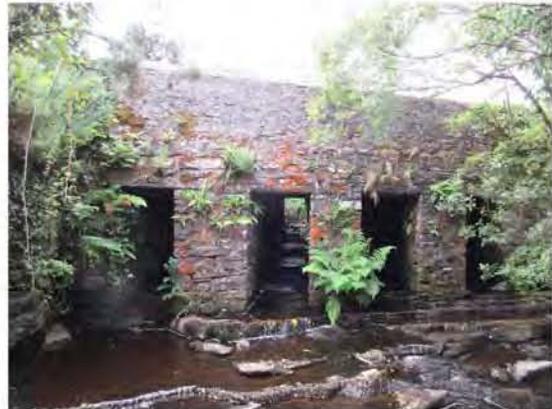
**Description:** Culvert bridge of rubble stone with five spans, level deck and orthogonal crossing. Recent cement coping. Rock floor exposed in river bed.

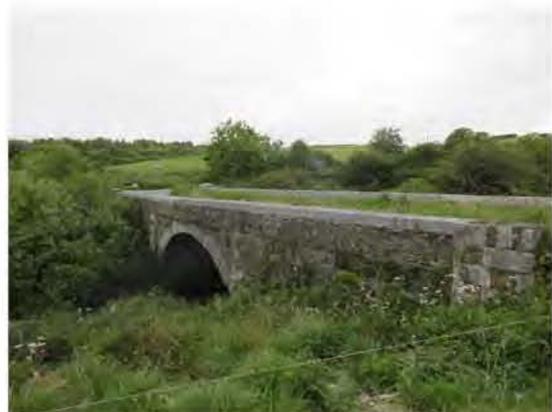
**Description:** Large single-span segmental-arched stone bridge, spanning watercourse at right angles and supporting a level deck. Large square cut-stone coping course on random squared stone parapets. Square piers to ends with pyramidal stone cappings. Parapet oversails spandrels of random square stones. Equal-sized voussoirs with hammered faces, barrel of random square stone. Abutments of coursed square stone. Wing walls of random squared stone battered below parapet line.

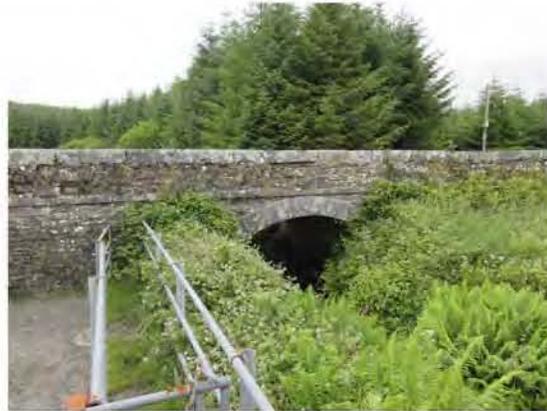
**Description:** Medium-sized single-span segmental-arched stone bridge, spanning watercourse in dogleg arrangement and supporting a humped deck. Large block stone coping course on rubble-stone parapets. Square string course above rubble-stone spandrels and battered wing walls. Equal-sized cut-stone voussoirs with hammered faces, rubble-stone barrel. Random square stone abutments.

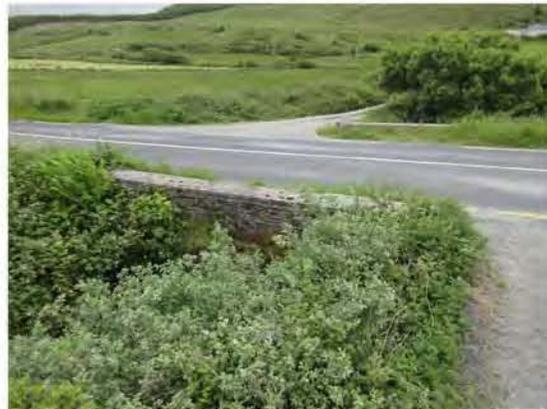
**Registration No.** 33  
**Name of Bridge**  
**Over Bridge** R460  
**Under Bridge**  
**Townland(s)** BOOLYNAMISCAUN \  
LETTERKELLY  
**Parish/Barony**  
**Type/OS coord** Road over watercourse  
X: 513551 Y: 679395  
**Estimated Date** 1750 to 1800  
**NIAH Reg. No.**  
**NRA Ref. No.**

**Description:** Culvert bridge of rubble stone with single spans, level deck and orthogonal crossing. Recent concrete coping.

**Condition:** Culvert deepset in ground, heavy vegetation to both sides and no access to water level or south elevation.

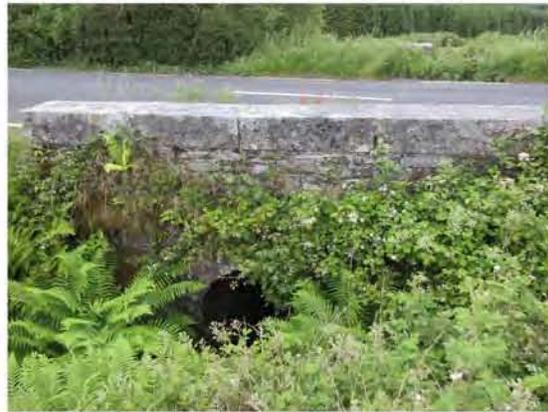
**Description:** Small single-span semi-circular arched stone bridge, spanning watercourse at right angles and supporting a level deck. Large square block stone coping course on rubble-stone parapet. Rubble-stone spandrels. Cut-stone voussoirs with hammered faces. Rubble-stone abutments. Concrete casing to footings.

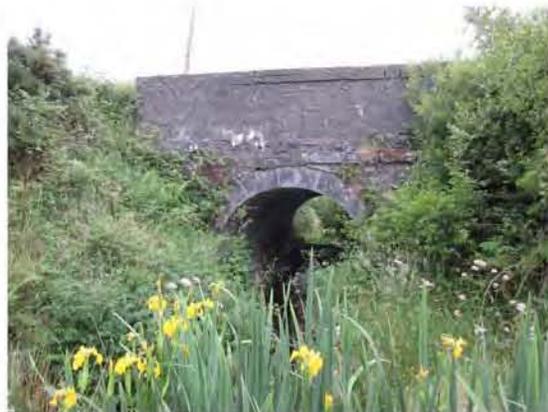
**Description:** Small single-span segmental-arched stone bridge, spanning watercourse at right angles and supporting a level deck. Replacement concrete blockwork parapets with square stone stringcourse below. Random square stone spandrels, battered ashlar wing walls with hammered faces. Equal sized voussoirs with hammered faces and smooth edging, barrel of random squared stone. Abutments of coursed square stone, footings encased in concrete.
