# THE BRIDGES OF NORTH COUNTY CLARE

*An Inventory of Civil Engineering Heritage*

*recorded and compiled by*  
**Lotts Architecture and Urbanism**

*for Clare County Council with the support of The Heritage Council*

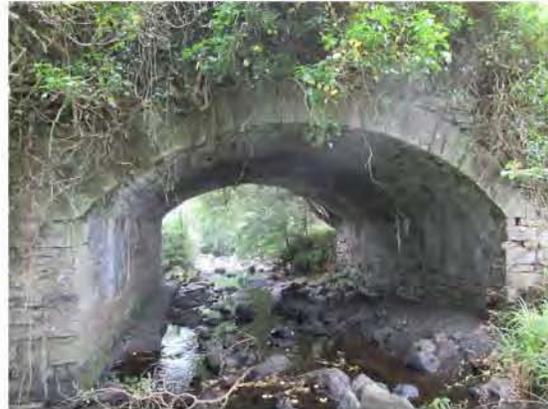
**Registration No.** 36  
**Name of Bridge** Cloonanaha Bridge  
**Over Bridge** L-1074-43  
**Under Bridge**  
**Townland(s)** CLOONANAHA  
**Parish\Barony**  
**Type/OS coord** Road over watercourse  
X: 515025 Y: 681271  
**Estimated Date** 1750 to 1800  
**NIAH Reg. No.**  
**NRA Ref. No.**

**Description:** Medium-sized single-span segmental-arched stone bridge, spanning watercourse at right angles and supporting a ramped deck. Soldier course coping on rubble-stone parapet walls. Spandrels and wing walls of random rubble stone. Voussoirs of unequally sized squared stones. Barrel and abutments of random squared stone. Large square footing stones.

**Condition:** 4: Poor. Dense vegetation, including ivy, to both elevations. Stones loosening in many areas.

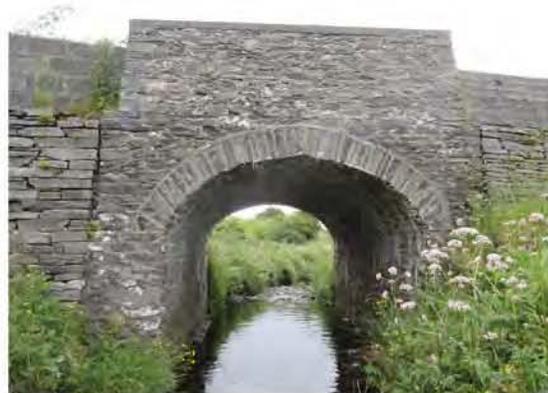
**Registration No.** 37  
**Name of Bridge**  
**Over Bridge** L-10744  
**Under Bridge**  
**Townland(s)** CLOONANAHA  
**Parish\Barony**  
**Type/OS coord** Road over watercourse  
X: 514232 Y: 680984  
**Estimated Date** 1900 to 1930  
**NIAH Reg. No.**  
**NRA Ref. No.**

**Description:** Small single-span elliptical-arched stone bridge, spanning watercourse at right angles and supporting a flat deck. Rebuilt rubble-stone parapets with cement cappings. Rubble-stone spandrels. Voussoirs of unequal stones, barrel of rubble stone. Abutments of layered rubble stone. Wing wall parapets of concrete block on battered rubblestone embankments.

**Condition:** 4: Poor. Very poor cement pointing throughout. Low quality finish to wing walls.

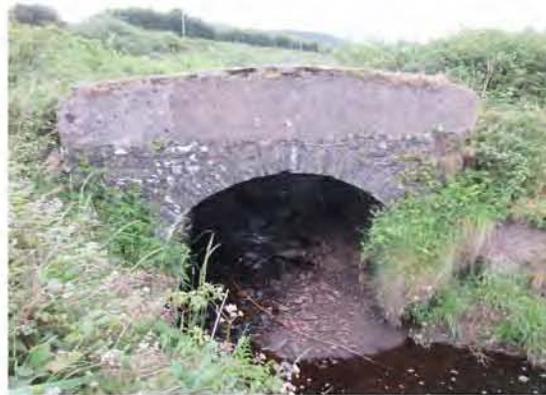
**Registration No.** 38  
**Name of Bridge**  
**Over Bridge** Branch off R460  
**Under Bridge** Kildeema River  
**Townland(s)** LETTERKELLY  
**Parish\Barony**  
**Type/OS coord** Road over watercourse  
X: 512149 Y: 678286  
**Estimated Date** 1900 to 1930  
**NIAH Reg. No.**  
**NRA Ref. No.**

**Description:** Small single-span elliptical-arched stone bridge, spanning watercourse at right angles and supporting a humped deck. Recent rendered parapet on west side, no east parapet visible. Rubble-stone spandrels with rough-stone voussoirs to arch. Rubble-stone abutments.

**Condition:** 4: Poor. Very poor cement pointing throughout. Low quality finish to wing walls.

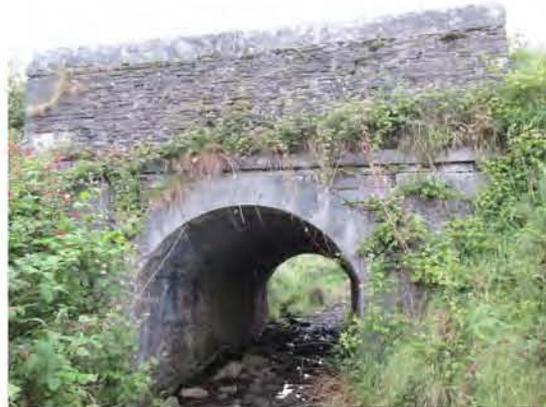
**Registration No.** 39  
**Name of Bridge**  
**Over Bridge** R460  
**Under Bridge**  
**Townland(s)** CLOGHAUN BEG  
**Parish\Barony**  
**Type/OS coord** Road over watercourse  
X: 511243 Y: 677994  
**Estimated Date** 1750 to 1800  
**NIAH Reg. No.**  
**NRA Ref. No.**

**Description:** Small single-span segmental-arch stone bridge, spanning watercourse at right angles and supporting a flat deck. Large square coping course on rubble-stone parapet, soldier course of roughly squared stones to centre portion of copings. Square string course above rubble-stone spandrels, arch of equally sized cut-stone voussoirs, barrel of squared rubble stone. Abutments of random squared rubble stone. Battered wing buttresses of ashlar.

**Appraisal** A well composed and elegant structure. It is a good example of the style and craftsmanship used in bridges from this time.

**Condition:** 3: Fair. Ivy and other vegetation in areas.

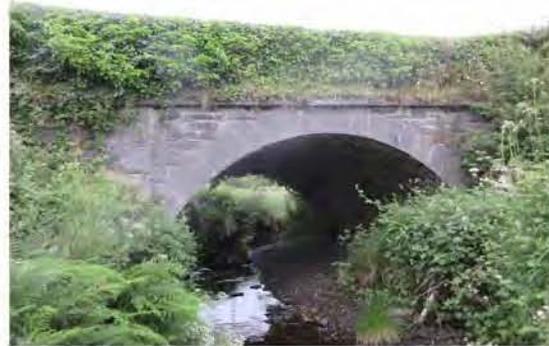
**Description:** Large single-span segmental-arched stone bridge, dated 1872, spanning a watercourse at right angles and supporting a level deck. Large squared stone coping course on rubble-stone parapets. Squared stone stringcourse over squared stone spandrels keyed with smooth cut-stone voussoirs. All flanked by battered rock-faced buttresses. Barrel and abutments of squared random stone.

**Appraisal** An elegant and imposing structure, now largely concealed by vegetation, that could give strong architectural definition to its rural setting and approach to Milntown Malbay. Plaque mentioned in RPS not found.

**Condition:** 3: Fair. Dense vegetation cover including ivy. Some abutment stones coming loose.

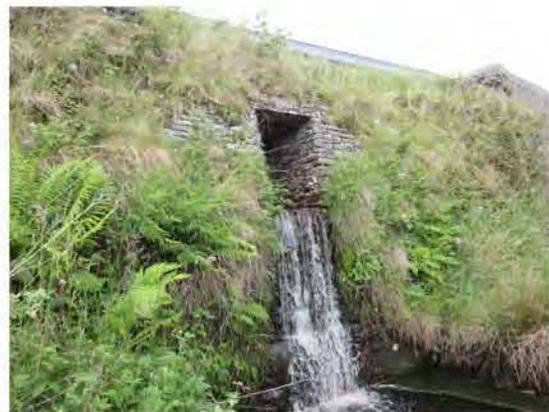
**Description:** Culvert bridge of rubble stone with single span, level deck and orthogonal crossing. South parapet damaged and removed, north parapet of recent concrete blockwork. South face in elevated position with wing walls and face of dry laid random squared stone spilling water to pool below. Soffit of span of large flat stones.

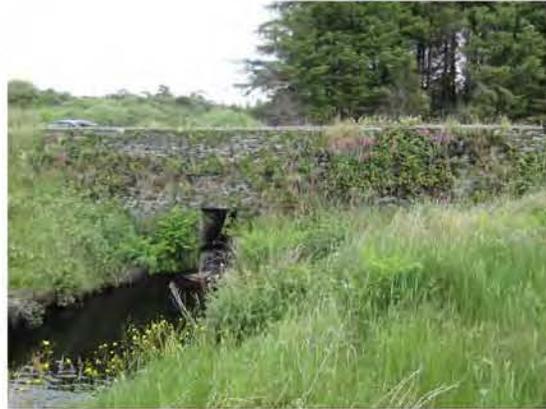
**Registration No.** 42  
**Name of Bridge**  
**Over Bridge** R474  
**Under Bridge** Caheraran River  
**Townland(s)** SHANAVOGH EAST  
**Parish\Barony**  
**Type/OS coord** Road over watercourse  
X: 512372 Y: 675622  
**Estimated Date** 1750 to 1800  
**NIAH Reg. No.**  
**NRA Ref. No.**

**Description:** Culvert bridge of rubble stone with single span, level deck and orthogonal crossing. Recent cement coping. Splayed bank wall on north redirecting watercourse.

**Appraisal** A modest structure typically used in crossing small watercourses using local materials. It has a large face to its landscape context to the south.

**Condition:** 3: Fair. Vegetation on faces.

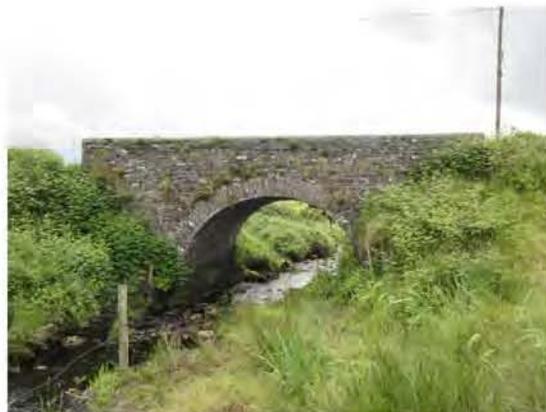
**Description:** Medium-sized single-span semi-circular arched stone bridge, spanning watercourse at right angles and supporting a level deck. Cement coping on rubble-stone parapets. Rubble-stone spandrels. Small rough unequal squared stone voussoirs with large splayed keystone, barrel and abutments of random small squared stone. Footings of larger squared random stones.

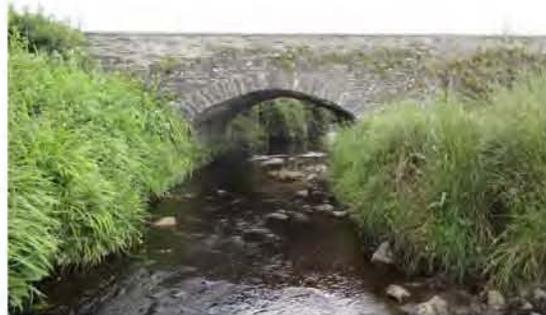
**Registration No.** 44  
**Name of Bridge** Doonsallagh Bridge  
**Over Bridge** R474  
**Under Bridge** Kildeema River  
**Townland(s)** DOONSALLAGH EAST \  
DOONSALLAGH WEST \  
KNOCKBRACK  
(CORCOMROE)

**Description:** Medium-sized single-span four-centred stone arch bridge, spanning watercourse at right angles and supporting a level deck. Rebuilt south parapet of rubble stone with flat stone copings, north parapet of rubble stone with cement finish to coping level. Rubble-stone spandrels, unequal rough-stone voussoirs with large splayed keystones. Rubble-stone barrel and squared random-stone abutments.

**Appraisal** A structure of robust appearance with an elegantly constructed arch. It is a good example of the construction technique for bridge structures of this time

**Condition:** 3: Fair. Crack in spandrel. Cement pointing in many areas

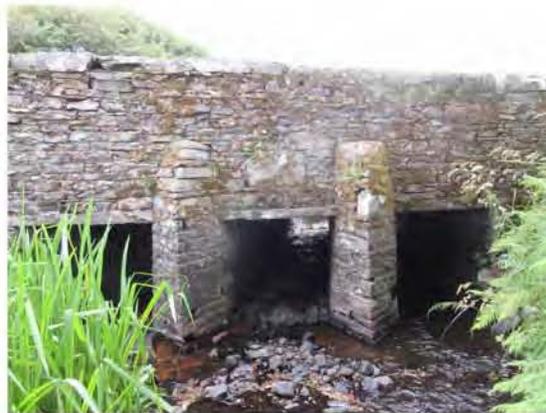
**Description:** Culvert bridge of rubble stone with three spans, level deck and orthogonal crossing, v-cutwaters. Larger stone coping course to north parapet. Stone dressing to beds.

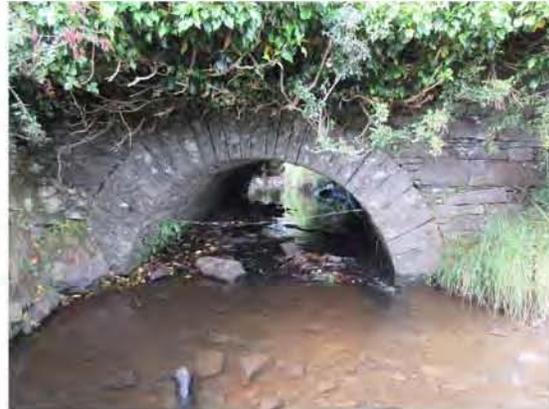
**Description:** Small single-span semi-circular stone arched bridge, spanning watercourse at right angles and supporting a level deck. Remains of rubble-stone parapets. Rubble-stone spandrels and wing walls. Arch voussoirs of unequal splayed flat faced stones. Rubble-stone barrel.

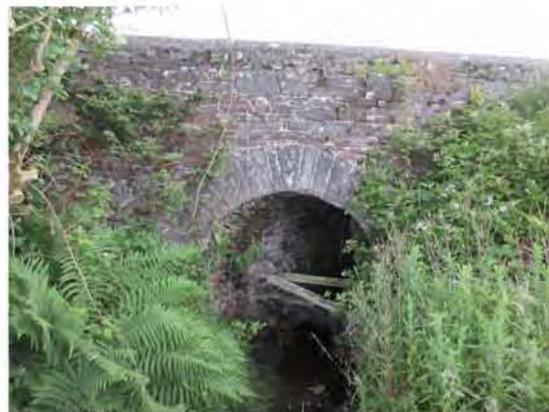
**Description:** Small single-span semi-circular stone arched bridge, spanning watercourse at skewed angle and supporting a level deck. Cement coping on rubble-stone parapets. Rubble-stone spandrels and wing walls. Arch voussoirs of unequal splayed flat faced stones. Rubble-stone barrel and abutments.

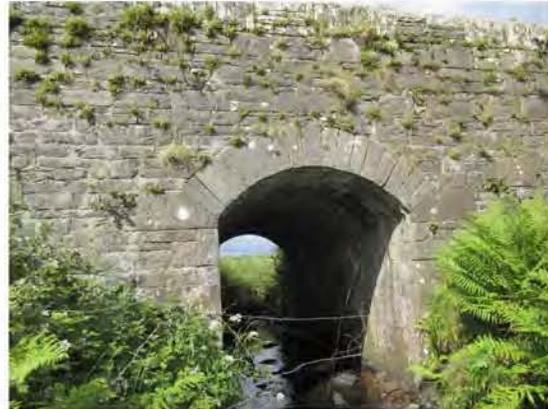
**Description:** Small single-span segmental-arched stone bridge, spanning watercourse at right angles and supporting a level deck. Coping course of rough square stones arranged in alternate vertical and horizontal manner, large square block stones to ends, all on random squared stone parapets, spandrels and wing walls. Arch of splayed voussoirs of varying sizes resting on wide set springing stones. Barrel of random squared stone. Abutments of coursed random squared stone. Stone lining to bank on south side

**Appraisal** A well composed structure with an elegant arch composition, demonstrating a good range of stone techniques for a structure of its time.

**Condition:** 2: Good. Cement pointing in areas. Ivy in areas

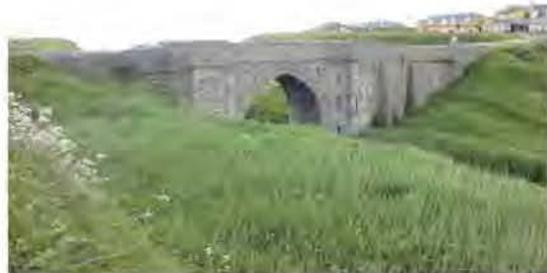
**Description:** Large and tall single-span stone bridge, dated 1824, spanning watercourse at right angles and supporting a flat deck. Wider approach to both ends meet bridge bay with advanced turret-bays and concave walls. Capping stones of parapets sloping to and oversailing outer face of parapets. Ashlar parapets standing on stepped brackets in arch bay and on stepped string courses beyond. Balustraria recesses to face of turret parapets on west side. Ashlar spandrels with circular recess and offset wing-shaped recesses. Two-centred pointed arch having equal-sized cut-stone voussoirs framed by square stone band. Arch and spandrels framed by square stone band. Barrel of roughly squared stones, abutments of coursed square block stone. Cruciform and slit balustrarias to concave walls framing arch bay. Turret face with shields baring cruciform and band motifs, slot and cruciform balustrarias below with battered footing at base. Ashlar wing walls on west side, rubble stone wing walls on east side.

**Appraisal** A striking and original composition in neo-Gothic style in a fine estuary landscape setting. It is a strong architectural landmark on the coast to the south of Spanish Point. Similar in appearance to the Dry Bridge at Pollophuca in County Wicklow, generally attributed to Alexander Nimmo.

**Condition:** 2: Good. Quality of deck reduced by incongruous crash barriers. Poor stone repairs in areas.

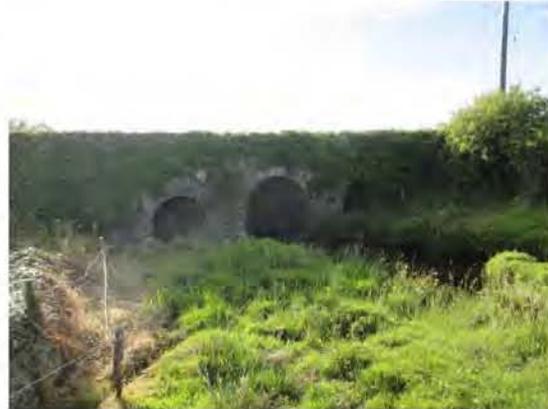
**Description:** Middle-sized three-span semi-circular arched stone bridge, spanning watercourse at right angles and supporting a level deck. Larger arch span in centre. Coping course of squared horizontal stones broken with soldier courses on rubble-stone parapets. Spandrels of rubble stone, voussoirs of unequal rough square stones with intermittent splayed sections and keystone, barrel of rubble stone. Abutments and v-cutwaters of rubble stone. Rubble-stone wing walls.

**Appraisal** A fine composition of arched spans and raised embankment. Parapet coping detail typical of bridges of later date and likely to be additions.

**Condition:** 3: Fair. Damage to parapets. Dense vegetation and general growth on bridge faces. Service pipe on west face.

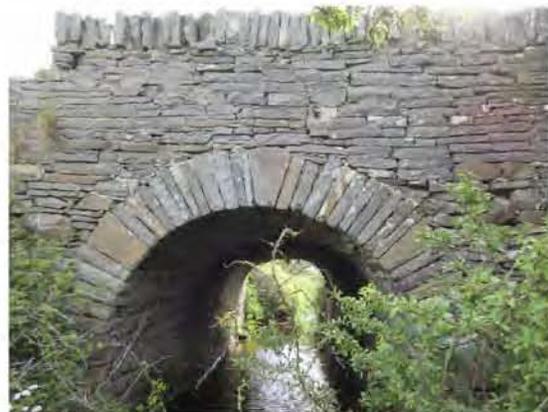
**Description:** Small single-span semi-circular stone arched bridge, spanning watercourse at right angles and supporting a level deck. Scotch coping on rubble-stone parapets. Rubble stone spandrels. Rough square stone voussoirs with intermittent splayed stones and splayed keystone, squared rubble-stone barrel and abutments. Rubble-stone wing walls.

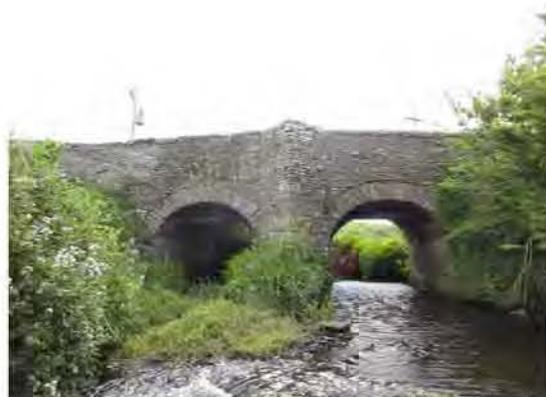
**Description:** Medium-sized two-span semi-circular arched stone bridge, spanning a watercourse at right angles and supporting a humped deck. Large random squared stone coping course on rubble-stone parapets. West parapet incorporating v-refuge over cutwater below with stone raised floor. Spandrels, abutments, cutwater, barrel and wing walls of roughly squared and layered rubble stone. Arch voussoirs of squared rough stone with large splayed keystones.

**Appraisal** A handsome bridge composition of robust character in a fine landscape setting. The bridge refuge allows pedestrians to better appreciate the structure and watercourse. It's close proximity and similarity to bridge 53 adds further interest to the context.

**Condition:** 3: Fair. Parapets rebuilt in areas using cement mortar. Service pipe penetrating barrel. Dense vegetation, including ivy, in areas.

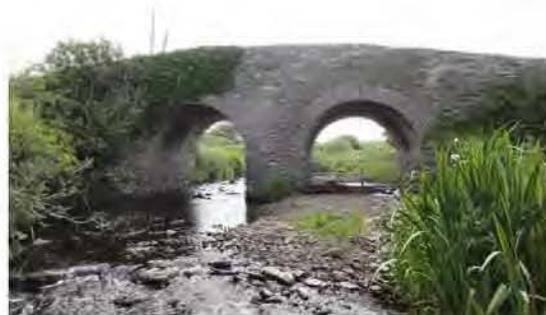
**Description:** Medium-sized two-span semi-circular arched stone bridge, spanning a watercourse at right angles and supporting a humped deck. Large random squared stone coping course on rubble-stone parapets. West parapet incorporating v-refuge over cutwater below. Spandrels, abutments, cutwater, barrel and wing walls of roughly squared and layered rubble stone. Arch voussoirs of squared rough stone with large splayed keystones.

**Appraisal** A handsome bridge composition of robust character in a fine landscape setting. The bridge refuge allows pedestrians to better appreciate the structure and watercourse. It's close proximity and similarity to bridge 53 adds further interest to the context. NIAH records show images for this bridge with wrong name of Stackpooles Bridge (South) (recorded as site 51 in this survey).

**Condition:** 3: Fair. Parapets rebuilt in areas using cement mortar. Service pipe penetrating cutwater. Vegetation, including ivy, in areas. Similar to neighbouring bridge 52

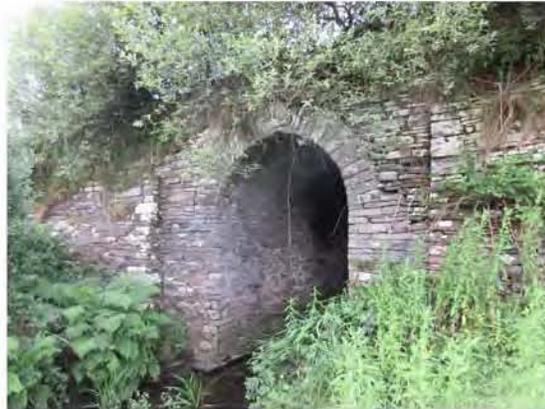
**Description:** Small single-span semi-circular arched stone bridge, spanning watercourse at right angles and supporting a level deck. Spandrels, tall abutments, barrel and battered wing walls of roughly squared and layered rubble stone. Arch voussoirs of squared rough stone with larger splayed keystones.

**Appraisal** A well-composed arrangement in a fine landscape setting. It is a good demonstration of stone construction techniques for its time.

**Condition:** 3: Fair. Parapets heavily overgrown. Service pipe penetrating barrel. Spandrel stones loose in areas.

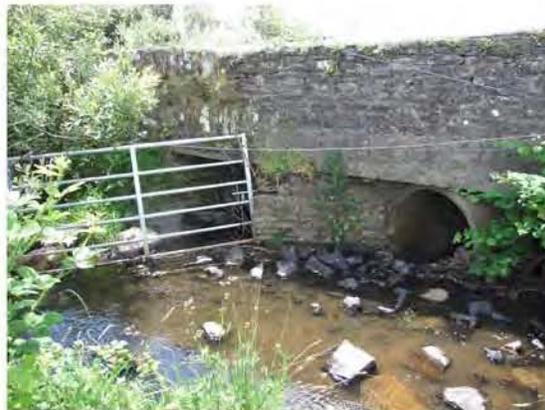
**Description:** Culvert bridge of rubble stone with three spans, level deck and skewed crossing. One v-cutwater and one flat arch remaining. Parapets poorly rebuilt with cement coping and pointing. Soffit replaced with reinforced concrete. Channels filled with concrete pipes, abutments rebuilt.

**Appraisal** An example of a modest and typical structure altered and amended in a very unsympathetic manner

**Condition:** 4: Poor. Subjected to poor quality repairs and alterations

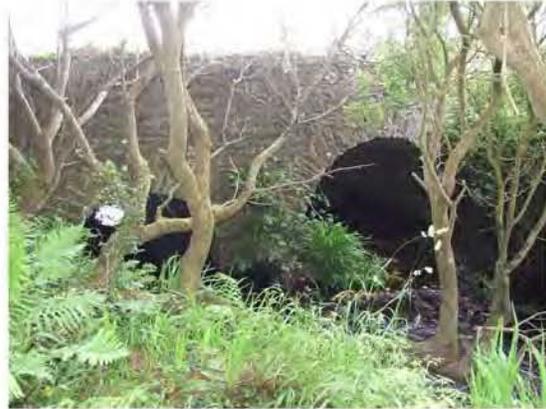
**Description:** Small two-span semi-circular arched stone bridge, spanning watercourse in dogleg arrangement and supporting a humped deck. Cement coping layer on rubble-stone parapets. Rubble-stone spandrels. Arch voussoirs of squared rough stone with larger splayed keystones, north span larger than south span. Barrel and abutments of rubble stone. V-cutwater on west elevation. Stone dressing to river bed. Stone-lined curved bank on north-west side.

**Appraisal** A small structure of robust expression. It demonstrates stone construction typical for bridges of its date. The stone lining to the bed is a notable feature.

**Condition:** 3: Fair. Cement finish to parapet and cement pointing throughout. Channels partially blocked by plant debris. Dense vegetation in areas.

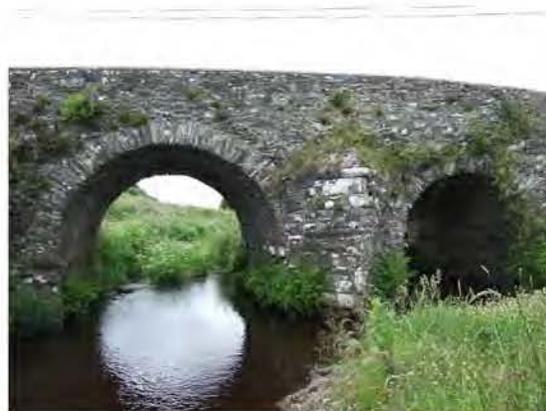
**Description:** Medium-sized two-span semi-circular arched stone bridge, spanning watercourse at right angles and supporting a humped deck. Cement coping layer on rubble-stone parapets. Rubble-stone spandrels. Arch voussoirs of squared rough stone with larger splayed keystones, north span smaller than south span. Barrel and abutments of rubble stone, projecting corbels at seat of barrel. V-cutwater on east elevation.

**Appraisal** The structure is a handsome composition with robust expression standing in a prominent landscape location. It is a good demonstration of stone construction of its date. The projecting corbels for the barrel formwork are of special note.

**Condition:** 3: Fair. Cement pointing throughout. Replacement sections of wing walls with concrete blocks. Crack in barrel of south span. Vegetation growth to faces in areas.

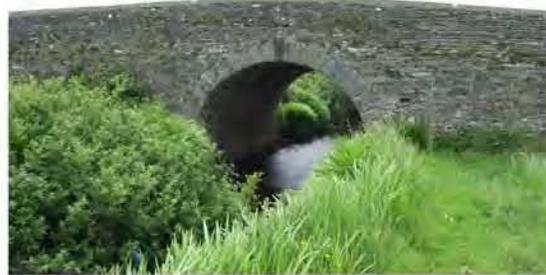
**Description:** Medium-sized single-span semi-circular arched stone bridge, spanning watercourse at right angles and supporting a humped deck. Cement coping on rubble-stone parapets. Rubble-stone spandrels, wing walls and abutments. Barrel of rubble stone and arch voussoirs of roughly splayed unequally sized stones with large keystone.

**Appraisal** A well composed structure of simple expression in a fine open landscape setting. The bridge stands lightly askew, affording good views of its faces. Similar to bridge 59

**Condition:** 3: Fair. Cement pointing in areas, cement coping. Abutment stones loosening in areas.

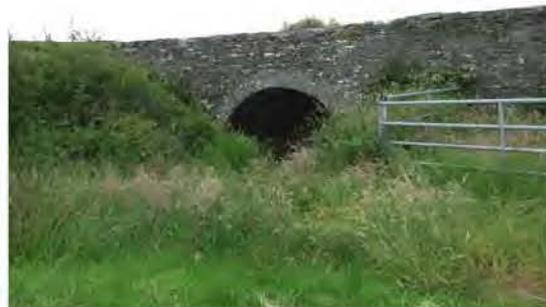
**Description:** Medium-sized single-span segmental-arched stone bridge, spanning watercourse at right angles and supporting a humped deck. Cement coping with some larger flat stones on rubble-stone parapets. Rubble-stone spandrels and wing walls. Abutments of random squared stone. Barrel of rubble stone and arch voussoirs of roughly splayed unequally sized stones with large keystone.

**Condition:** 3: Fair. Cement pointing in areas, cement coping. Abutment stones loosening in areas.

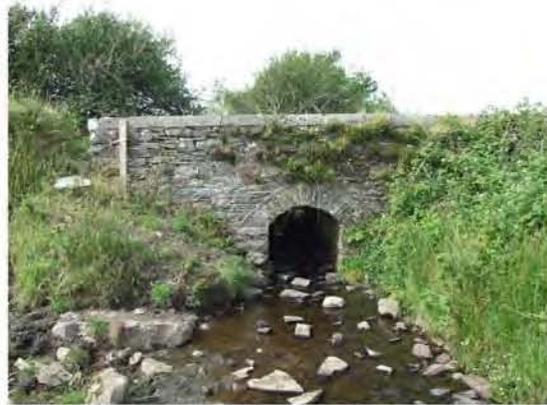
**Description:** Small single-span segmental arched stone bridge. Cement coping on rubble-stone parapets. Rubble-stone spandrels and wing walls. Rough unequal sized stone voussoirs to arch, barrel of rubble stone. Rubble-stone abutments. Remains of stone dressing to bed.

**Condition:** 3: Fair. Heavy-handed cement coping and pointing throughout.

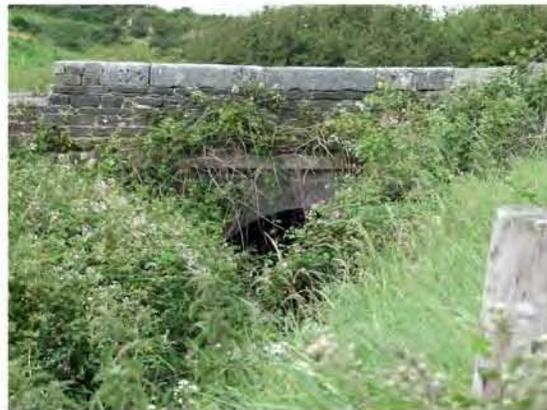
**Description:** Small but deep set single-span semi-circular arched stone bridge, spanning watercourse at right angles and supporting a level deck. Large square coping course on rubble-stone parapets. Square string course over rubble-stone spandrels. Equally sized hammer-faced voussoir stones.

**Condition:** 3: Fair. Damage to parapets. Dense vegetation including ivy, north side completely overgrown

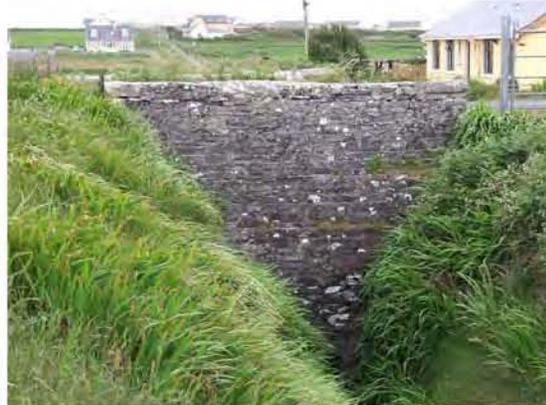
**Registration No.** 62  
**Name of Bridge**  
**Over Bridge** R482  
**Under Bridge**  
**Townland(s)** BREAFFY SOUTH  
**Parish\Barony**  
**Type/OS coord** Road over watercourse  
X: 503207 Y: 679159  
**Estimated Date** 1750 to 1800  
**NIAH Reg. No.**  
**NRA Ref. No.**

**Description:** Small single-span culvert bridge in deep-set channel. Tall stepped rubble-stone face and parapet, coping course including large flat squared stones.

**Condition:** 3: Fair. Damage to parapets

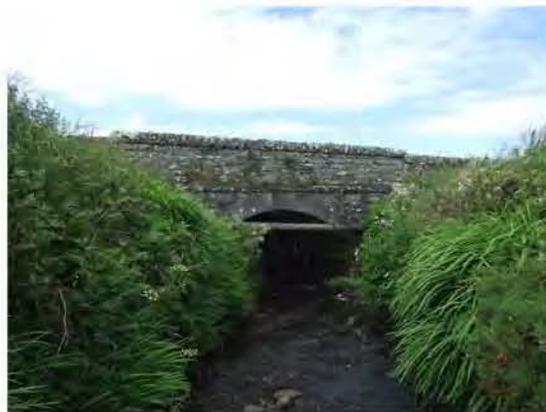
**Description:** Medium-sized single-span segmental-arched stone bridge, crossing watercourse at right angles and supporting a level deck. Rock-faced soldier course coping course with large block end stones on random-squared rock-faced parapets. Square stone string course above random-squared rock-faced spandrels and hammer-faced evenly sized arch voussoirs. Barrel of random squared stone. Abutments of rock-faced squared stone. Wing walls and wing-wall parapets same as bridge proper.

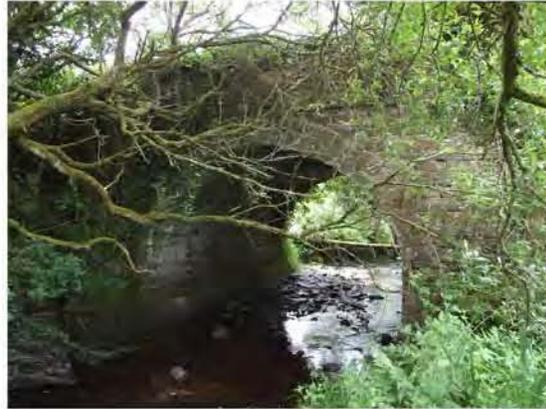
**Description:** Medium-sized single-span semi-circular arched stone bridge, spanning watercourse at right angles and supporting a level deck. Coping course of roughly squared stones in alternate vertical and horizontal pattern on rubble-stone parapets. Parapets slightly oversailing spandrels of random-squared rubble stone. Voussoirs of equally-sized stones with larger keystone and rough faced springing stones. Abutments and footings of random squared stone, rounded corners at footing level. Remains of stone dressing to river bed.

**Condition:** 3: Fair. Dense vegetation, including ivy, to both faces. Parapets largely overgrown.

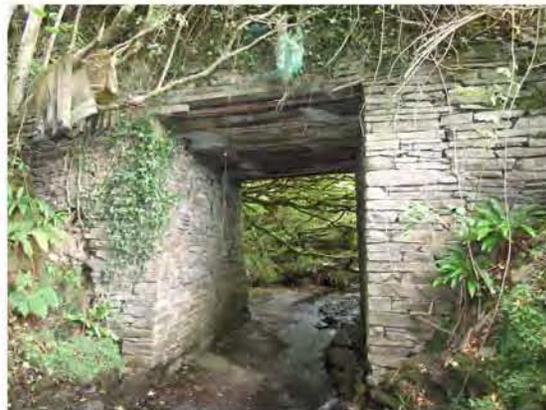
**Description:** Medium-sized single flat-span stone and iron bridge, spanning watercourse in dogleg arrangement and supporting a flat deck. Span of equally spaced iron beams infilled with stone flags. Faces and abutments of random squared stone, some stone slips remaining to face of edge metal beam. Exposed stone floor to bed. Curved stone-dressed embankment to south-east abutment.

**Condition:** 4: Poor. Dense vegetation growing at deck level. Wing walls collapsing in areas. Metal beams badly corroded and sagging.

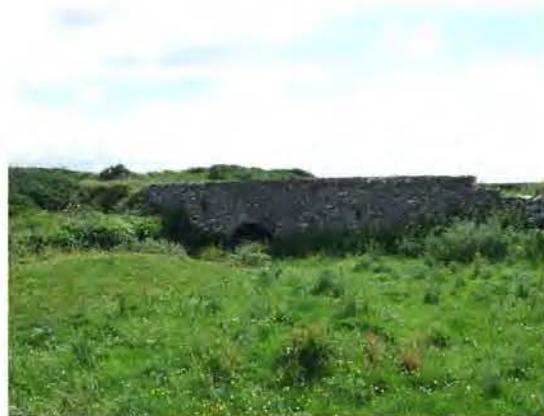
**Description:** Small single-span semi-circular arched stone bridge, spanning watercourse at right angles and supporting a level deck. Coping course of large squared stones alternating with short courses of vertically arranged square stones, all on parapets of roughly-squared rubble-stone with drainage slots. Spandrels and wing walls also of roughly-squared rubble stone. Arch of unequally sized voussoirs, barrel of roughly-squared rubble stone. Footings of larger squared stones.

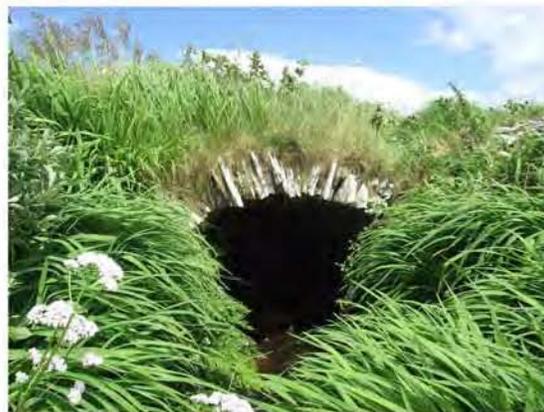
**Registration No.** 67  
**Name of Bridge**  
**Over Bridge**  
**Under Bridge** Cloonbony River  
**Townland(s)** CLOONBONY \ FINTRA  
MORE  
**Parish/Barony**  
**Type/OS coord** Road over watercourse  
X: 505598 Y: 680576  
**Estimated Date** 1700 to 1750  
**NIAH Reg. No.**  
**NRA Ref. No.**

**Description:** Small single-span semi-circular arched stone bridge, crossing watercourse at right angles and supporting a level deck. Barrel of rubble-stone, faces to both sides missing.

**Condition:** 4: Poor. Faces to both sides fallen away and abutments collapsing in areas. Dense vegetation throughout.

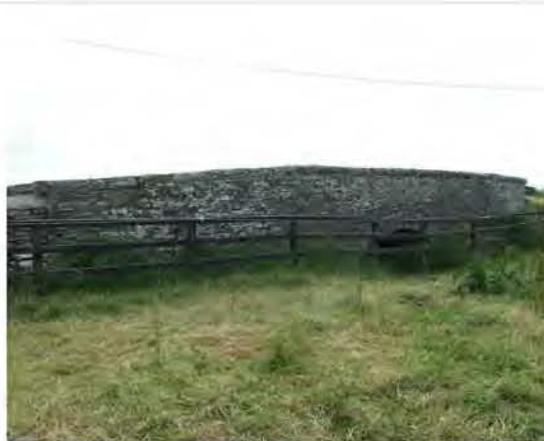
**Description:** Medium-sized single span semi-circular arched stone bridge, spanning dismantled railway line at skewed angle and supporting a humped deck. Coping course of large square rock-faced stones on rubble-stone parapets. Spandrels of rubble stone. Arch of rock-faced voussoirs, barrel of roughly-squared rubble stone. Abutment of random squared rock-faced stone.

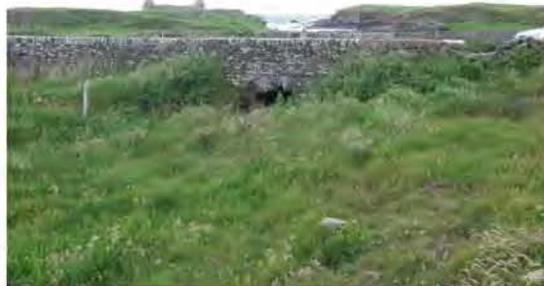
**Description:** Small single-span elliptical arched stone bridge, spanning watercourse at right angles and supporting a level deck. Soldier coping course of large squared stones on parapets of roughly-squared rubble-stone. Spandrels and wing walls also of roughly-squared rubble stone. Arch of unequally sized voussoirs, barrel of rubble stone. Footings of larger squared stones.

**Condition:** 3: Fair. Settlement in areas. Voussoir stones breaking. Cement pointing in areas

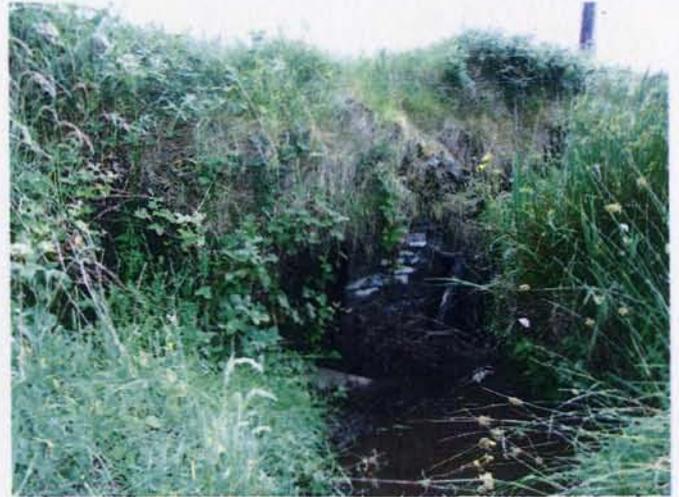
**Registration No.** 71  
**Name of Bridge**  
**Over Bridge** Former railway  
**Under Bridge**  
**Townland(s)** DRUMMIN (IBRICKAN)  
**Parish\Barony**  
**Type/OS coord** Railway over access way  
X: 505350 Y: 681988  
**Estimated Date** 1860 to 1890  
**NIAH Reg. No.**  
**NRA Ref. No.**

**Description:** Small single-span semi-circular arched stone bridge, spanning former accessway at right angles and supporting a former railway line. No parapets remaining, spandrels of roughly-squared rubble stone. Arch of rock-faced voussoirs, barrel of rubble stone. Abutments of random squared stone. Soldier course of squared stone on sloping retaining walls to either side of opening.

**Condition:** 4: Poor. Copings missing, dense vegetation to top.

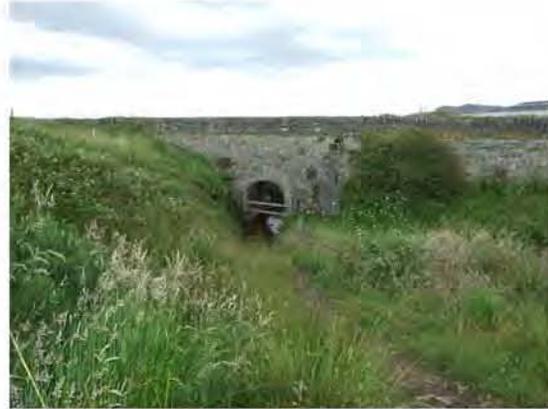
**Description:** Small sized single span set in large structure with semi-circular arch, spanning watercourse at right angles and supporting a level deck. Scotch coping on rubble-stone parapets. Random-squared spandrels and wing walls, large square iron restraining plates to both faces. Arch of rough unequal voussoir stones. Barrel and abutments now concealed by gunnitting. Footings of concrete.

**Condition:** 4: Poor. Unsympathetic treatment of barrel and abutments. Poor reconstruction of parapets in areas.

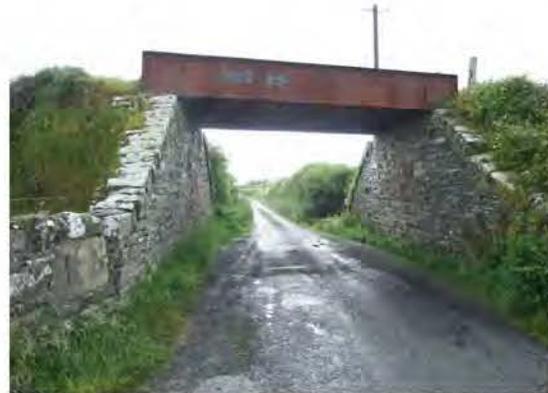
**Registration No.** 73  
**Name of Bridge**  
**Over Bridge**  
**Under Bridge** L-6236-0  
**Townland(s)** DRUMMIN (IBRICKAN)  
**Parish\Barony**  
**Type/OS coord** Railway bridge over road  
X: 505236 Y: 681204  
**Estimated Date** 1860 to 1890  
**NIAH Reg. No.**  
**NRA Ref. No.**

**Description:** Medium-sized single-span flat-beam bridge, spanning road at right angles and supporting a flat deck. Parapets of cast iron having framework of cast-iron profiles with plate infill, all riveted. Beam supports to deck of cast-iron profiles with recent concrete infill. Abutment walls of coursed random square stone with sloping wings capped by soldier course of roughly squared stone, large flat copings to ends.

**Condition:** 3: Fair. Iron profiles corroding badly. Some parapet stones missing

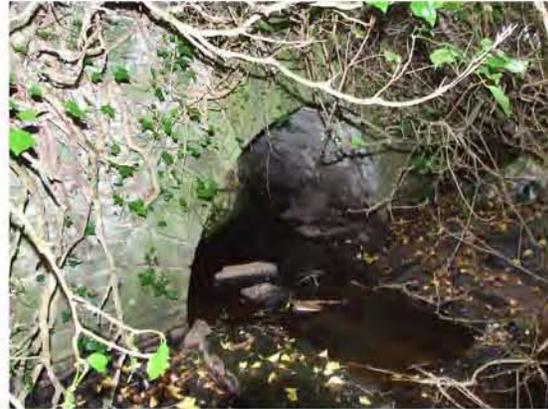
**Description:** Small single-span semi-circular arched bridge, spanning watercourse in dogleg arrangement and supporting a level deck. No parapets visible. Spandrels and wing walls of rubble stone. Arch voussoirs of smooth faced stone. Rubble-stone barrel.

**Condition:** 3: Fair. North face not accessible. Dense vegetation at deck level to both sides.

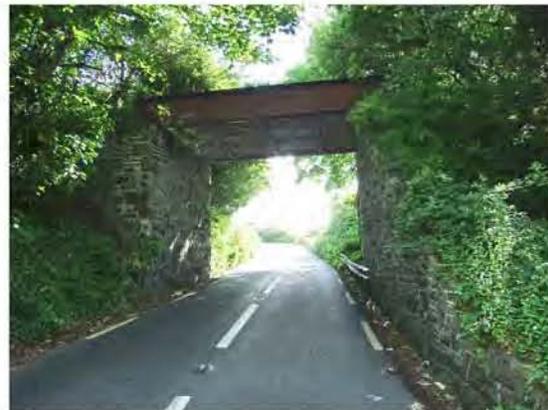
**Description:** Medium-sized single-span flat-beam bridge, spanning road in dogleg arrangement and supporting a flat deck. Parapets of cast iron having framework of cast-iron profiles with plate infill, all riveted. Beam supports to deck of cast-iron profiles with recent concrete infill. Abutment walls of coursed random square stone with vertical wing walls, sloping wing wall to south east capped by soldier course of flat squared stone.

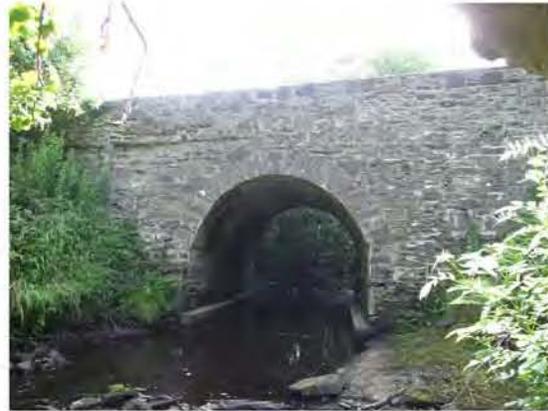
**Description:** Medium-sized single-span semi-circular arched stone bridge, spanning river at right angles and supporting a level deck. Rubble-stone parapet on rubble-stone spandrels and wing walls. Unequal sized rhomboid arch stone interspersed with splayed voussoirs and key stone. Rubble-stone barrel and abutments. Abutments continue to line banks on all but one face. Footings encased in concrete.

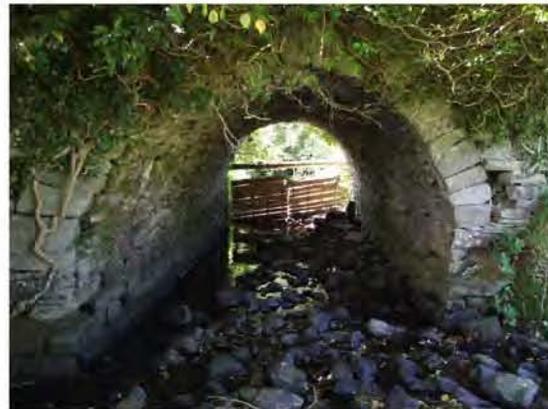
**Description:** Small single span semi-circular arched stone bridge, spanning watercourse at right angles and supporting a level deck. Parapets overgrown. Spandrels and wing walls of rubble stone. Arch voussoirs a mix of square and splayed stones. Barrel and abutments of rubble stone.

**Condition:** 4: Poor. Dense vegetation, including ivy, at deck level. Parapets concealed. Stones loose in areas.

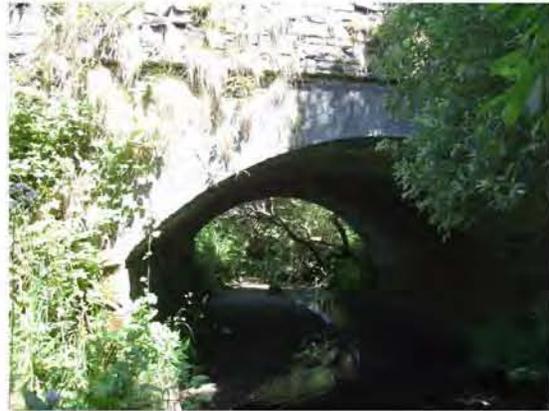
**Description:** Medium-sized single-span segmental-arched stone bridge, spanning watercourse at right angles and supporting a ramped deck. Large squared stone coping course on rubble-stone parapets. Parapet oversailing rubble-stone spandrels. Arch voussoirs of cut stone, equally wide but increasing in depth towards arch abutments. Barrel of rubble stone. Abutments and footings of coursed squared stone.

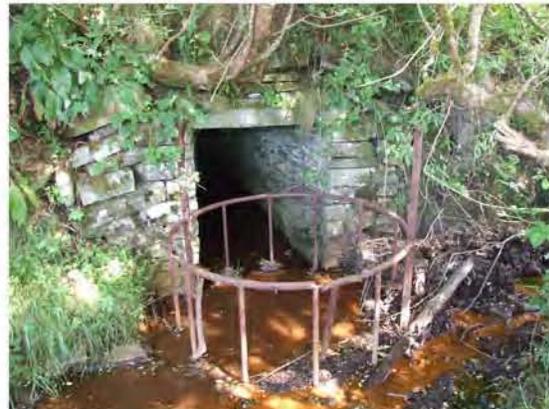
**Description:** Small single-span culvert, spanning a watercourse at right angles and supporting a level deck.

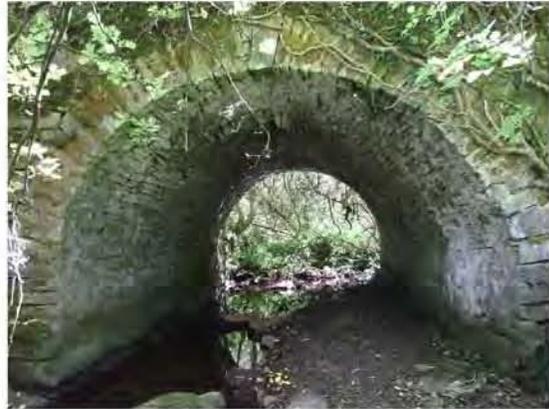
**Description:** Medium-sized single-span semi-circular arched stone bridge, spanning watercourse in dogleg arrangement and supporting a level deck. Large squared stone coping course on rubble-stone parapets. Rubble-stone spandrels and wing walls. Arch of roughly squared stones with intermittent splayed stones and keystone. Barrel and abutments of rubble stone. Large stones in footing course. Stone lining to north-west bank.

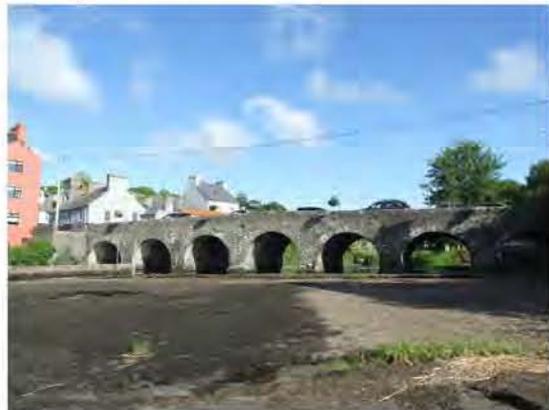
**Description:** Large seven-span segmental-arched stone bridge, spanning river at right angles and supporting a humped deck. Coping course of large square stones with rounded upper edges on rubble-stone parapets. Parapet to southwest curves with road, parapets to east end abutting buildings either side of road. Plaque on parapet reads 'MICHAEL CONWAY/VOLUNTEER MID CONWAY BRIGADE I.R.A./ KILLED IN ACTION JULY 1920/ Solas na bhFlaitheas sa anam'. Rubble-stone spandrels. Arch voussoirs of unequally-sized and roughly-squared stones with intermittent splayed units, larger arches to centre of bridge. Barrels of rubble stone, two to east end with gunnitting. Abutments of squared rubble stone. Ashlar v-cutwaters to south side with half-pyramid cappings.

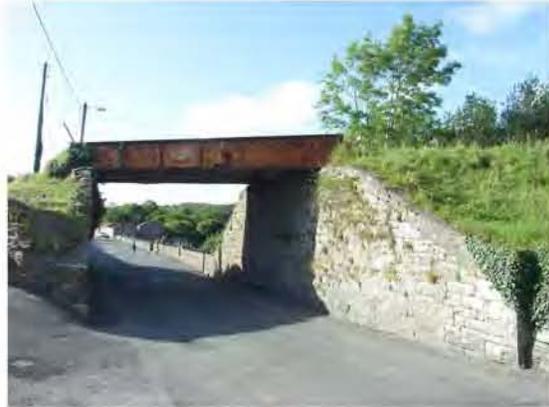
**Registration No.** 82  
**Name of Bridge**  
**Over Bridge**  
**Under Bridge** New Line  
**Townland(s)** ARDNACULLIA NORTH  
**Parish\Barony**  
**Type/OS coord** Former railway over road  
X: 513057 Y: 688209  
**Estimated Date** 1860 to 1890  
**NIAH Reg. No.**  
**NRA Ref. No.**

**Description:** Medium-sized single-span flat-beam bridge, spanning road at skewed angle and supporting a flat deck. Parapets of cast iron having framework of cast-iron profiles with plate infill, all riveted. Beam supports to deck of cast-iron profiles with recent concrete infill. Abutment walls of coursed random square stone with wing walls sloping with embankments.

**Condition:** 4: Poor. Iron profiles corroding badly. Coping stones to wing abutment missing

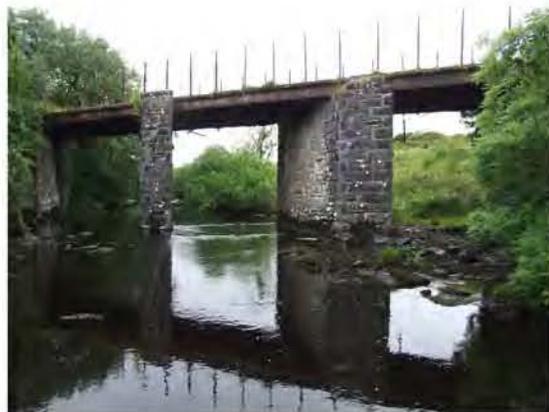
**Description:** Large-sized three-span flat-beam bridge, spanning river at skewed angle and supporting a flat deck. Shallower edge beams and two deep beams of cast iron composed of riveted cast-iron flanges and webs, deck floor of recent concrete. Rhomboid support piers walls of random square rock-faced stone, dressed at pier corners, centre cast-iron beams resting on projecting stone course. Abutments of random square rock-faced stone, also dressed at corners.

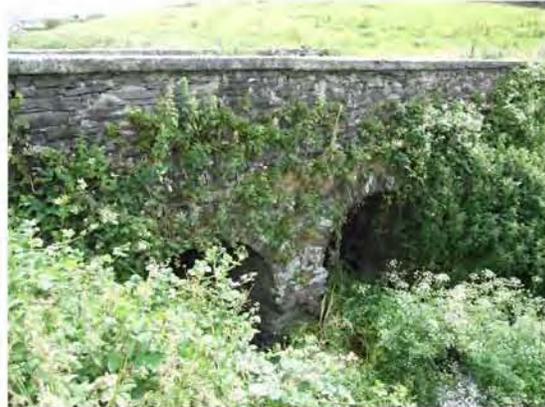
**Description:** Small two-span semi-circular arched stone bridge, spanning a watercourse at shewed angles and supporting a level deck. Concrete coping on rubble-stone parapets. Rubble-stone spandrels and wing walls. Arch of mixed square and splayed voussoirs. Barrel of rubble stone, abutments of squared rubble stone.

**Condition:** 4: Poor. Unsympathetic concrete coping and cement pointing throughout. Vegetation growing on both faces. No access to water level due to steep banks and dense vegetation.

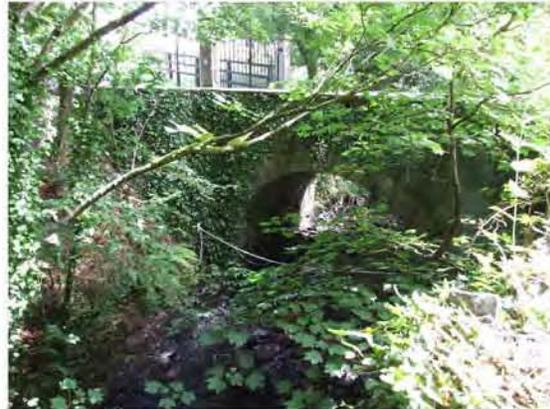
**Description:** Small-sized single-span semi-circular arched stone bridge, spanning watercourse at right angles and supporting a flat deck. The bridge leads to the entrance of Kilmanaheen Glebe and abuts retaining wall to road on south side. Sloped cut-stone saddle stone coping with metal connecting cramps on rubble-stone parapet walls. Parapet walls splay on north side at location of tall stone gate piers. Rubble-stone spandrels. Arch of cut-stone voussoirs with projecting keystone. Rubble stone barrel, abutments and footings.

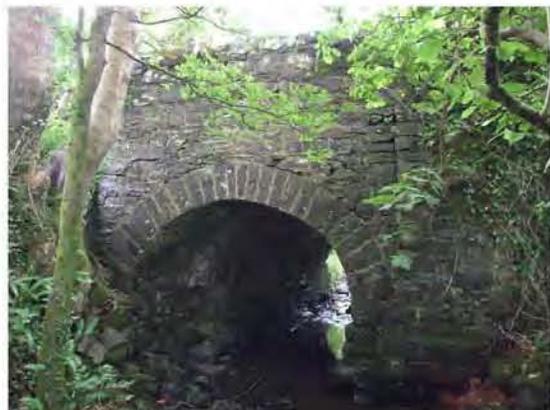
**Description:** Small single-span semi-circular arched stone bridge, spanning a watercourse at right angles and supporting a level deck. Cow-and-calf coping course on rubble-stone parapets. Rubble-stone spandrels and wing walls, battered wing walls flanking arch on west side. Arch of unequally-sized voussoirs. Rubble-stone barrel and abutments. Footings slope to stone-dressed bed.

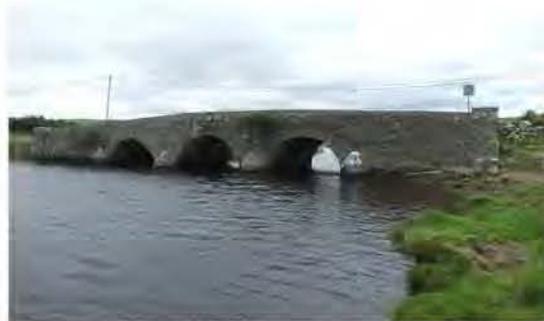
**Description:** Large three-span semi-circular arched stone bridge, spanning river at right angles and supporting a ramped deck. Large squared stone coping course on rubble-stone parapets. Pyramidal cappings to square piers at ends of parapets. Spandrels of rubble stone. Arch of unequally-sized voussoirs. Rubble-stone barrels. Abutments of large irregular squared stones. V-cutwaters on west side of square large stones and to cappings. V-cutwaters on east side encased in concrete and raised above height of arch that support a ramped concrete services platform along the face of the bridge, this is supported on the bank sides by concrete buttress piers, the ramped element is cased by a haunch concrete roof along its full length.

**Condition:** 4: Poor. Poor repairs in areas, cement pointing throughout. Damage to parapet ends.

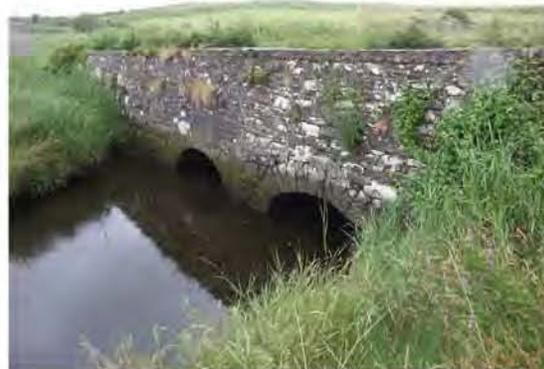
**Registration No.** 89  
**Name of Bridge**  
**Over Bridge** L-1046-0  
**Under Bridge** Knocknaraha River  
**Townland(s)** KILLASPUGLONANE  
**Parish\Barony**  
**Type/OS coord** Road over watercourse  
 X: 509509 Y: 689966  
**Estimated Date** 1750 to 1800  
**NIAH Reg. No.**  
**NRA Ref. No.**

**Description:** Small twin-span elliptical-arched stone bridge, spanning watercourse at right angles and supporting a level deck. Cement topping to rubble-stone parapets. Rubble-stone spandrels and wing walls. Arch voussoirs of unevenly-sized square and splayed stones.

**Condition:** 3: Fair. Cement finish to parapets. Some vegetation to faces. No access to water level.

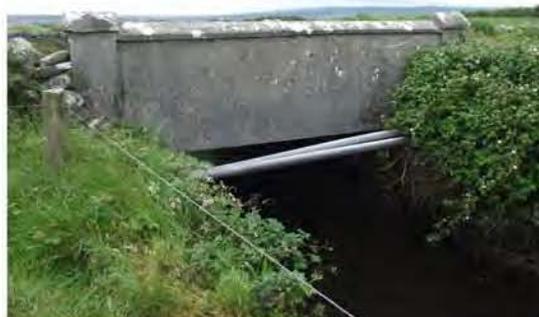
**Registration No.** 90  
**Name of Bridge** Laghcloon Bridge  
**Over Bridge** R478  
**Under Bridge**  
**Townland(s)** LAGHCLOON / LISCANNOR  
**Parish\Barony**  
**Type/OS coord** Road over watercourse  
X: 507251 Y: 688907  
**Estimated Date** 1900 to 1950  
**NIAH Reg. No.**  
**NRA Ref. No.**

**Description:** Small single flat-span bridge, spanning watercourse at right angles and supporting a flat deck. Rendered ridge copings on rendered parapets with gabled cappings over square end piers. Sluice shaft and mechanism on south elevation. Abutments of rubble stone.

**Condition:** 3: Fair. Cappings displaced in areas.

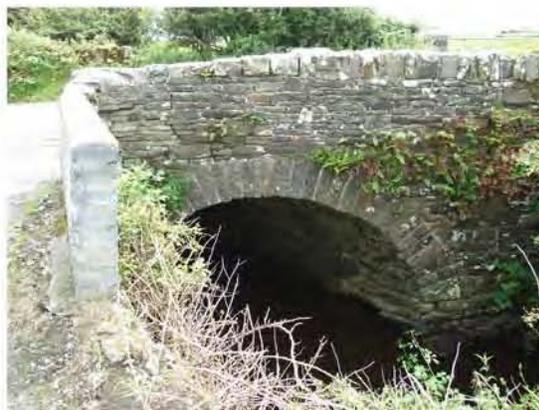
**Description:** Small single-span semi-circular arched stone bridge, spanning watercourse at skewed angle and supporting a level deck. Scotch coping to rubble-stone parapets. Rubble-stone spandrels and wing walls. Arch of unequally-sized square and splayed voussoirs. Barrel and abutments of rubble stone.

**Condition:** 3: Fair. Damage and rebuilt parapets. No access to water level or to south elevation.

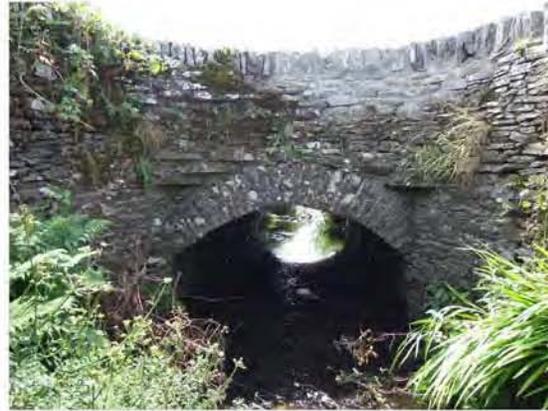
**Description:** Small single-span segmental-arched stone bridge, spanning watercourse at right angles and supporting a flat deck. Crossroads junction over bridge deck at skewed angle relative to span and watercourse. Scotch coping on rubble-stone parapets. Curved parapets meeting wing walls at junction corners and resting on corbelled spandrels. Rubble-stone outbuilding with stone flagged roof attached to east parapet. Arch voussoirs of roughly squared and splayed stones. Rubble-stone barrel and abutments.

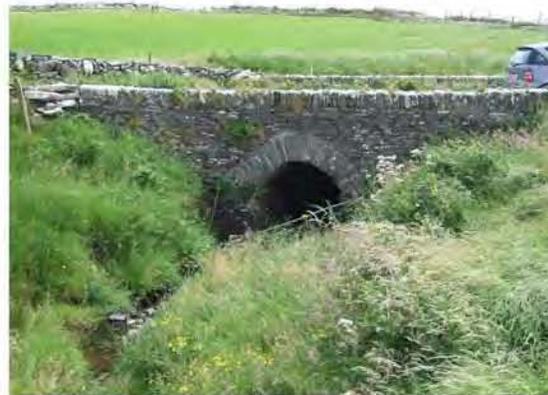
**Description:** Small single-span elliptical-arched stone bridge, spanning watercourse at right angles and supporting a level deck. Scotch coping to rubble-stone parapets with large blocks to ends. Rubble-stone spandrels and wing walls. Arch voussoirs of large unequally sized square and splayed stones. Rubble-stone barrel and abutments. Concrete casing to footing and stream bed.

**Condition:** 3: Fair. Some damage to parapets. Concrete to footings and bed.

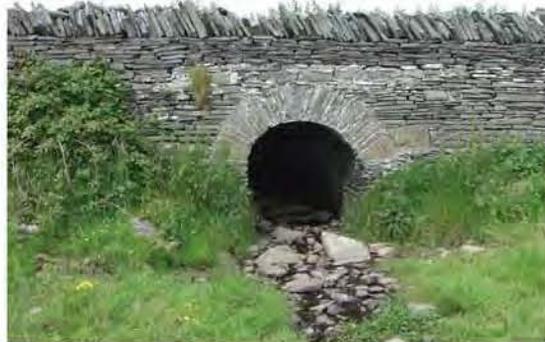
**Description:** Small single-span semi-circular arched stone bridge, spanning watercourse at right angles and supporting a ramped deck. Dry-stacked flat rubble-stone coping on rubble-stone parapets. Rubble-stone spandrels and wing walls. Arch voussoirs of roughly-squared flat and splayed stones. Barrel and abutments of rubble stone.

**Condition:** 3: Fair. Poor rebuilding and cement pointing in areas. North face blocked with metal sheet and cattle crush

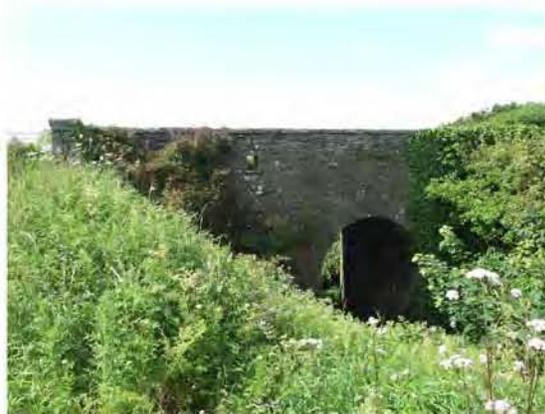
**Description:** Medium-sized single-span semi-circular arched stone bridge, spanning deep set watercourse at right angles and supporting a level deck. Large roughly squared coping stones on rubble-stone parapets. Parapets having drainage slots with sill stones, inscription on panel: MAGUIRES BRIDGE/BUILT IN 1938/BY THOMAS GREENE. Curved parapet end to southwest. Rubble-stone spandrels. Cut-stone voussoirs with larger keystone. Barrel and abutments of rubble stone.

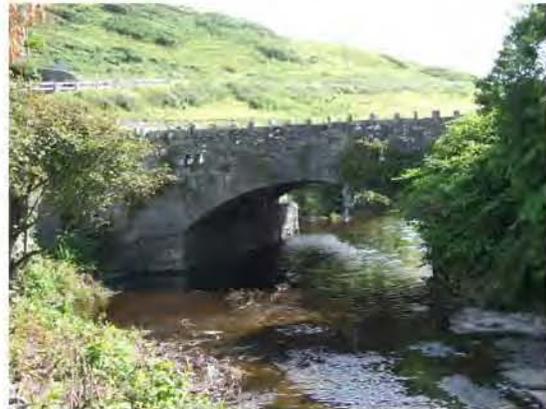
**Description:** Large single-span segmental-arched stone bridge, spanning watercourse at right angles and supporting a level deck. Cow-and-calf stone coping on coursed random squared stone parapets. Ashlar spandrels coursed into square-headed cut-stone spandrels, spandrels increase in depth towards abutments. Squared stone barrel and ashlar abutments.

**Condition:** 3: Fair. South side undergoing reconstruction or alteration. Vegetation to elevations, some facing stones missing.
