# THE BRIDGES OF NORTH COUNTY CLARE

*An Inventory of Civil Engineering Heritage*

*recorded and compiled by*  
**Lotts Architecture and Urbanism**

*for Clare County Council with the support of The Heritage Council*

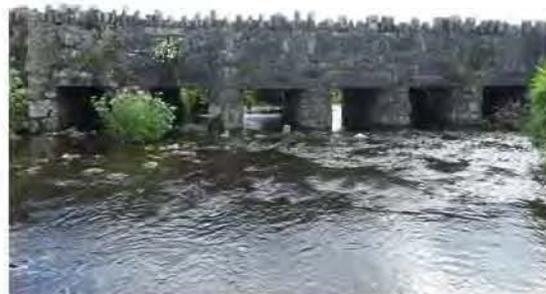
**Description:** Long arrangement of twelve-span trabeated stone bridge, spanning watercourse at right angles and supporting a level deck. Cow-and-calf coping on rubble-stone parapets. Parapets with drainage slots and two refuges over cutwaters on north side. Flat squared stones spanning between rubble-stone piers, piers with cutwaters on north side.

**Condition:** 3: Fair. Concrete beams replace stone beams in areas. Vegetation to areas of both faces. The wing walls were arranged in a funnell-like arrangement to the south side; this has now been partially removed and the previously narrow approach on the north side has been considerably widened. Large amounts of invasive species in river and along banks.

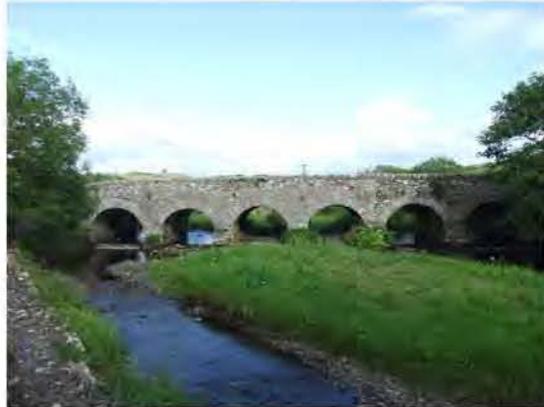
**Registration No.** 98  
**Name of Bridge**  
**Over Bridge** R479  
**Under Bridge**  
**Townland(s)** TEERGONEAN  
**Parish\Barony**  
**Type/OS coord** Road over watercourse  
X: 507972 Y: 697325  
**Estimated Date** 1750 to 1800  
**NIAH Reg. No.** 20400821  
**NRA Ref. No.**

**Description:** Large six-span segmental-arched stone bridge, spanning watercourse at right angles and supporting a ramped deck. Soldier course coping of rubble-stone on rubble-stone parapets. Drainage holes in parapet. Rubble-stone spandrels and wing walls. Equally-spaced arch voussoirs of alternate lengths. Rubble-stone barrels and coursed rubble-stone abutments having cutwaters on east side.

**Condition:** 3: Fair. Some vegetation growing on faces. Service pipe attached to east elevation. Invasive species in river and along river banks.

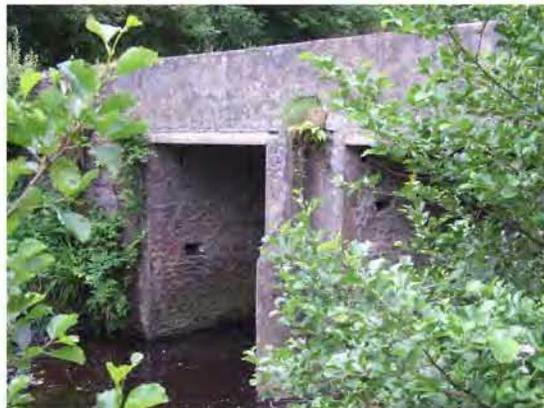
**Description:** Large two-span trabeated concrete and stone bridge, spanning watercourse at right angles and supporting a level deck. Rendered rubble-stone parapets. Cement plaque on parapet with inscription: 'Alla Bridge/Built Feb 29'. Concrete beams resting on square rubble-stone pier and abutments, pier having rendered cutwater on east side. Pocket holes at regular intervals in pier face. Wing walls and parapets of rubble stone.

**Condition:** 3: Fair. Unsympathetic cement rendering of parapets and treatment of wing wall copings. Drainage holes to deck blocked. No access to water level for inspection.

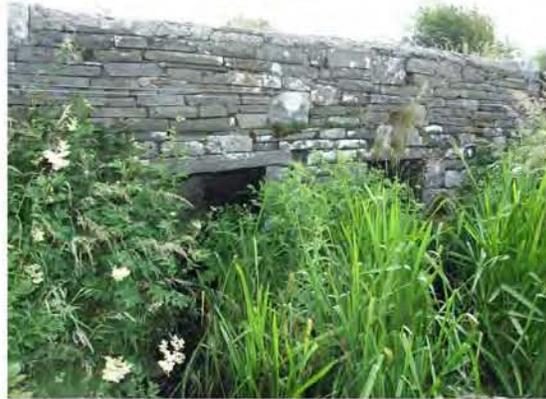
**Description:** Small twin-span culvert, spanning a watercourse at skewed angles and supporting a level deck. Cement finish on rubble-stone parapets, large square rock-faced cappings to parapet ends. Large flat stones spanning between abutments and central pier, both of rubble stone.

**Condition:** 4: Poor. Channel ceiling collapsing in places. Vegetation growth to faces. Poor cement finish and pointing in areas.

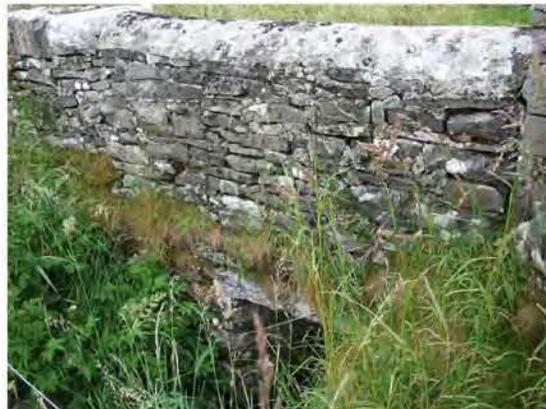
**Description:** Small single-span culvert, spanning a watercourse at skewed angles and supporting a level deck. Cement finish on rubble-stone parapets, east parapet set back from bridge face, large caps to ends. Large flat stones spanning between abutments of rubble stone. Rubble-stone dressing to banks in places.

**Condition:** 3: Fair. Vegetation growth to faces. Poor cement finish and pointing in areas.

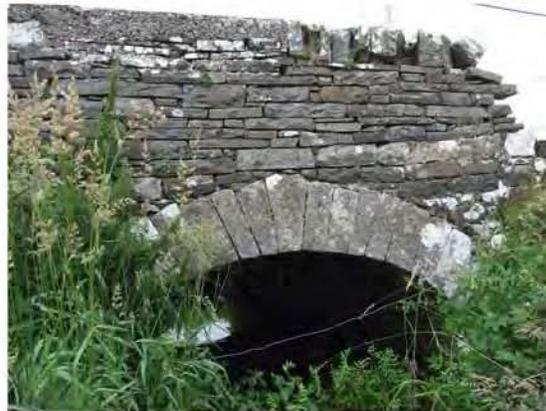
**Description:** Small single-span elliptical-arched stone bridge, spanning watercourse at skewed angle and supporting a level deck. Scotch coping to rubble-stone parapets with cappings to ends. Rubble-stone spandrels and wing walls. Arch of unequally sized voussoirs with larger keystone. Rubble-stone barrel and abutments. Rock exposed in river bed.

**Condition:** 4: Poor. Damage to parapets (stones on ground and in river bed). Unsympathetic cement repairs in areas. No access to east side.

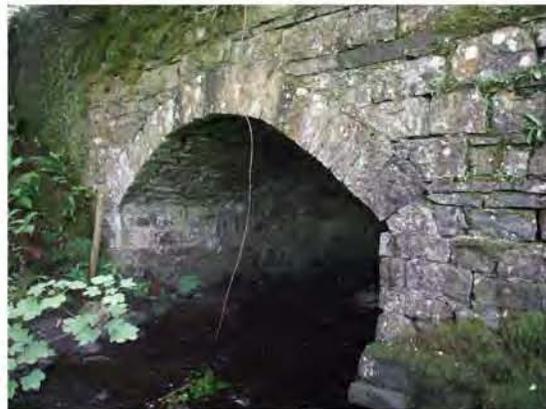
**Registration No.** 103

**Description:** Medium-sized single-span two-centred arched stone bridge, spanning watercourse at skewed angles and supporting a level deck. Parapets and spandrels of roughly-squared stone in irregular thin and thicker courses. Arch of roughly squared and some splayed voussoirs. Barrel and abutments of rubble stone. Rock exposed in river bed.

**Condition:** 3: Fair. Heavy vegetation to parapets. Opening in barrel along arch on south side.

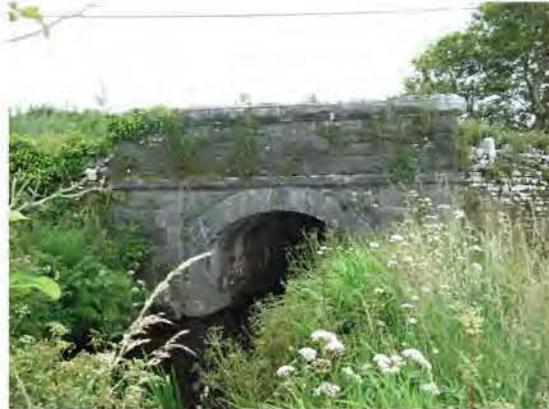
**Description:** Medium-sized single-span segmental-arched stone bridge, spanning watercourse at skewed angle and supporting a level deck. Dressed rock-faced coping oversailing random coursed rubble-stone parapets. Square string course over spandrels of squared stones and arch of equally-sized and hammer-faced voussoirs. Squared stones to barrel dressed in at skewed angle with ashlar abutments. Hammer dressing to corner stones of abutments. Battered flanking buttresses with rock-faced ashlar and hammer dressing to corner stones. Rubble-stone wing walls with Scotch copings.

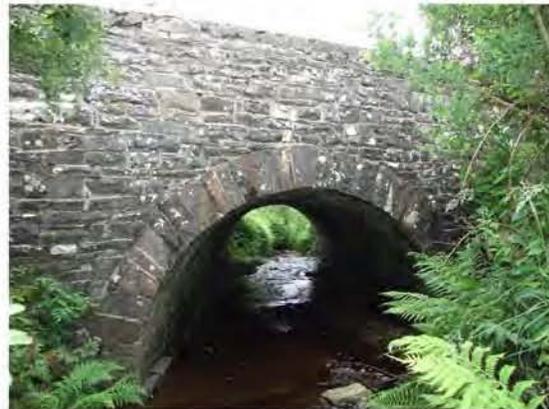
**Description:** Middle-sized single-span semi-circular arched stone bridge, spanning river at right angles and supporting a level deck. Culvert running parallel to south-west face. Rubble-stone parapets with cement parapets. Rubble-stone spandrels and wing walls. Arch of unequal voussoirs. Barrel and abutments of rubble stone. Stepped culvert having rubble-stone abutments and stone ceiling.

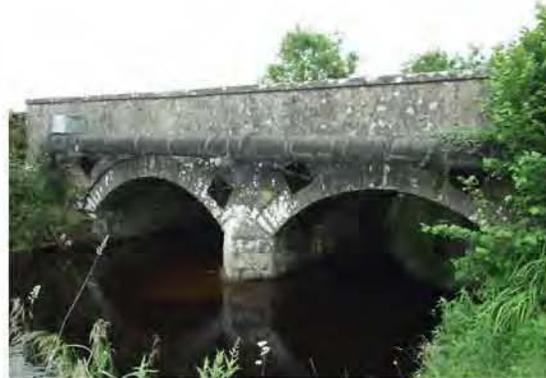
**Description:** Medium-sized two-span segmental-arched stone bridge, spanning watercourse at right angles and supporting a level deck. Cement rendered capping and parapet walls. Ashlar spandrels, arches of equally-sized voussoirs having hammered finish. Barrel of squared stones. Ashlar abutments and central pier, pier with v-cutwaters having pyramidal cappings. Large iron retaining plates to bridge faces.

**Condition:** 3: Fair. Later parapets not in sympathy with original design. Spandrels shifting despite iron plate restraints.

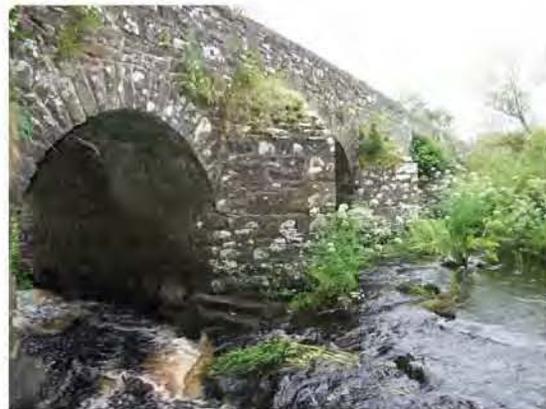
**Registration No.** 107

**Description:** Large five-span segmental-arched stone bridge, spanning watercourse at right angles and supporting a narrow ramped deck. Concrete coping on rubble-stone walls. Rubble-stone spandrels. Arches of unequally sized and shaped voussoirs, barrel of rubble stone, larger arch to centre. Abutments of rubble stone. Large cutwaters and pyramidal copings of rubble stone. Exposed bedrock in river beds.

**Condition:** 3: Fair. Vegetation, including ivy in areas. Unsympathetic use of concrete as parapets and cement pointing throughout.

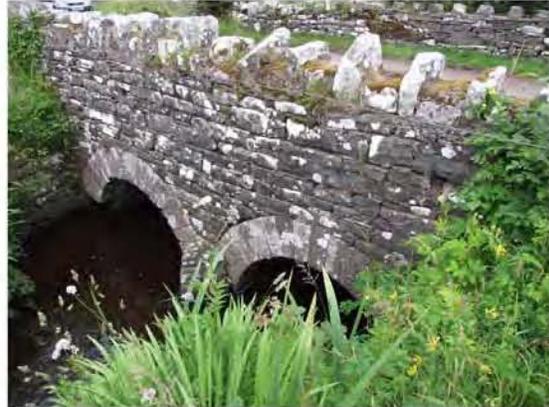
**Description:** Small double-span semi-circular arched stone bridge, spanning watercourse at right angles and supporting a level deck. Cow-and-calf stone coping on rubble-stone parapets. Rubble-stone spandrels. Arch of equally-sized hammer-faced voussoirs. Rubble-stone barrels and abutments. Small v-cutwater to east side.

**Condition:** 3: Fair. Parapet damaged with original stones lying in water. Ivy in areas.

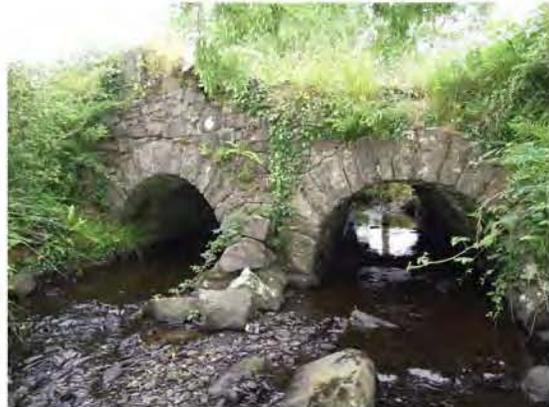
**Description:** Small double-span semi-circular arched stone bridge, spanning watercourse at right angles and supporting a level deck. Scotch coping on rubble-stone parapets. Rubble-stone spandrels. Arch of unequally-sized voussoirs. Rubble-stone barrels and abutments. Remains of v-cutwater to both sides.

**Condition:** 4: Poor. Parapet, spandrels and cutwater collapsed on south face. Cutwater damaged on north face. Dense vegetation to parapets, ivy on both faces.

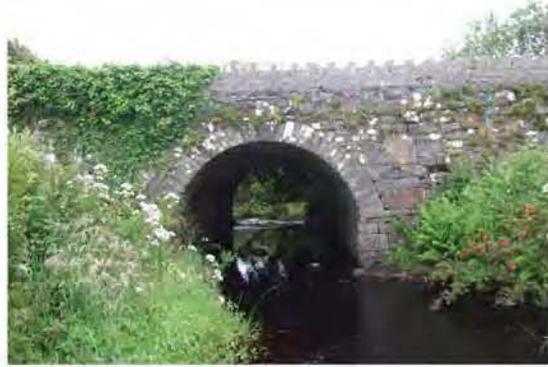
**Description:** Medium-sized single-span semi-circular arched stone bridge, spanning watercourse at right angles and supporting a level deck. Scotch coping on rubble-stone parapet remaining in areas. Rubble-stone spandrels and wing walls. Arch of unequally-sized voussoirs with larger keystone and springing stones. Barrel and abutments of rubble stone.

**Condition:** 4: Poor. North parapet replaced with inferior materials. Dense vegetation, including ivy, to south side.

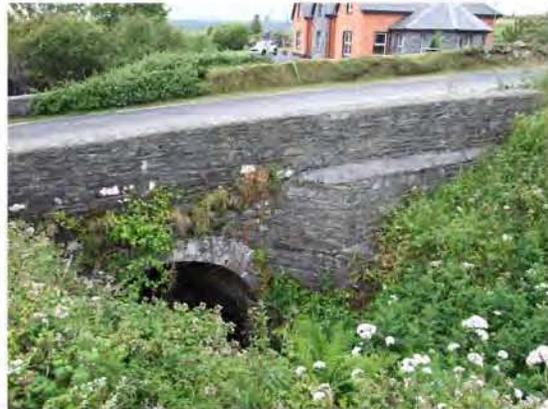
**Description:** Medium-sized single-span semi-circular arched stone bridge, spanning watercourse at skewed angle and supporting a level deck. Rebuilt rubble-stone parapets with cement capping. Rubble-stone spandrels. Arch of equally-sized cut-stone voussoirs. Barrel and abutments of rubble-stone. Rubble-stone shoulder to south-east wing wall.

**Condition:** 3: Fair. Unsympathetic cement finish to parapet top and to buttressing shoulder. Cement pointing in areas. Vegetation to faces in areas

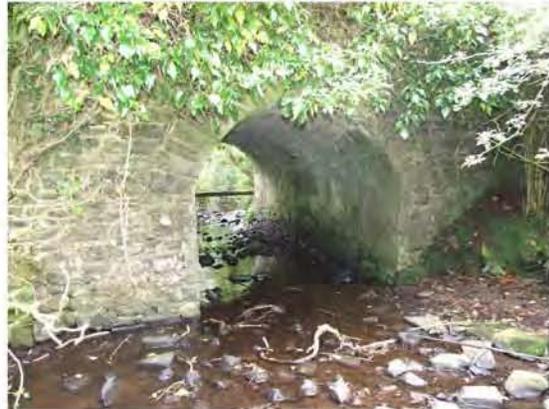
**Description:** Medium-sized single-span segmental-arched stone bridge, spanning watercourse at skewed angle and supporting a level deck. Squared soldier capping course with block ends on rubble-stone parapets. Rubble-stone spandrels. Arch of unequally sized voussoirs. Barrel and abutments of rubble stone.

**Condition:** 3: Fair. Heavy vegetation, including ivy, on parapets.

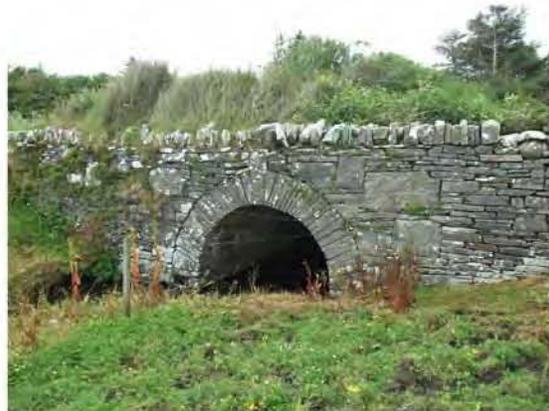
**Registration No.** 113  
**Name of Bridge**  
**Over Bridge** L-1044-14  
**Under Bridge**  
**Townland(s)** RANNAGH (CORCOMROE)  
**Parish\Barony**  
**Type/OS coord** Road over watercourse  
X: 507873 Y: 692128  
**Estimated Date** 1700 to 1750  
**NIAH Reg. No.**  
**NRA Ref. No.**

**Description:** Small single-span semi-circular arched stone bridge, spanning watercourse at right angles and supporting a level deck. Scotch coping on rubble-stone parapets. Rubble-stone spandrels and wing walls with some large facing stones. Arch of unequally sized voussoirs with larger splayed springing stones and large keystone reaching to coping level. Barrel and abutments of rubble stone

**Condition:** 3: Fair. Some damage to parapets and face stones coming loose in places. Vegetation growth, including ivy, in areas.

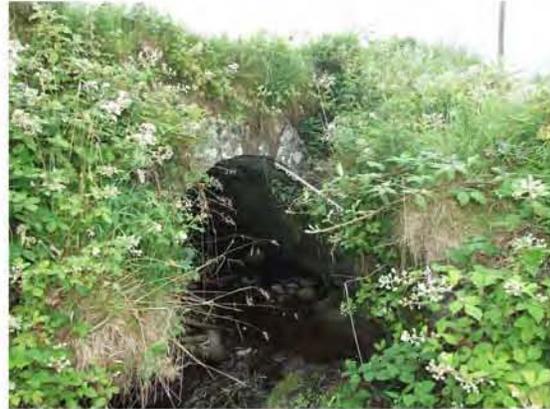
**Description:** Small single-span semi-circular arched stone bridge, spanning watercourse at skewed angle. Rubble-stone spandrels, arch to east side of unequally sized voussoirs. Barrel and abutments of rubble stone.

**Condition:** 4: Poor. Heavy vegetation to deck level concealing any remaining parapets. Arch face to west elevation fallen.

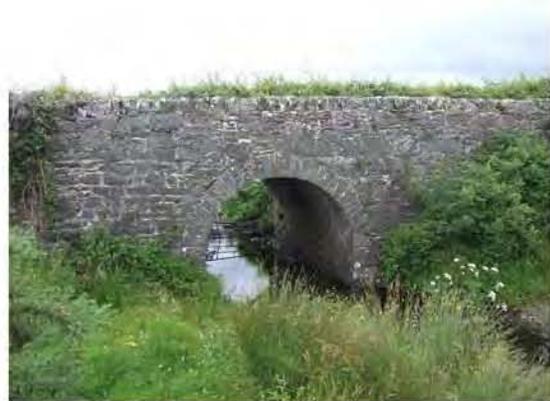
**Description:** Medium-sized single-span semi-circular arched stone bridge, spanning watercourse at right angles and supporting a level deck. Scotch coping on rubble-stone parapets. Rubble-stone spandrels and wing walls. Arch of almost equally-sized voussoirs with large keystone. Rubble-stone barrel. Ashlar abutments. Stone-dressed bed below span

**Condition:** 3: Fair. Cement pointing in many areas. Vegetation also in many areas.

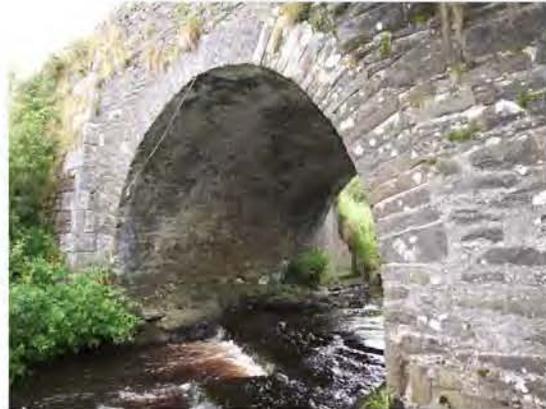
**Description:** Large single-span semi-circular arched stone bridge, spanning watercourse at right angles with a culvert to the south side, all supporting a level deck. Large squared coping course on rubble-stone parapets. Rubble-stone spandrels. Arch of unequally-sized voussoirs. Rubble-stone barrel and abutments. Stepped concrete v-cutwater and abutment to east side. Battered wing walls of rubble stone with stone-cut quoins on west side. Exposed rock in river bed. Culvert having flat stone soffit and rubble-stone walls with concrete floor.

**Condition:** 3: Fair. Cement pointing and render in areas. Vegetation to faces in areas.

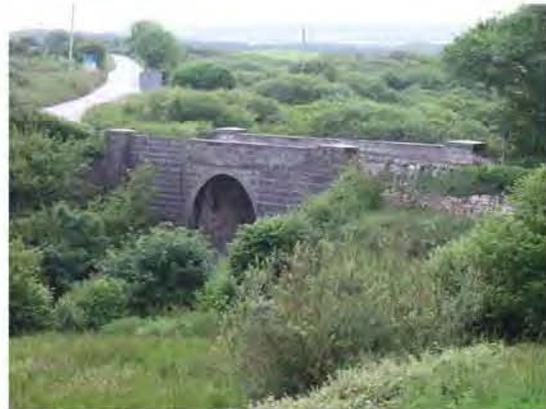
**Description:** Large single-span stone bridge spanning watercourse at right angles and supporting a level deck in a steep gorge setting. Span of semi-circular arch with large circular opening above. Ashlar parapet with rounded edges to coping course, large pyramidal cappings to end piers. Parapet oversails ashlar spandrels below. Arch and ring to circular opening above of equally sized voussoirs, barrels to both of random squared stone. Battered wing walls and battered advanced end piers of ashlar. Random-square facing to banks abutting bridge. Wing walls of rubble stone.

**Condition:** 3: Fair. Dense vegetation to banks, no access to water level.

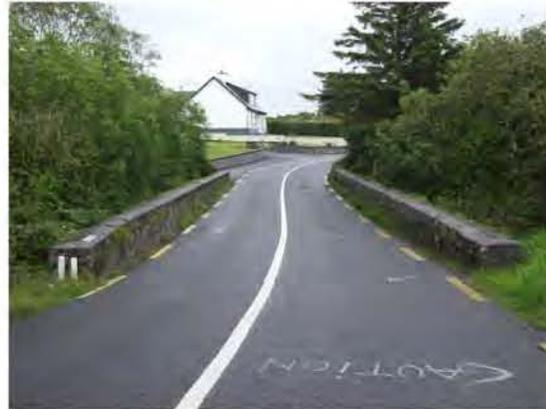
**Description:** Large single-span arched stone bridge, spanning watercourse at right angles and supporting a level deck. Large cut-stone coping course on rubble-stone parapets. Cut-stone string course above spandrels and battered ashlar wing walls. Ashlar abutments.

**Condition:** 3: Fair. No access or visibility to lower levels

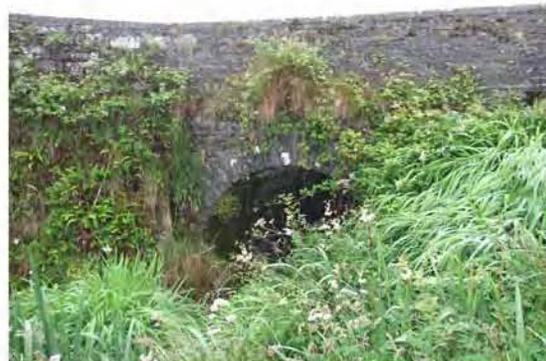
**Registration No.** 121  
**Name of Bridge**  
**Over Bridge** L-5062-0  
**Under Bridge** Aughoonta stream  
**Townland(s)** KNOCKNARANHY  
**Parish\Barony**  
**Type/OS coord** Road over watercourse  
X: 510718 Y: 697926  
**Estimated Date** 1700 to 1750  
**NIAH Reg. No.**  
**NRA Ref. No.**

**Description:** Medium-sized single-span semi-circular arched stone bridge, spanning a watercourse at right angles and supporting a level deck. Cement finish to top of rubble-stone parapets, east parapet in kinked line relative to west parapet. Rubble-stone spandrels and wing walls. Rubble-stone barrel and abutments.

**Condition:** 3: Fair. Cement in areas. Concrete casing of footings. No access to water level.

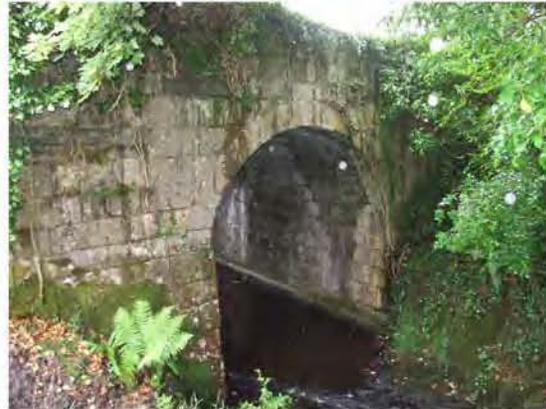
**Registration No.** 122  
**Name of Bridge**  
**Over Bridge** L-5064  
**Under Bridge** Aughonia Stream  
**Townland(s)** ARDEAMUSH  
**Parish\Barony**  
**Type/OS coord** Road over watercourse  
X: 511287 Y: 698734  
**Estimated Date** 1850 to 1900  
**NIAH Reg. No.**  
**NRA Ref. No.**

**Description:** Medium-sized single-span semi-circular arched stone bridge, spanning watercourse at right angles and supporting a level deck. Ashlar parapets with rounded edges to coping course, cut-stone pyramidal cappings to ashlar end piers. Ashlar spandrels and wing walls. Cut-stone arch voussoirs. Ashlar barrel, abutments and footings.

**Condition:** 3: Fair. Vegetation in joints to stone faces. Ivy on parapets. One bank is integrated with a garden of a neighbouring house.

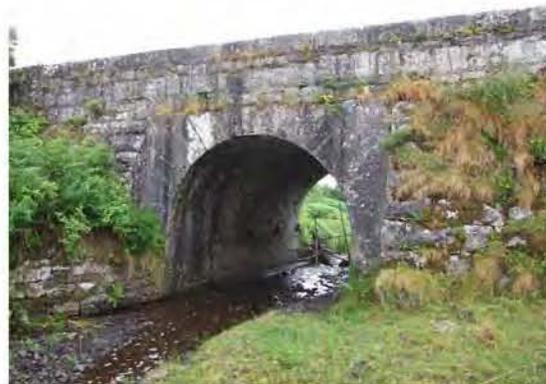
**Description:** Medium-sized single-span semi-circular arched stone bridge, spanning watercourse at right angles and supporting a level deck. Cut-stone coping course on rubble-stone parapets. Cut-stone voussoirs filling spandrel square, dressed and rock-faced keystone. Random square stone barrel, ashlar abutments with projecting support stones for formwork. Rock-faced ashlar to battered wing walls flanking arch, random squared ashlar wing walls beyond. Rubble-stone dressing to north-east bank.

**Condition:** 3: Fair. Cement pointing in areas. Vegetation growing on faces.

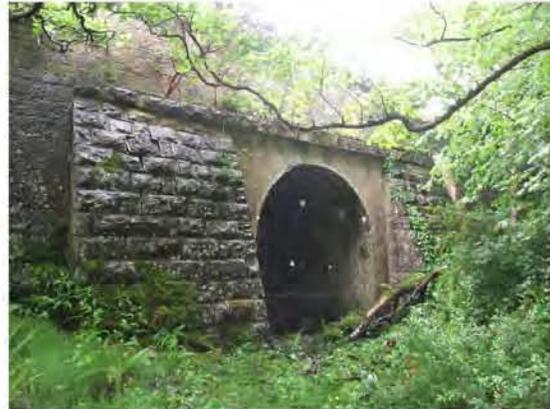
**Registration No.** 124  
**Name of Bridge**  
**Over Bridge** R-477-178  
**Under Bridge**  
**Townland(s)** BALLYNALACKAN  
**Parish\Barony**  
**Type/OS coord** Road over watercourse  
X: 510279 Y: 700275  
**Estimated Date** 1850 to 1900  
**NIAH Reg. No.** 0  
**NRA Ref. No.** CL-477

**Description:** Large single-span semi-circular arched stone bridge, spanning watercourse at right angles and supporting a level deck. Ashlar parapets. Rock-faced string course. Cut-stone voussoirs filling spandrel square, ashlar barrel and abutments. Abutments with projecting support stones for formwork. Rock-faced ashlar to battered wing walls flanking arch, random squared ashlar wing walls beyond. Stone-dressed bed remaining in areas. Cast-iron pedestrian access gate on road to northwest of bridge.

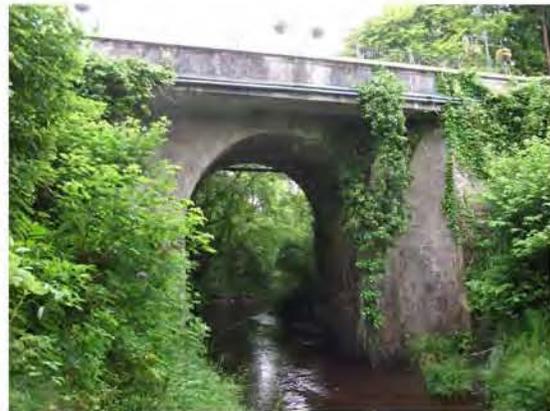
**Description:** Large single-span semi-circular arched stone bridge, spanning watercourse at right angles and supporting a level deck. Recent metal railings on painted rendered parapets on widened sections supported by concrete either side or original span. Ashlar spandrels, cut-stone arch voussoirs, ashlar barrel and abutments. Ashlar wing walls with concave sections flanking arch opening.

**Condition:** 3: Fair. Overgrown and no access to the west side, ivy to east face in areas. Recent parapets not sympathetic to the historic appearance of the bridge.

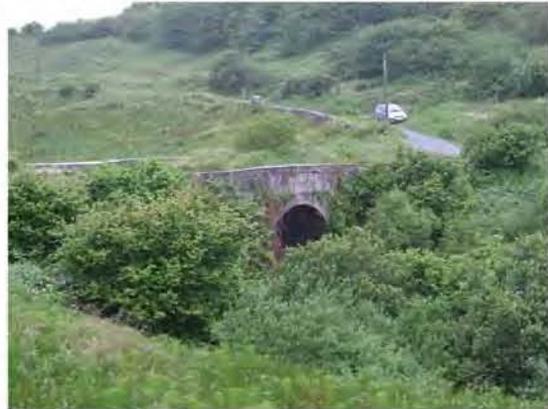
**Description:** Large single-span segmental-arched stone bridge, spanning a deep-set watercourse at right angles and supporting a level deck. Ashlar parapets with pyramidal cappings on end piers. Cut-stone arch rings.

**Condition:** 3: Fair. Vegetation growing on faces in areas. Dislocated parapet stones. Dense vegetation to banks prevented closer inspection

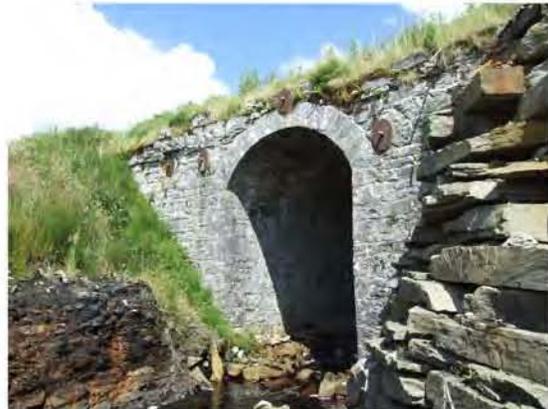
**Description:** Medium-sized single-span segmental-arched stone bridge, spanning watercourse at right angles and supporting a level deck. Rubble-stone spandrels and wing walls. Recent steel retaining plates to face. Cut-stone arch voussoirs. Rubble-stone barrel and abutments

**Condition:** 3: Fair. Loss of parapet, possible coping stones in river bed, cement haunching and markers in its place.

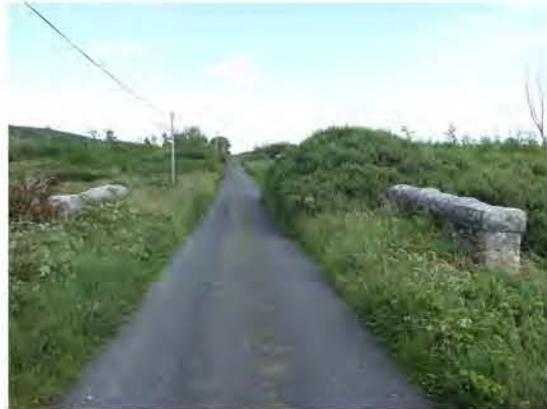
**Description:** Small single-span segmental-arched stone bridge, spanning watercourse at right angles and supporting a level deck. Dressed rock-faced coping course on rock-faced ashlar parapets. Ashlar spandrels and cut-stone voussoirs to arch. Ashlar abutments. Battered rock-faced wing walls.

**Condition:** 3: Fair. Heavily overgrown. No access to north side or water level

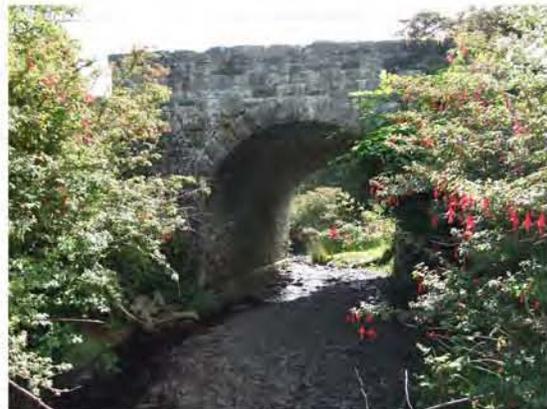
**Description:** Medium-sized single-span semi-circular arched stone bridge, spanning watercourse at right angles and supporting a level deck. Rough rock-faced blocks as coping course to rubble-stone parapets. Rubble-stone spandrels. Dressed rock-faced voussoirs to arch. Rubble-stone barrel and abutments,

**Condition:** 3: Fair. Cement pointing in areas. Alterations to parapets. Concrete cover to footings.

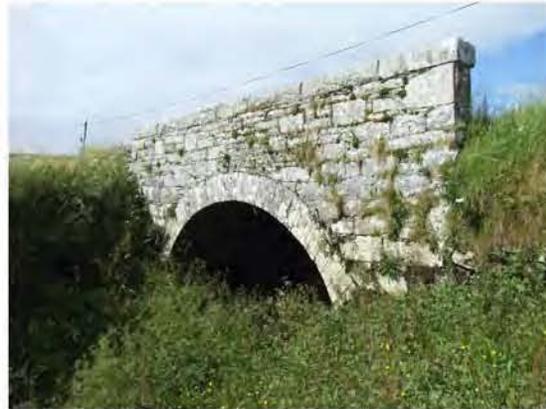
**Registration No.** 130  
**Name of Bridge**  
**Over Bridge** L-5050-36  
**Under Bridge**  
**Townland(s)** CAHERCLOGGAUN \  
 KILLEANY  
**Parish\Barony**  
**Type/OS coord** Road over watercourse  
 X: 516120 Y: 700480  
**Estimated Date** 1750 to 1800  
**NIAH Reg. No.**  
**NRA Ref. No.**

**Description:** Small single-span segmental-arched stone bridge, spanning watercourse at right angles and supporting a level deck. Large squared course blocks as coping course on random-rubble parapets. Random-rubble spandrels and wing walls. Cut-stone voussoirs. Rubble-stone barrel and ashlar abutments. Stone-dressed river bed.

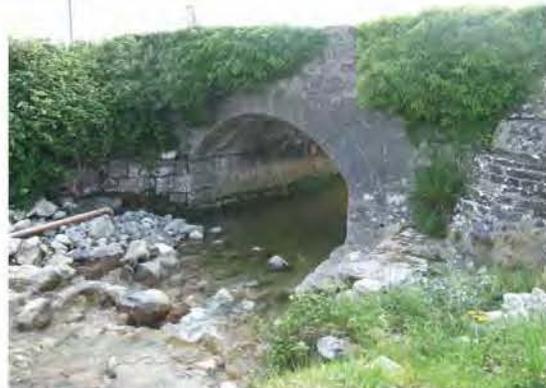
**Description:** Medium-sized single-span segmental-arched stone bridge, spanning watercourse at right angles and supporting a level deck. Rendered finish to top and inside of rubble-stone parapets. Ashlar spandrels, cut-stone voussoirs. Ashlar barrel and abutments, stone footings. Abutments continue to line splayed banks on both sides. Exposed stone in river bed.

**Condition:** 3: Fair. Cement render to parapets. Vegetation, including ivy, in areas. Pipe to west elevation

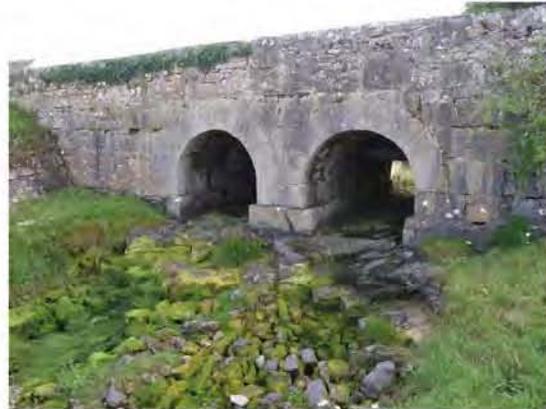
**Registration No.** 132  
**Name of Bridge**  
**Over Bridge** R477  
**Under Bridge**  
**Townland(s)** BALLYVAGHAN  
**Parish\Barony**  
**Type/OS coord** Road over watercourse  
X: 522890 Y: 707993  
**Estimated Date** 1750 to 1800  
**NIAH Reg. No.** 0  
**NRA Ref. No.** CL-R477-001.00

**Description:** Medium-sized two-span semi-circular arched stone bridge, spanning watercourse at right angles. Squared stone coping course on rubble-stone parapets. Random-squared spandrels and wing walls. Large cut-stone arch voussoirs. Rubble-stone barrels, ashlar abutments and footings. V-cutwaters standing on footing to south face with curved coping. Exposed rock-bed in channels. Further watercourse to south with opening in bank wall.

**Condition:** 3: Fair. Concrete path to south side. Cement pointing in areas. South parapet tilting inwards.

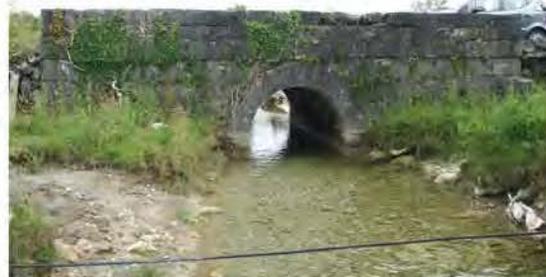
**Registration No.** 133  
**Name of Bridge**  
**Over Bridge**  
**Under Bridge** Rathbomey River  
**Townland(s)** CLOONMARTIN\CROAGH  
NORTH  
**Parish\Barony**  
**Type/OS coord** Road over watercourse  
X: 520526 Y: 704844  
**Estimated Date** 1750 to 1800  
**NIAH Reg. No.**  
**NRA Ref. No.**

**Description:** Small single-span semi-circular arched stone bridge, spanning watercourse at right angles and supporting a level deck. Rough ashlar parapets oversailing spandrels and wing walls below. Random squared spandrels and wing walls. Cut-stone voussoirs to arch, some voussoirs double sized with fake joints. Rubble-stone barrels and abutments. Stone-laid bed in river.

**Condition:** 3: Fair. Ivy in several areas

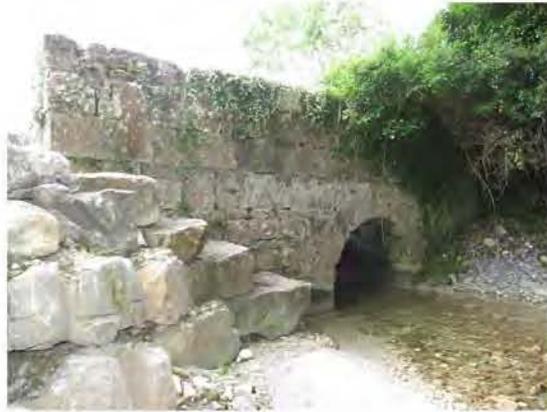
**Description:** Small single-span semi-circular arched stone bridge, spanning watercourse in dogleg arrangement and supporting a level deck. Rough ashlar parapets oversailing spandrels and wing walls below. Random squared spandrels and wing walls. Cut-stone voussoirs to arch, some voussoirs double sized with fake joints. Rubble-stone barrels and abutments. Stone-laid bed in river.

**Condition:** 3: Fair. Very poor quality by-pass piping appearing near the south face contrasts with the fine appearance of the bridge and its setting

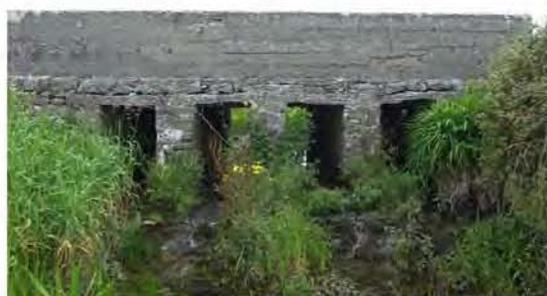
**Description:** Small four-span stone culvert bridge, spanning watercourse at right angles and supporting a level deck. Concrete parapets. Rubble-stone course above flat stones spanning rubble-stone abutments.

**Condition:** 4: Poor. Cement pointing throughout. Replacement lintel on east side.

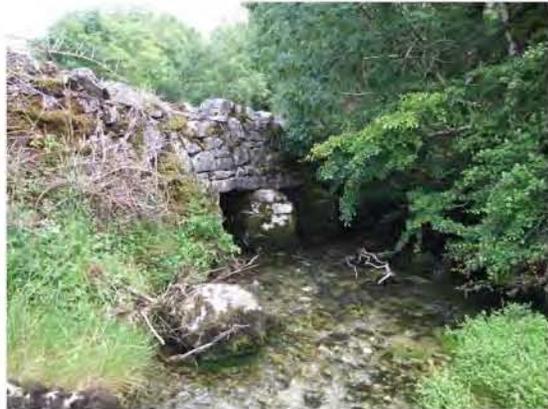
**Description:** Small four-span stone culvert bridge, spanning watercourse in dogleg arrangement and supporting a level deck. Cow-and-calf coping course on rubble-stone parapets. Flat stones spanning rubble-stone abutments. V-cutwaters to east abutments.

**Condition:** 4: Poor. Stones missing to parapets in several areas. Vegetation in many areas

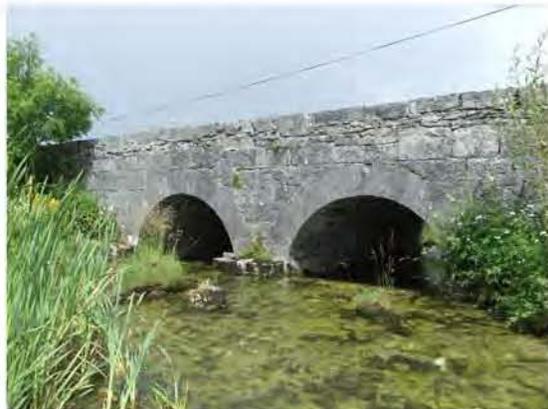
**Description:** Medium-sized double-span semi-circular arched stone bridge, spanning watercourse at right angles and supporting a ramped deck. Large squared stone coping course on rubble-stone parapet, pyramidal cappings to end piers. Ashlar spandrels and wing walls. Cut-stone voussoirs and rubble-stone barrels. Ashlar abutments.

**Condition:** 3: Fair. Ivy in several areas. Cement pointing in areas. Damage to north parapet.

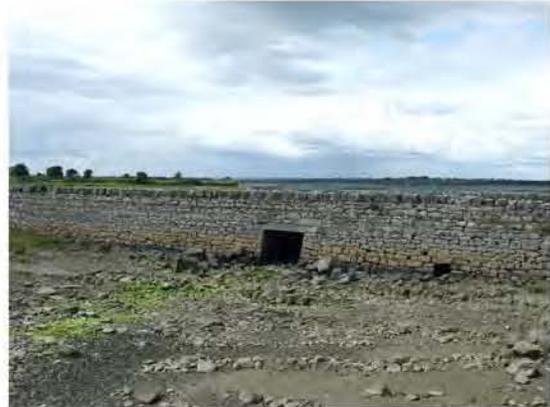
**Description:** Small single-span elliptical-arched stone bridge integrated in long sea wall supporting a level deck. Scotch coping on rubble-stone parapets on battered rubble-stone seawalls. Large rough lintel supporting opening in wall faces. Elliptical arches behind with unequally-sized voussoirs and rubble-stone barrel and abutments.

**Condition:** 3: Fair. Parapets damaged in areas.

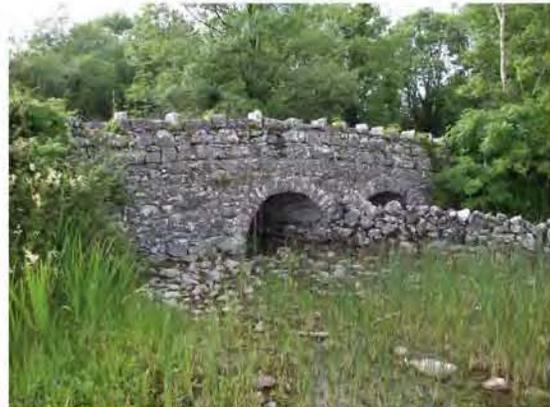
**Description:** Small two-span segmental-arched stone bridge, spanning watercourse at right angles and supporting a ramped deck. Cow-and-calf coping course on rubble-stone parapets. Rubble-stone spandrels and wing walls. Unequal voussoir stones. Rubble-stone barrel and abutments.

**Condition:** 3: Fair. Vegetation, including ivy in areas.

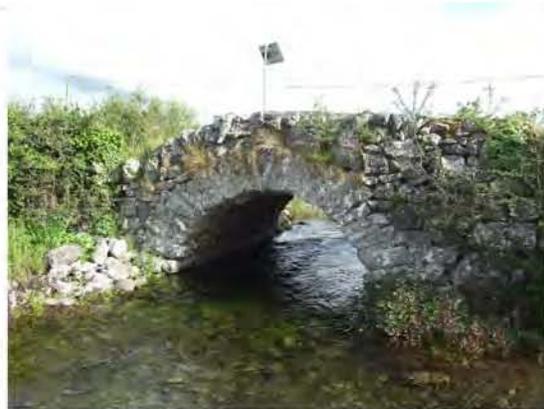
**Registration No.** 140  
**Name of Bridge**  
**Over Bridge** L-50101  
**Under Bridge**  
**Townland(s)** POULATAGGLE  
**Parish\Barony**  
**Type/OS coord** Road over watercourse  
X: 540315 Y: 701256  
**Estimated Date** 1700 to 1750  
**NIAH Reg. No.**  
**NRA Ref. No.**

**Description:** Small single-span segmental-arched stone bridge, spanning watercourse at right angles and supporting a humped deck. Remains of rubble-stone parapets. Rubble-stone spandrels. Rough and unequally-sized arch voussoirs. Rubble-stone barrel and abutments.

**Condition:** 4: Poor. Damaged parapets, cement pointing in areas.

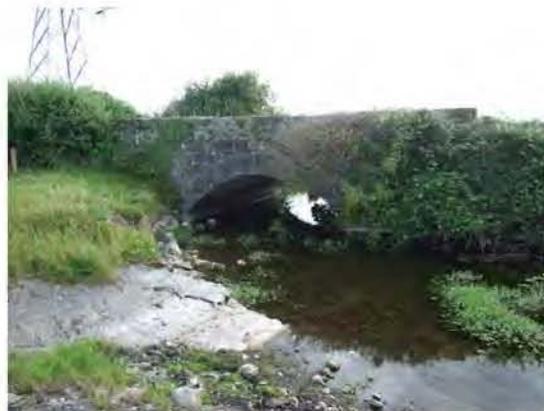
**Registration No.** 141  
**Name of Bridge**  
**Over Bridge** L-1008-0  
**Under Bridge**  
**Townland(s)** CARROWCRAHEEN \  
DERRYOWEN  
**Parish\Barony**  
**Type/OS coord** Road over watercourse  
X: 539625 Y: 694191  
**Estimated Date** 1750 to 1800  
**NIAH Reg. No.**  
**NRA Ref. No.**

**Description:** Medium-sized single-span segmental-arched stone bridge, spanning watercourse in dogleg arrangement and supporting a level deck. Rubble-stone parapet. Random-squared spandrels and wing walls. Cut-stone arch voussoirs. Ashlar barrel and abutments.

**Condition:** 3: Fair. No access to west side. East arch splitting from barrel

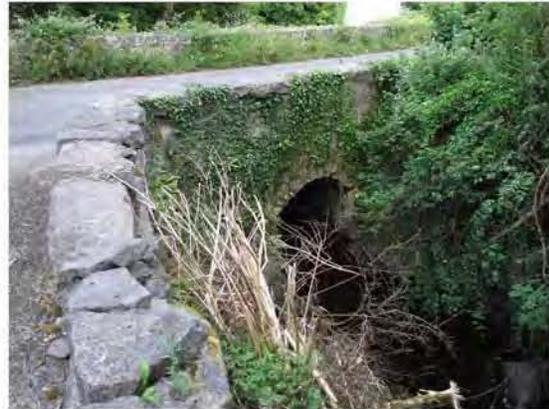
**Registration No.** 142  
**Name of Bridge** Lughid Bridge  
**Over Bridge** L-4120  
**Under Bridge** Carheeney River  
**Townland(s)** DERRYGARIFF\  
MONREAGH\  
SRANAGALLOON

**Description:** Medium-sized two-span segmental-arched stone bridge, spanning watercourse at right angles and supporting a level deck. Square stone coping course on rubble-stone parapets. Random-square spandrels and wing walls. Unequally-sized voussoirs. Rubble-stone barrel and abutments. V-cutwater on east side with stepped-stone capping. Watercourse to west side separated by long embankment, south span smaller than north span, all possibly a remnant of the mill arrangement

**Condition:** 3: Fair. Cement pointing in areas. Vegetation, including ivy, in many areas.

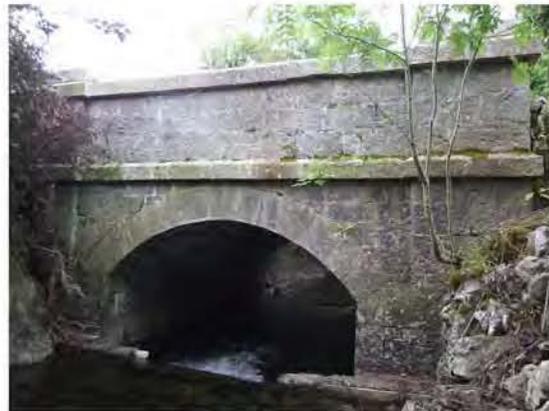
**Registration No.** 143  
**Name of Bridge**  
**Over Bridge** L-1106  
**Under Bridge**  
**Townland(s)** KELLS

**Description:** Medium-sized single-span segmental-arched bridge, spanning watercourse at right angles and supporting a level deck. Ashlar coping projecting over outer face only. Pyramidal cappings to end piers resting on projecting coping course. Parapets and end piers of random squared ashlar. Squared string course with sloping upper side over spandrels and to end piers. Ashlar spandrels and cut-stone voussoirs. Random-squared stone barrel and ashlar abutments. Randoms-stone lining to banks.

**Condition:** 2: Good. Concrete breakwater on north (upstream) side

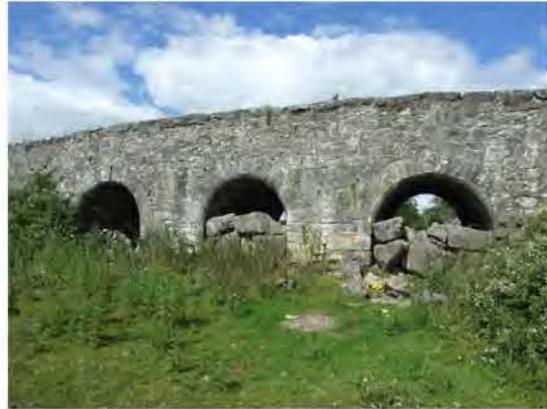
**Description:** Medium-sized three-span semi-circular arched stone bridge supporting a ramped deck. Rubble-stone parapets with larger squared stones for coping course. Rubble-stone spandrels and wing walls. Arch voussoirs of unequal size with projecting keystones. Arch barrels and abutments gunnitted. Abutments in east elevation of large rubble-stone units, tall v-cutwaters on west elevation of rubble-stone with curved rubble-stone cappings. Two culverts at raised level north of the arched portion of the bridge.

**Condition:** 3: Fair. Unsympathetic gunnitting to barrels and abutments. Cement pointing in areas. Some parapet stones missing. Arches blocked by large boulders.

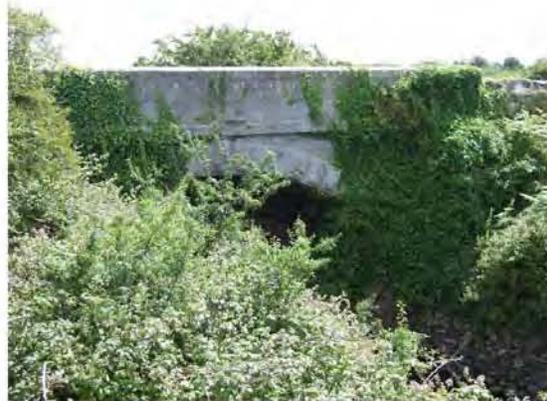
**Description:** Large single-span segmental-arch stone bridge, spanning watercourse at right angles and supporting a level deck. Ashlar parapets with curved top profile, profile extends over square end piers. Some parapet stones extending over two courses with dovetail detail. String course with bevelled top over ashlar spandrels. Dressed rock-faced voussoirs with large projecting keystone.

**Condition:** 2: Good. No access to steep banks or water level due to vegetation and field with bull

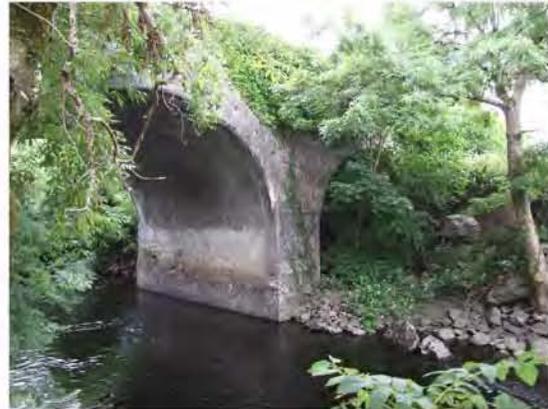
**Description:** Large three-span semi-circular arched stone bridge, spanning watercourse at right angles and supporting a ramped deck. Larger central arch. Large square stone coping course to rubble-stone parapets. Rubble-stone spandrels. Arch of cut-stone voussoirs projecting slightly from bridge face with alternate voussoirs half sized. Gunnetting to barrels. Ashlar abutments and v-cutwaters to north elevation.

**Condition:** 3: Fair. Gunnetting to barrels. Vegetation, including ivy, in areas. Some stone faces in abutments deteriorated

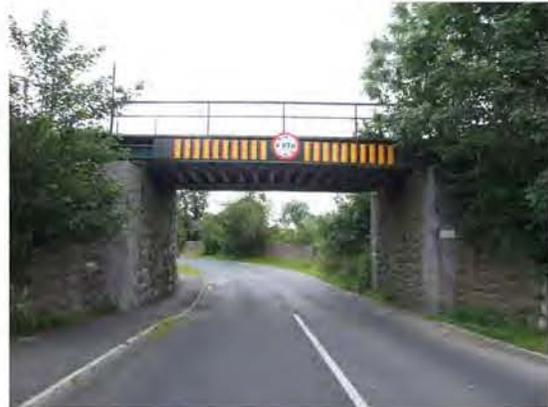
**Registration No.** 147  
**Name of Bridge**  
**Over Bridge** Railway  
**Under Bridge** R-458  
**Townland(s)** CAHERAPHUCA \  
 CRUSHEEN  
**Parish\Barony**  
**Type/OS coord** Railway over road  
 X: 539390 Y: 687806  
**Estimated Date** 1860 to 1890  
**NIAH Reg. No.**  
**NRA Ref. No.**

**Description:** Large single-span trabeated cast-iron and stone bridge spanning road at right angles. Rivited cast-iron edge beams with rivited profiled web infill, supported on stone abutments. Concrete widening to both sides located over cast-iron beams. Random-squared rock-faced stone abutments. Recent stone abutments to ends of historic abutments supporting steel crash barriers over span. Rock-faced retaining walls beyond east side of abutments with rock-faced coping to sloped tops.

**Condition:** 2: Good. Ivy on wing walls to east. Cement strap pointing throughout

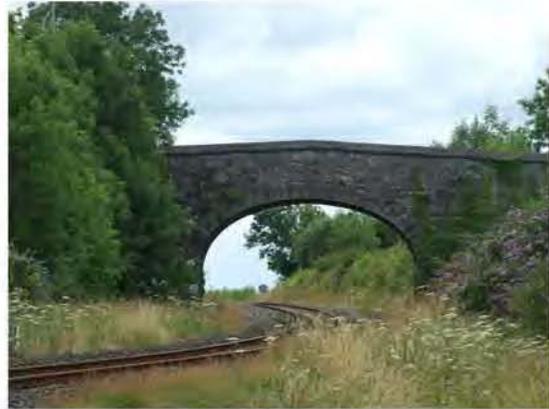
**Registration No.** 148  
**Name of Bridge**  
**Over Bridge** L-4120  
**Under Bridge** Railway  
**Townland(s)** DRUMUMNA \  
GORTAFICKA  
**Parish\Barony**  
**Type/OS coord** Road over railway  
X: 540169 Y: 689250  
**Estimated Date** 1860 to 1890  
**NIAH Reg. No.**  
**NRA Ref. No.**

**Description:** Large single-span elliptical-arched stone bridge, spanning a railway line in a dogleg arrangement and supporting a ramped deck. Recent precast concrete capping on coursed rubblestone parapets. Rock-faced ashlar spandrels and wing walls. Dressed rock-faced arch voussoirs. Ashlar barrel and rock-faced ashlar abutments

**Condition:** 2: Good. Unsympathetic recent coping detail. Ivy on faces in areas

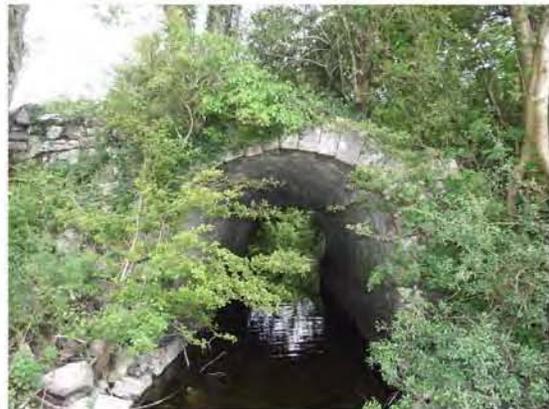
**Registration No.** 149  
**Name of Bridge**  
**Over Bridge** L-5240  
**Under Bridge**  
**Townland(s)** GARRYNALLAHA \  
RINROE  
**Parish\Barony**  
**Type/OS coord** Road over watercourse  
X: 532972 Y: 691114  
**Estimated Date** 1750 to 1800  
**NIAH Reg. No.**  
**NRA Ref. No.**

**Description:** Small single-span semi-circular arched stone bridge, spanning watercourse at right angles and supporting a level deck. Remains of rubble-stone spandrels. Arch of unequally wide cut-stone voussoirs. Rubble-stone barrel. Coursed roughly-squared stone abutments.

**Condition:** 4: Poor. Parapets and spandrels in ruinous state and heavily overgrown.

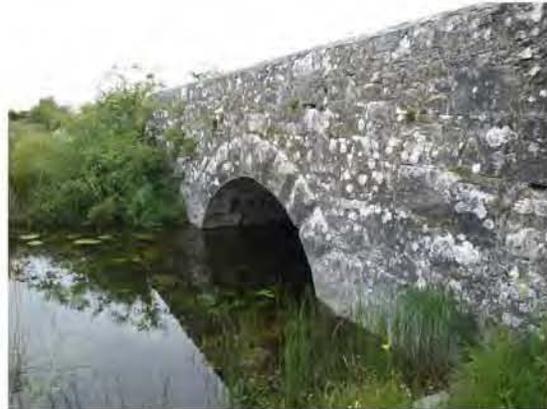
**Description:** Medium-sized single-span segmental-arched stone bridge, spanning watercourse at right angles and supporting a level deck. Cement saddle capping to rubble-stone parapets having large rock-faced end quoins. Rubble-stone spandrels and wing walls. Large dressed rock-faced arch voussoirs. Rubble-stone barrel. Raised ulvert to north with stone arch.

**Condition:** 3: Fair. Large crack in west elevation. Ivy in areas. Damage to parapets

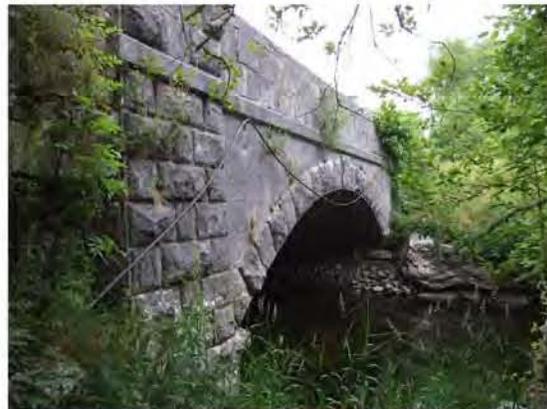
**Description:** Large single-span segmental-arched stone bridge, spanning watercourse at right angles and supporting a level deck. Ashlar parapets with curved profile to coping course, some stones two-courses high with dovetail detail to coping, large cappings to square end piers. Cut-stone string course with bevelled top over ashlar spandrels and rock-faced ashlar pier ends. Dressed rock-faced arch voussoirs with large keystone. Ashlar barrel resting on abutment string course and ashlar wall below. Raised channel in rubble-stone south wing wall with stone arch.

**Condition:** 3: Fair. Some parapet stones shifting. Dense vegetation, including ivy, in areas.

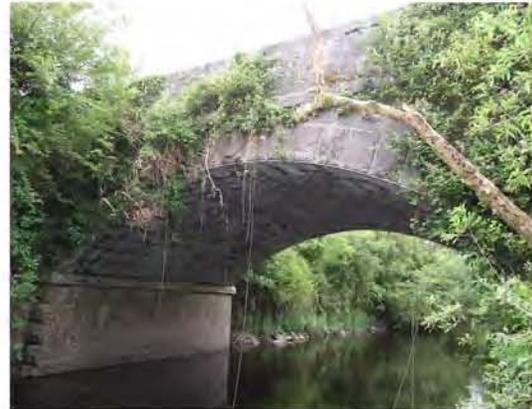
**Description:** Large single-span segmental-arched stone bridge, spanning watercourse at right angles and supporting a level deck. Ashlar parapets with curved profile to coping course, some stones two-courses high with dovetail detail to coping, large cappings to square end piers. Decorative carving on centre of south parapeth with intertwining wreaths on block base. Cut-stone string course with bevelled top over ashlar spandrels and rock-faced ashlar pier ends. Dressed rock-faced arch voussoirs with large keystone. Ashlar barrel resting on abutment string course and ashlar wall below.

**Condition:** 3: Fair. Dense vegetation, including ivy, in areas.

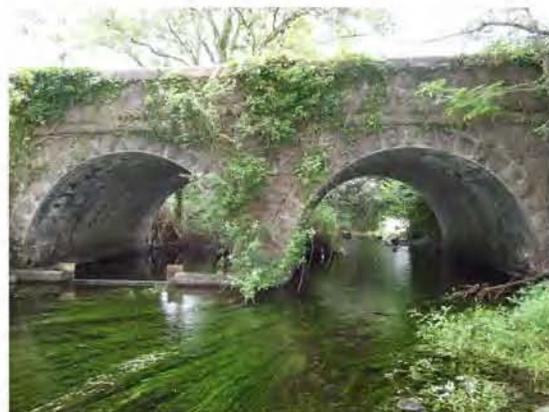
**Description:** Medium-sized two-span semi-circular arched stone bridge, spanning watercourse at right angles and supporting a level deck. Large flat-stone copings with rounded upper edge on rubble-stone and random rock-faced parapets. Square string course to full elevation. Random rock-faced spandrels. Arches with dressed rock-faced voussoirs. Ashlar barrels and rock-faced ashlar abutments. Battered rock-faced ashlar buttresses and rubble-stone wing walls.

**Condition:** 2: Good. Vegetation, including ivy, to faces.

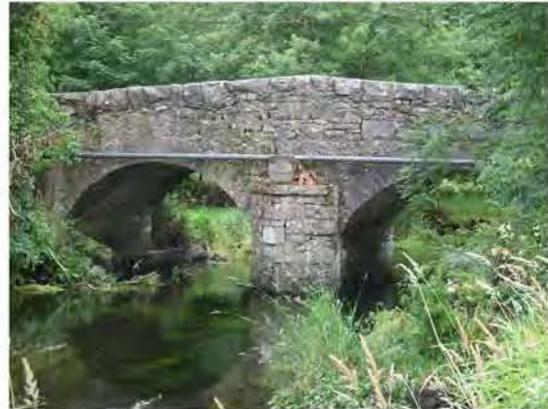
**Description:** Medium-sized two-span segmental-arched stone bridge, spanning watercourse at right angles and supporting a narrow ramped deck. Large stone coping course with flat upper face, all on rubble-stone parapets. Rubble-stone spandrels. Equally-sized arch voussoirs, rubble-stone barrels. Ashlar abutments, v-cutwater with flat coping stones. Battered wing walls to north side and concrete buttress to wing wall to southeast.

**Condition:** 4: Poor. Cement pointing in many areas. Cement or concrete finish to west barrel. Concrete buttressing to south-east wing wall. V-cutwater tilting above abutment level. Vegetation and tree roots to faces. Pipes attached and standing along both bridge faces.

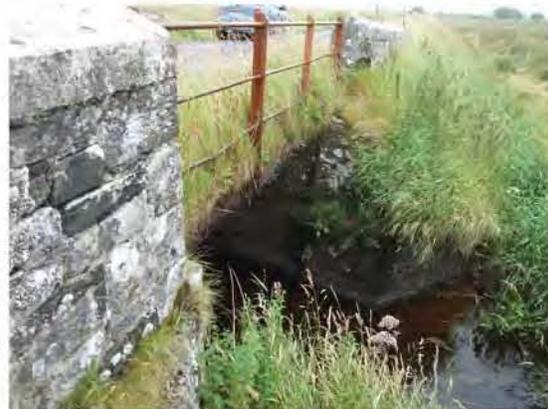
**Description:** Medium-sized single-span trabeated steel and stone bridge, spanning watercourse at right angles and supporting a level deck. Cement ridge capping with hipped ends on rubble-stone parapets either side of span, steel balustrade above span of square uprights with round horizontals. Six bolted steel beams with infill of shallow corrugated steel barrels. All resting on rubble-stone abutments having large concrete casings to footings. Footings and river embankments splay to accommodate skewed relationship to river channel.

**Condition:** 3: Fair. Cement pointing throughout. Steel profiles corroding. Cracks in parapets and abutments.

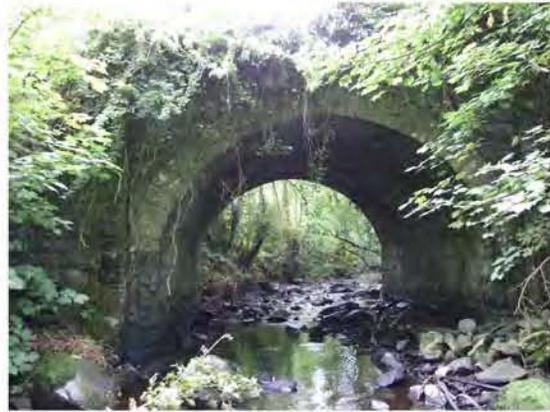
**Registration No.** 156  
**Name of Bridge**  
**Over Bridge** L-5250  
**Under Bridge** River Fergus  
**Townland(s)** KNOCKROE (CORCOMROE)  
**Parish\Barony**  
**Type/OS coord** Road over watercourse  
X: 521579 Y: 691444  
**Estimated Date** 1850 to 1900  
**NIAH Reg. No.**  
**NRA Ref. No.**

**Description:** Large single-span segmental-arched stone bridge, spanning watercourse at right angles and supporting a level deck. Square coping course on rubble-stone parapets. Random rock-faced spandrels. Cut-stone arch voussoirs and random squared stone barrel. Random rock-faced abutments. Battered rock-faced buttresses flanking arch.

**Appraisal** An impressive structure with fine stonework.

**Condition:** 3: Fair. Dense vegetation including ivy. Stones loosening from buttress faces.

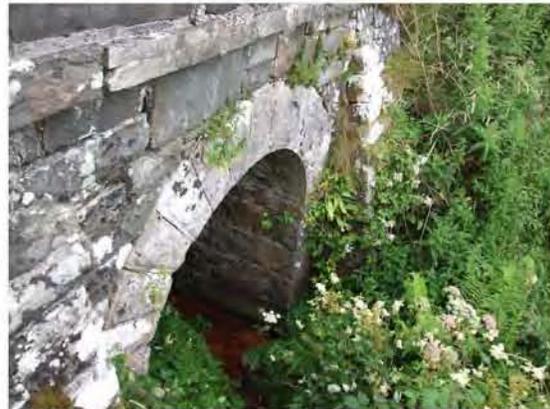
**Description:** Small single-span semi-circular arched stone bridge, spanning watercourse at right angles and supporting a level deck. Concrete block parapet. Rubble-stone spandrels. Dressed rock-faced arch voussoirs. Rubble-stone barrel and abutments. Projecting stones to seat of barrel for timber formwork.

**Appraisal** A modest structure in a prominent landscape setting. It has a robust appearance with some good stone detailing.

**Condition:** 4: Poor. Unsympathetic parapet added recently. No access to east side as overgrown.
