# THE BRIDGES OF NORTH COUNTY CLARE

*An Inventory of Civil Engineering Heritage*

*recorded and compiled by*  
**Lotts Architecture and Urbanism**

*for Clare County Council with the support of The Heritage Council*

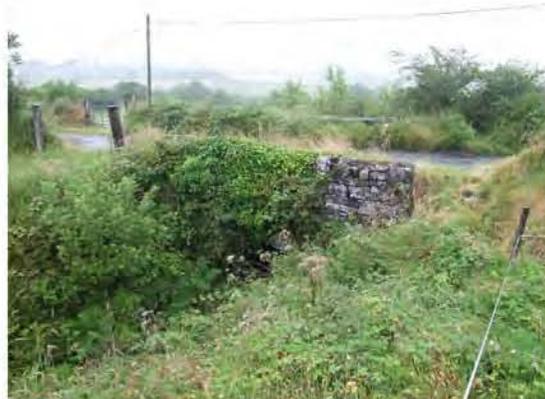
**Registration No.** 158  
**Name of Bridge**  
**Over Bridge** L-1116  
**Under Bridge**  
**Townland(s)** KILFENORA  
**Parish\Barony**  
**Type/OS coord** Road over watercourse  
X: 518509 Y: 693122  
**Estimated Date** 1850 to 1900  
**NIAH Reg. No.**  
**NRA Ref. No.**

**Description:** Small single-span semi-circular arched stone bridge, spanning watercourse at right angles and supporting a sloping deck. Coping of large squared stone blocks with upper rock-face to parapet on west side, no coping to parapet on east side. Rubble-stone parapets. Rock-faced voussoirs

**Appraisal** A modest structure of robust appearance with some good stonework marking it as a feature of the rural context.

**Condition:** 4: Poor. Heavily overgrown. No access to water level over steep banks.

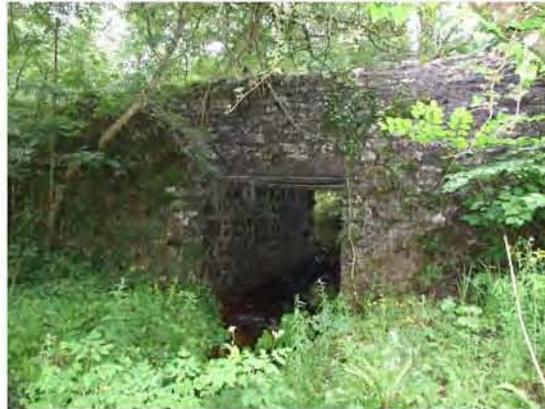
**Registration No.** 160  
**Name of Bridge**  
**Over Bridge** L-5090-8  
**Under Bridge** Aille River  
**Townland(s)** CAHERMAKERRILA  
**Parish/Barony**  
**Type/OS coord** Road over watercourse  
X: 517562 Y: 698916  
**Estimated Date** 1900 to 1950  
**NIAH Reg. No.**  
**NRA Ref. No.**

**Description:** Small single-span trabeated stone and concrete bridge, spanning watercourse at right angles and supporting a level deck. Large roughly-squared stone coping on rubble-stone parapet on south side, earth embankment to north. Concrete beams resting on rubble-stone abutments.

**Appraisal** A bridge is marked on this road on the 6" OS map. The current structure may integrate parts of an earlier structure. A simple structure with little detailing that remains a feature of its rural context.

**Condition:** 3: Fair. Overgrown in areas. Cement pointing in areas.

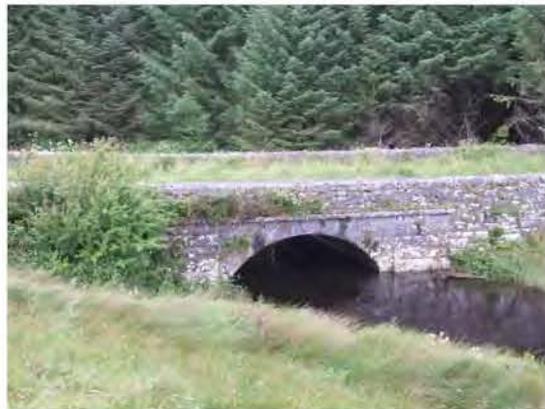
**Registration No.** 161  
**Name of Bridge**  
**Over Bridge** L-1072-0  
**Under Bridge**  
**Townland(s)** BALLYTEIGE \  
LISDOONVARNA  
**Parish/Barony**  
**Type/OS coord** Road over watercourse  
X: 515173 Y: 698719  
**Estimated Date** 1800 to 1850  
**NIAH Reg. No.**  
**NRA Ref. No.**

**Description:** Large single-span segmental-arched stone bridge, spanning watercourse at right angles and supporting a level deck. Cut-stone ridge-profiled coping on rubble-stone parapets. Square stone string course. Ashlar spandrels. Cut-stone arch voussoirs splaying upwards from horizontal of impost. Ashlar barrel. Battered rock-faced buttresses flanking arch. Long random rock-faced wing walls and parapets with drainage holes for deck.

**Appraisal** An elegant composition with very fine stonework making a fine feature in a rugged landscape setting.

**Condition:** 2: Good. Some vegetation to faces

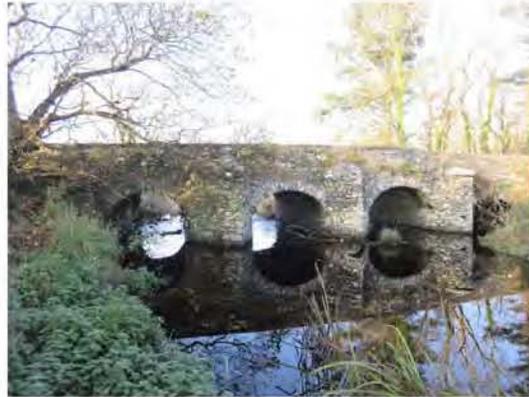
**Description:** Medium-sized four-span elliptical-arched stone bridge, spanning watercourse at right angles and supporting a level deck. Concrete top to rubble-stone parapets, parapet on east side set back from bridge face. Rubble-stone spandrels. Unequally-sized arch voussoirs, smaller span to north end. Rubble-stone barrels. Larger random square stones to abutments and tall v-cutwaters, larger cutwater between southernmost spans. Cement topping to cutwaters. Rubble-stone wing walls with rubble-stone buttress to southeast.

**Appraisal** An impressive structure of rustic appearance with unusually tall cutwaters and elegant elliptical arches. It is a strong feature in its rural setting. Similar to nearby bridge number 107

**Condition:** 3: Fair. Trees growing beside south-east wing wall, on cutwaters and deck. Cement pointing throughout. Damage to some cutwaters. Service pipe on west elevation

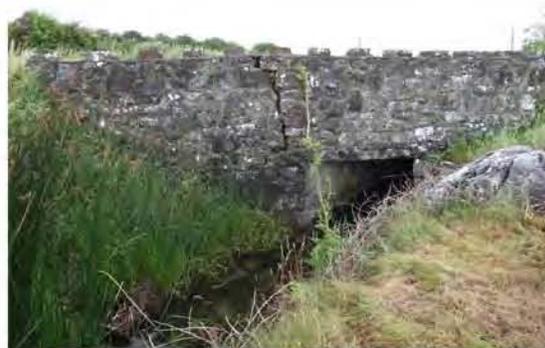
**Description:** Small single-span culvert, spanning watercourse at skewed angle and supporting a level deck. Recent stone and cement coping to east elevation, ridged concrete coping to west elevation, all on rubble-stone parapets. Stones spanning at face with concrete spanning between. Rubble-stone abutments

**Appraisal** A simple structure of robust appearance demonstrating use of local stone. Ballyporty castle to the south along the same stream.

**Condition:** 4: Poor. Damage to both parapets. Cement pointing throughout

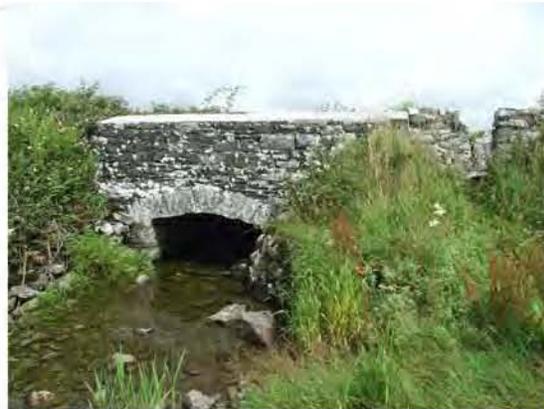
**Description:** Small single-span segmental-arched stone bridge, spanning watercourse at right angles and supporting a level deck. Cement topping to rubble-stone parapets. Roughly-formed voussoirs. Cement facing to soffit. Rubble-stone abutements and wing walls. Stile in wing wall south of west parapet

**Appraisal** A simple structure of rustic expression with a handsome flat arch. It is a strong feature of its rural context.

**Condition:** 3: Fair. Service pipes and inspection chamber to east side. Cement finish to barrel. Cement pointing throughout.
