Freshwater Pearl Mussel Survey of the Doonbeg, Annageeragh and Creegh Rivers, Co. Clare

(October 2016)

Doc Ref: 1620/A

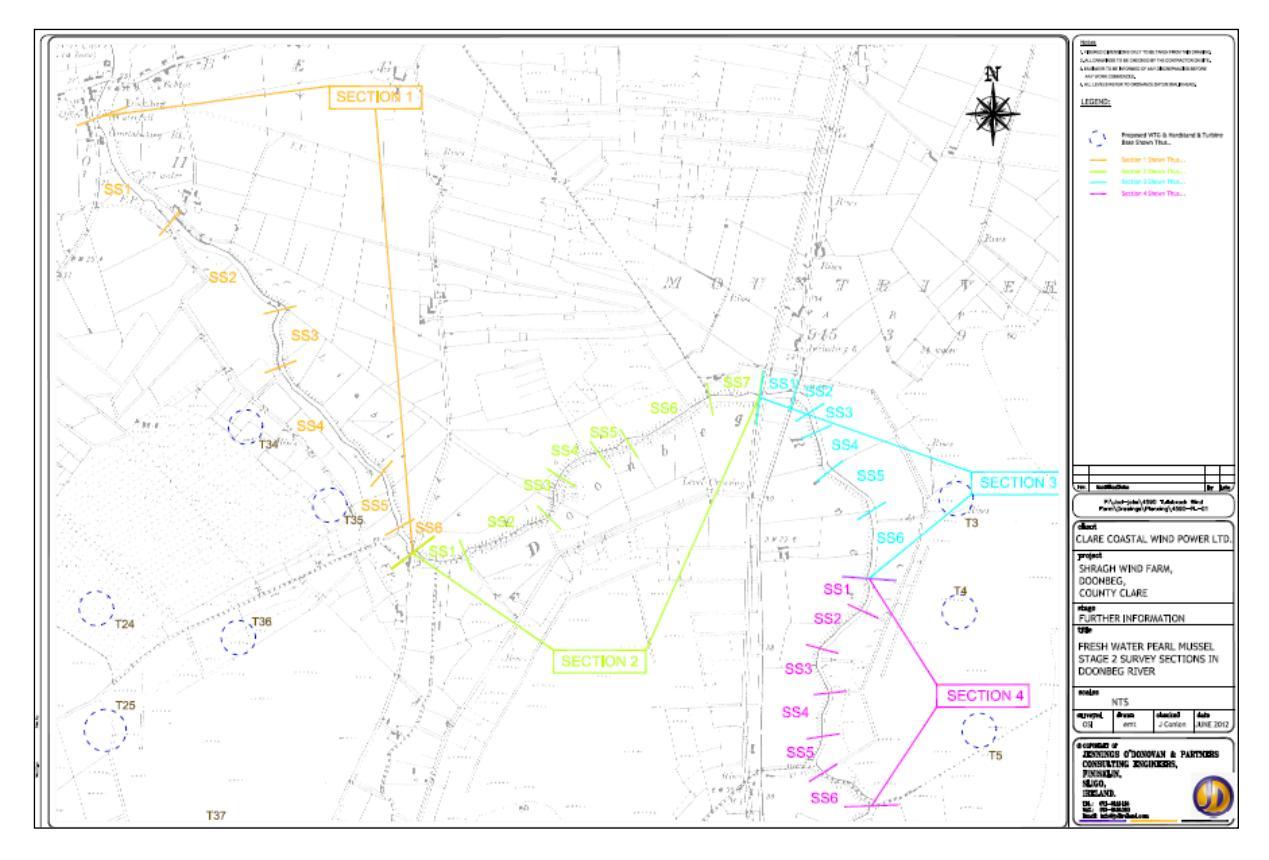
Figure 1. Sections surveyed along lower Doonbeg River in 2012.

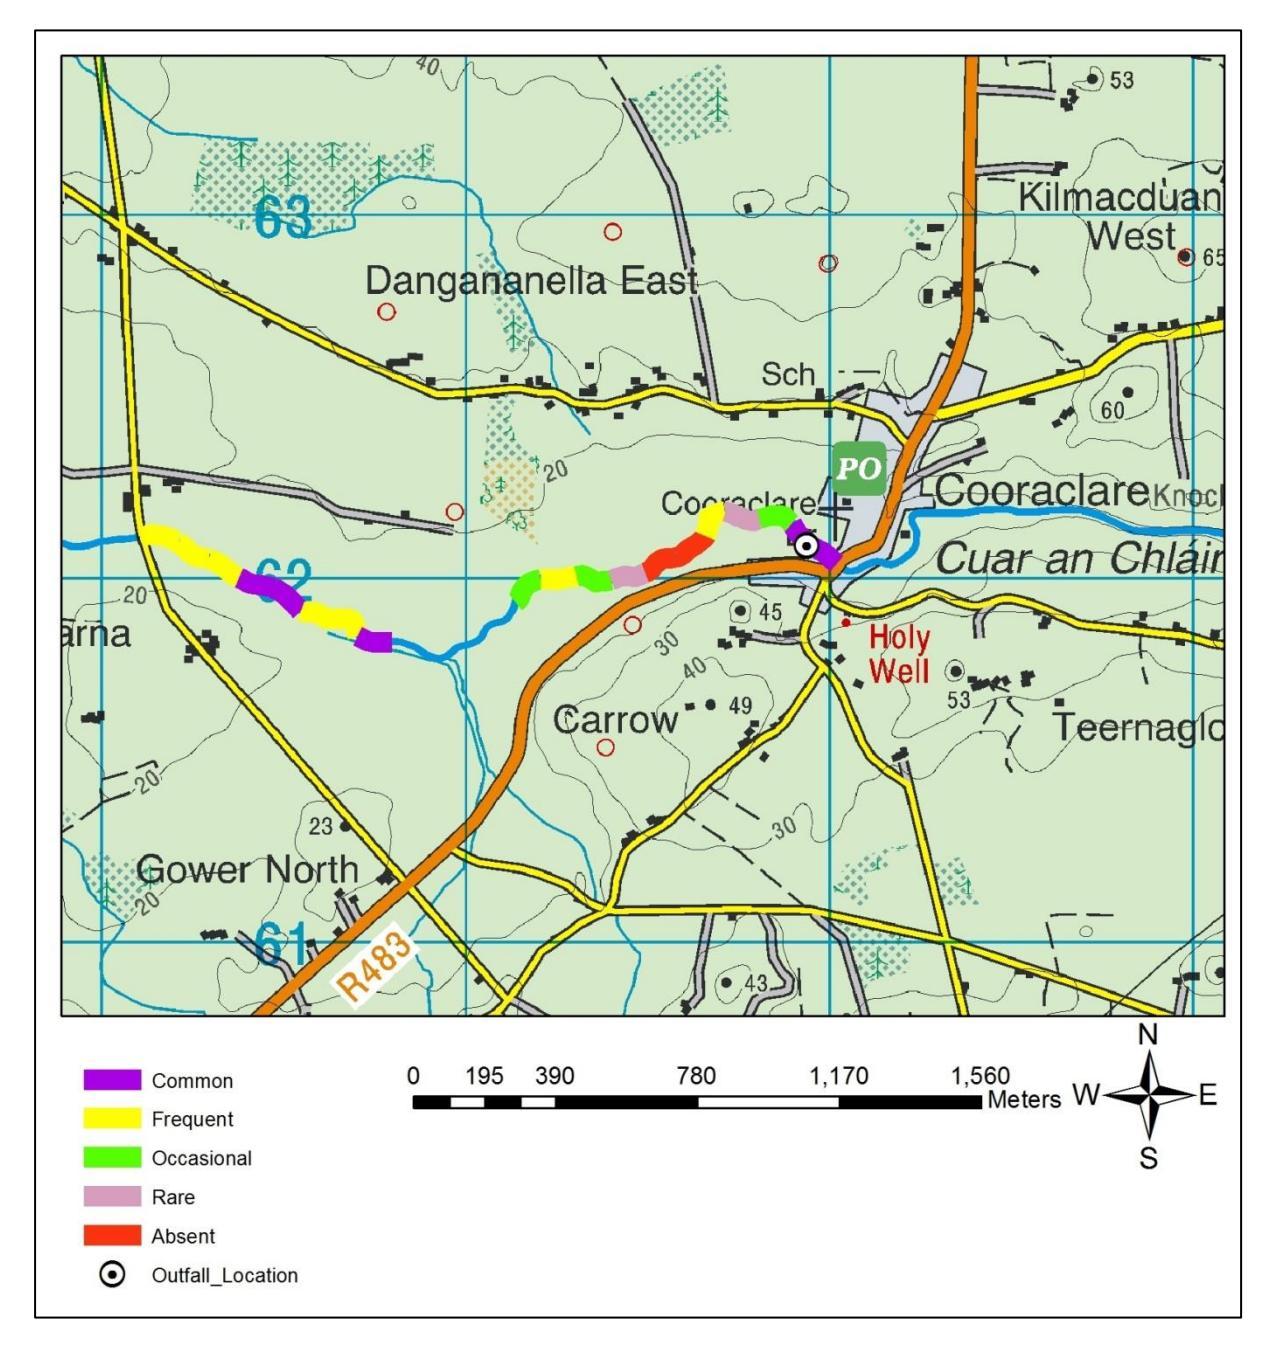
The Stage 2 survey focussed on a stretch of the Doonbeg River between Cooraclare and Aughagarna Bridge which had not been previously surveyed for Freshwater pearl mussels. Raw data showing mussel locations and abundance are presented in Appendix 1. Photographs of representative river reaches are presented in Appendix 2. Figure 2 illustrates mussel abundance in the stretch of the Doonbeg River surveyed according to the ACFOR scale applied.

On October 12th 2016, 800m of river channel was surveyed working in an upstream direction from Aughagarna Bridge. A total of 812 mussels were recorded in that reach. On October 13th 2016, c.1,100m of channel was surveyed, beginning about half way between Cooraclare Bridge and Aughagarna Bridge. A total of 335 mussels were recorded in that reach. Overall, a total of 1,147 mussels were recorded in the two reaches surveyed, covering about 1.9km of river channel. Mussels were much more abundant in the 800m upstream of the 1st bridge downstream of Cooraclare (average = 1.02 mussels per linear metre of channel) compared to the 1100m reach downstream of Cooraclare village (average = 0.3 mussels per linear metre of channel).

Figure 2. Mussel abundance in Doonbeg River downstream of Cooraclare using the ACFOR scale.

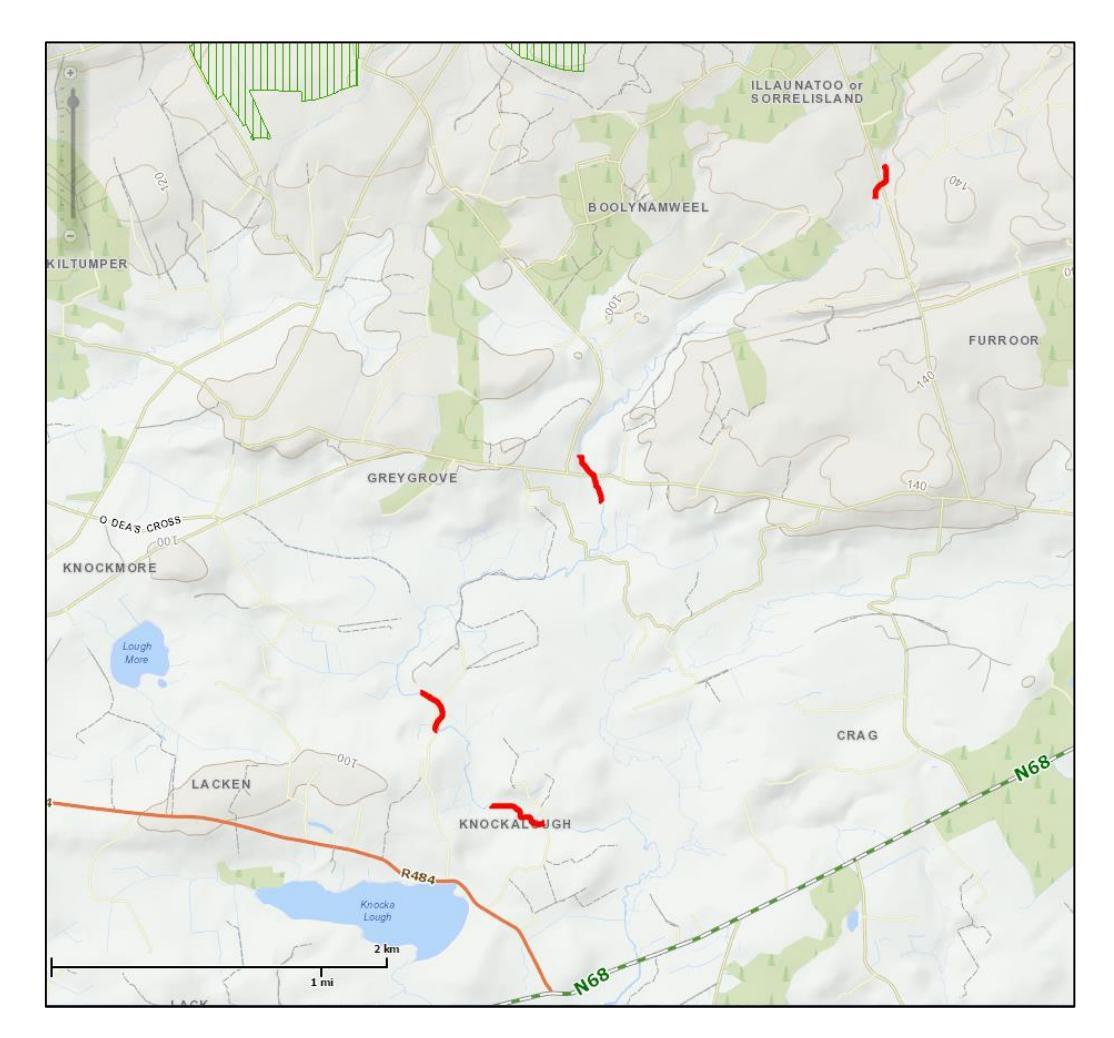
Figure 3 shows the location of the Stage 1 survey locations on the Greygrove River. A total of four stations were surveyed, the lowest at Knockalough, the next at Lackan, the third at Greygrove Bridge and the last at Sorrel Island Bridge. All stations were centred on bridges to facilitate ease of access. The Greygrove River varies from approximately 7-8m in width at the lower stations to approximately 3-4m width in the upper station at Sorrel Island Bridge. The lower section of the river has been subject to some recent instream fisheries enhancement measures. Substrates throughout were dominated by cobble with frequent boulders and pockets of gravel and coarse sands. Dense growth of willow-moss (*Fontinalis antipyretica*) was present throughout which obscured large amounts of the substrate. Small amounts of filamentous algae were recorded in the vicinity of Lackan, but overall the water quality appeared high, though the water has a very high tannin content which limits visibility in water over 30cm depth. The flow regime was typically riffle with fast glide and occasional slow glide and pool conditions. Despite the potential suitability of the habitat, no evidence of mussels was recorded during this survey.

Figure 3. Stretches of the Greygrove River surveyed (in red).

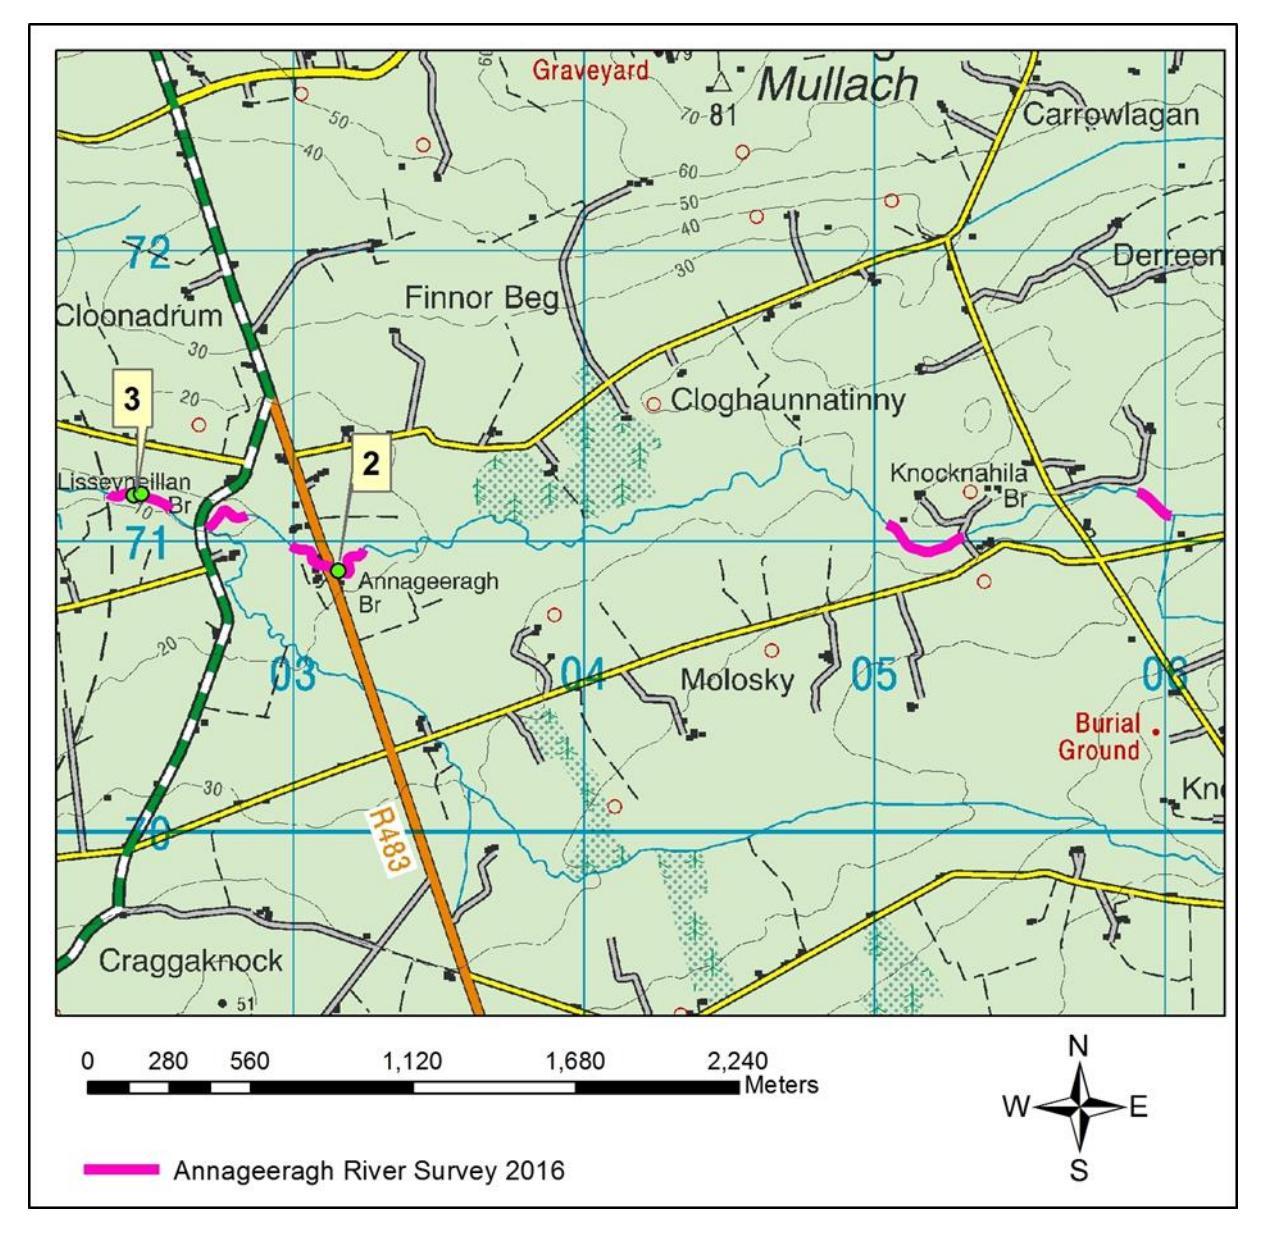
Figure 4 shows the reaches of the Annageeragh surveyed in August 2016 along with locations of the 5 adult mussels recorded. The sites were selected to supplement previous surveys undertaken by ASU staff (ASU, 2014).

The Annageeragh River has very low numbers of mussels, but does have some suitable substrate and may historically have been a reasonably good pearl mussel river. Much of the river has been modified by drainage and engineering works, both historically and recently. The lower reaches, including just upstream of Annageeragh Bridge and downstream of Lissyneillan Bridge have a greater proportion of suitable substrate for mussels compared to reaches further upstream. These reaches, however, have been the most affected by historical drainage and recent engineering works and also have high levels of filamentous green algal growth (*Oedogonium* spp.); fine silt and detritus: at levels that exceed freshwater pearl mussel regulation thresholds (S.I. 296 of 2009). Detailed results of the Stage 1 survey are presented in Appendix 3.

Figure 4. Survey reaches on Annageeragh River (in pink) with mussel location and total numbers

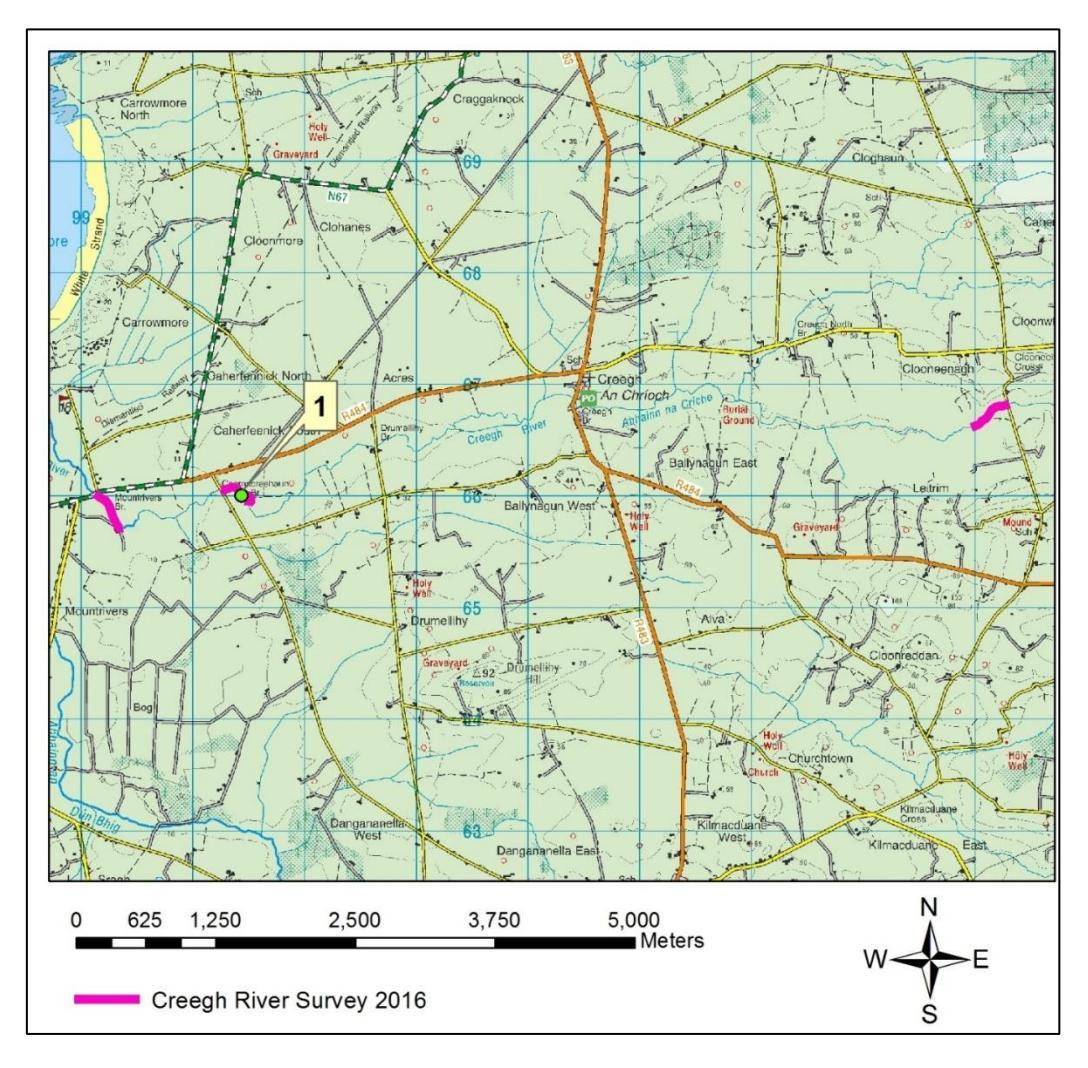
Figure 5 shows the reaches of the Creegh surveyed in September 2016 along with the location of the single adult mussel recorded. The sites were selected to supplement previous surveys undertaken on behalf of the Office of Public Works (Ryan Hanley, 2014) and ASU (2016).

The Creegh River was almost certainly once a good, perhaps a very good, freshwater pearl mussel river. However, it appears that in all likelihood, owing to severe historical and ongoing drainage along most of its main channel, there may only be one remaining adult mussel in the river. The large size (and therefore apparent advanced age) of the mussel (150mm) suggests that it probably escaped the dredging bucket during original drainage operations and has survived until 2016. The species can thus be considered effectively extinct in the Creegh catchment. Detailed results of the Stage 1 survey are presented in Appendix 4.

Figure 5. Survey reaches on River Creegh (in pink) with mussel location and total abundance.

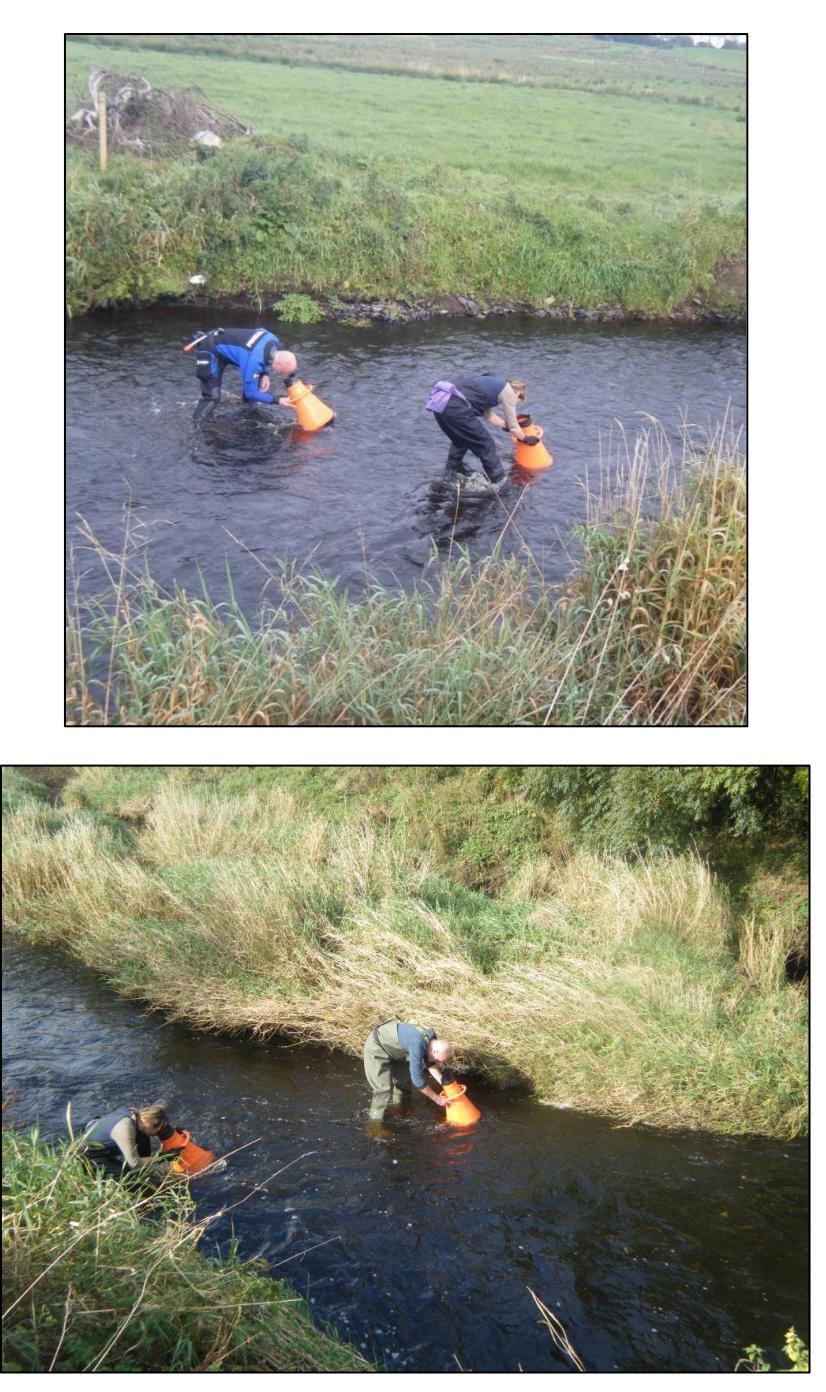
Plates 1 & 2. Surveying in typical, wadeable reaches of the Doonbeg River (13/10/16)

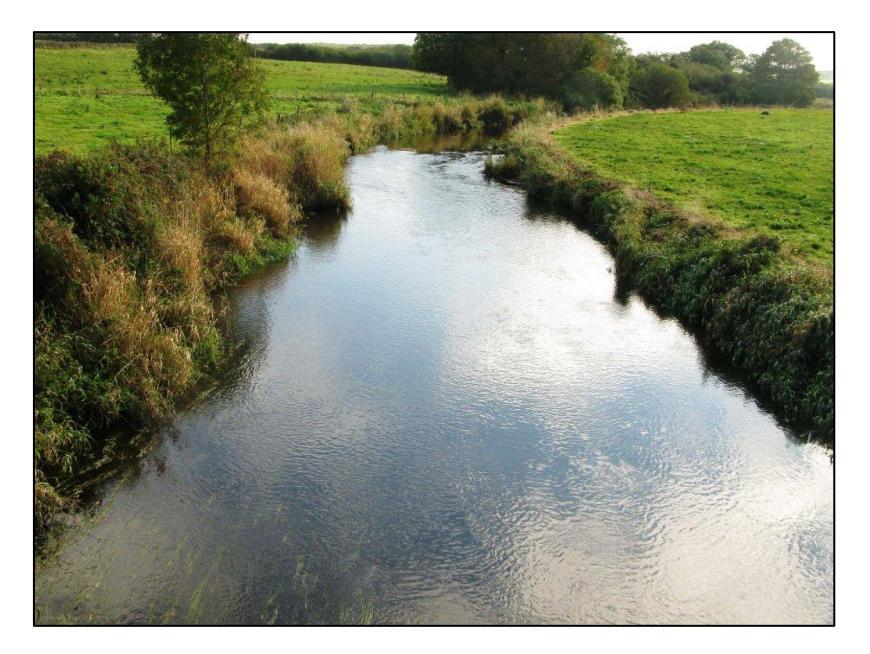
Plate 3. View u/s from Aughagarna Bridge where scattered adult mussels in the 'Frequent' abundance category were recorded.

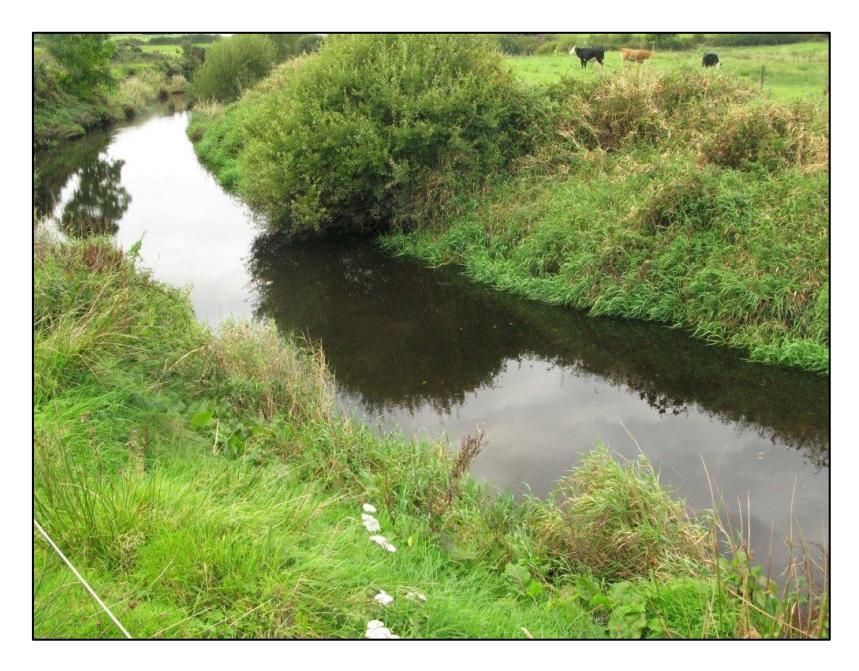
The stretch of river between grid ref. 102219 162091 and 102791 161819 was characterised by deep slow flowing section of river, where snorkelling was necessary. It was difficult in this reach to accurately record every mussel given the combination of water depth, high water colour and turbid conditions. It is estimated that mussel numbers in these deeper reaches may be 10-20% higher than those recorded. It was only possible to dive for a short time and very difficult to maintain a uniform coverage of the river bed snorkel. Continuous diving also disturbed silty deposits further reducing the already poor visibility.

Plate 4. Typical deep, sluggish section of the Doonbeg, up to 1.5m depth with substrates of clay, and mixed cobble/small boulder with silty detritus. Surprisingly (because this habitat would not be considered typical for the species) these reaches had mussels up to 'Common' in abundance category, with patchy distribution. There were occasional, quite dense clusters of mussels.

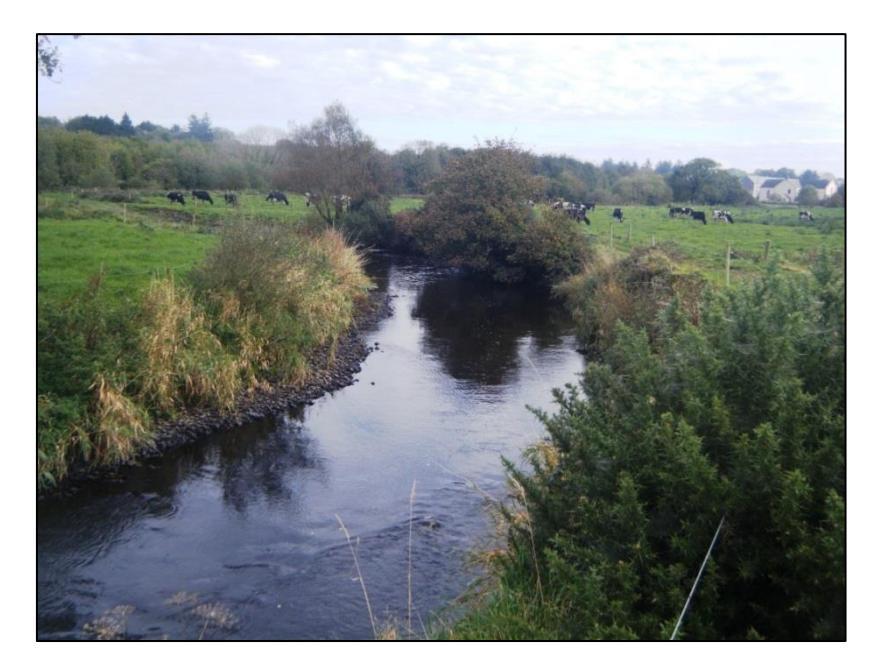
Plate 5. Typical glide/riffle section about 500m downstream of Cooraclare village where mussels were 'Absent'.

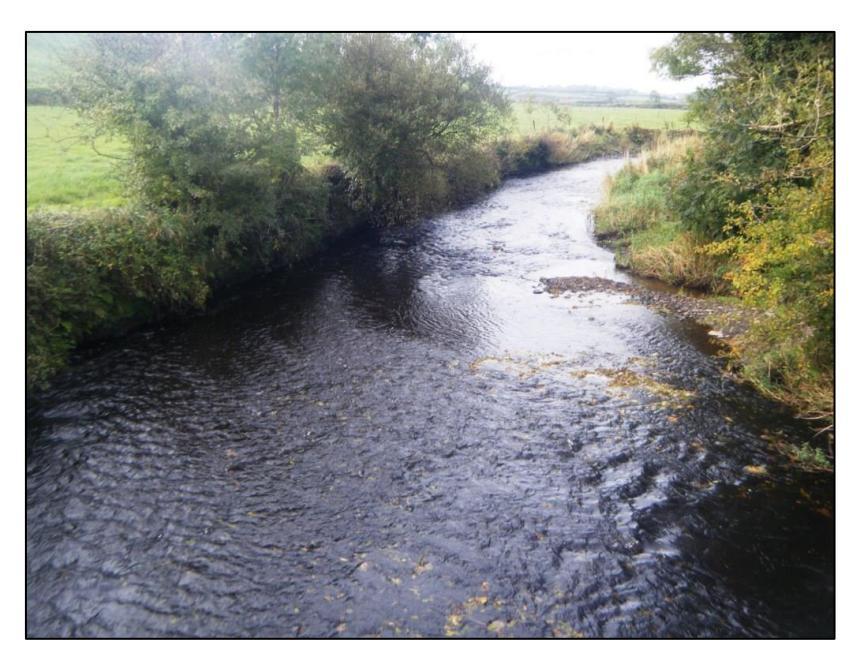
Plate 6. Typical shallow riffle section about 550m downstream of Cooraclare village where mussels were 'Rare'. A few mussels were confined to more stable gravel patches just d/s of the riffle head under bankside trees on left.

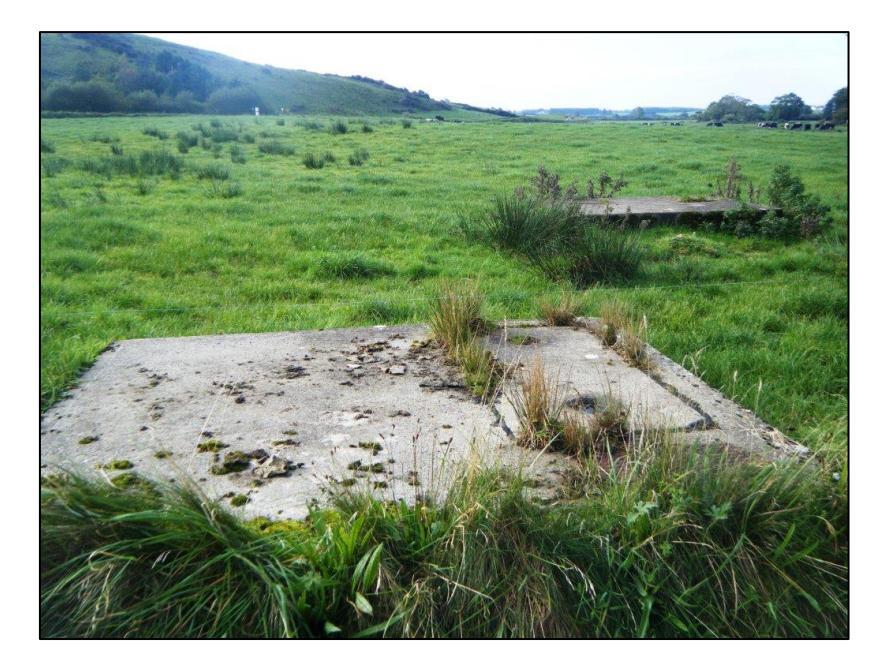
A sewage input was noted just downstream of Cooraclare village, comprising a grey, strong smelling discharge. Patches of sewage fungus were present on some substrates and decaying leaf litter up to 100m downstream of the input. There was no defined outfall pipe: it appeared to be septic tank seepage, perhaps a combined group septic tank as shown in Plate 7, Appendix 2.

Plate 7. Concrete covers, possibly over large septic tanks in fields on south bank of river with associated discharge to the river, located just downstream of Cooraclare village.

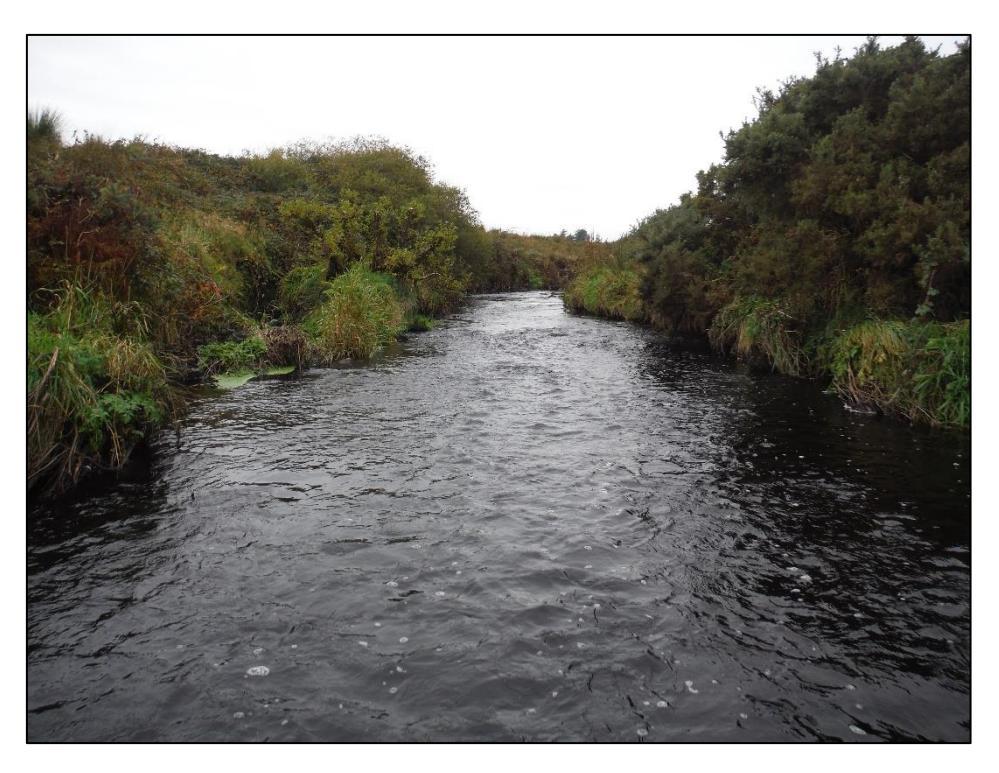
Plate 8. Stretch of the Greygrove River near Knockalough.

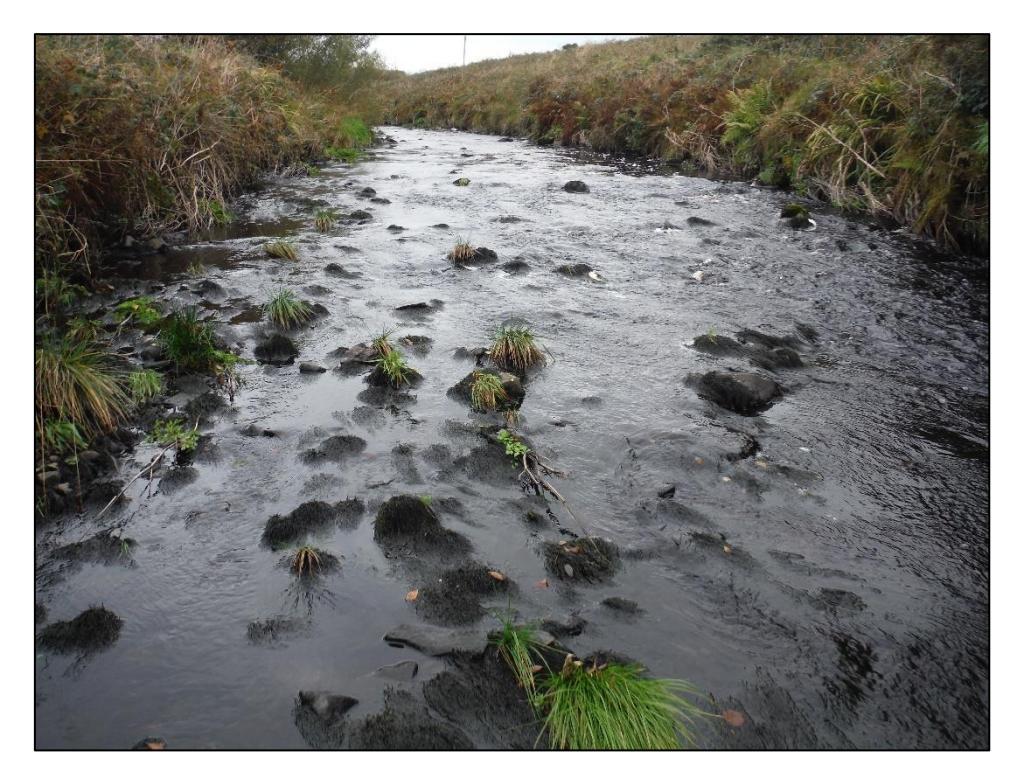
Plate 9. Greygrove River showing cobble substrate and dense willow moss growth.

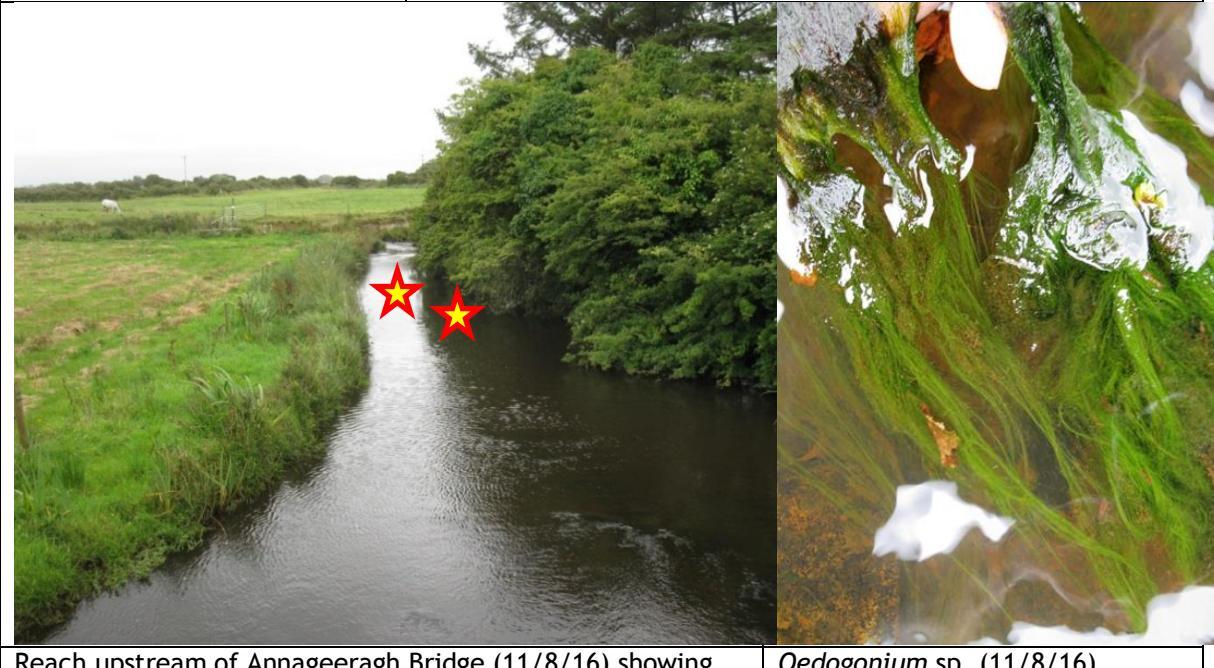
| Location | Reach upstream of R483. Annageeragh Bridge |
|---|--|
| Mussels | 2 large adults located around 25m upstream of bridge. |

Reach upstream of Annageeragh Bridge (11/8/16) showing approximate location of 2 adult mussels.

Oedogonium sp. (11/8/16)

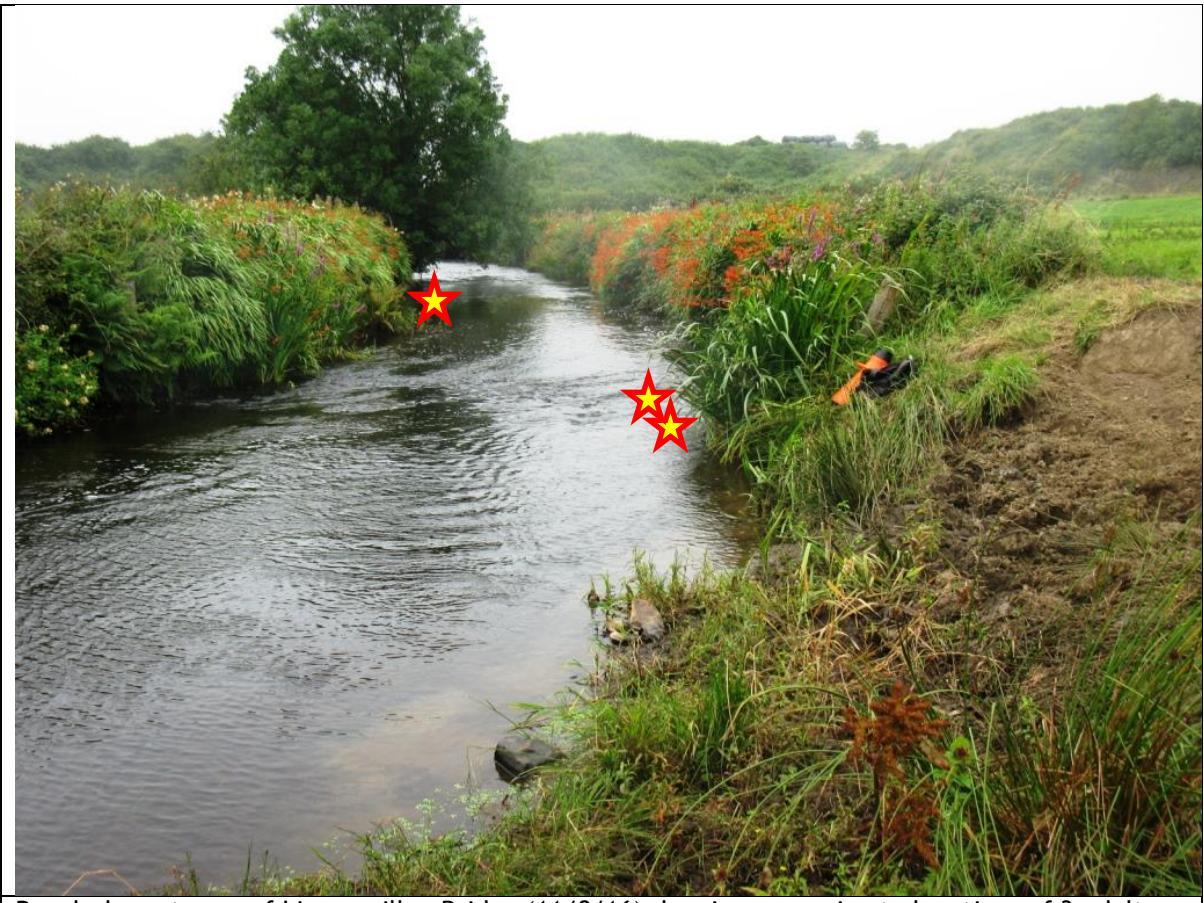
| Location | Reach upstream of disused railbridge d/s of Lisseyneillan Bridge |
|---|---|
| Mussels | 1 large adult @ R02449 71160; 2 large adults @ R02475 71165. |

Reach downstream of Lisseyneillan Bridge (11/8/16) showing approximate locations of 3 adult mussels. Note cattle access in foreground on True Right bank.

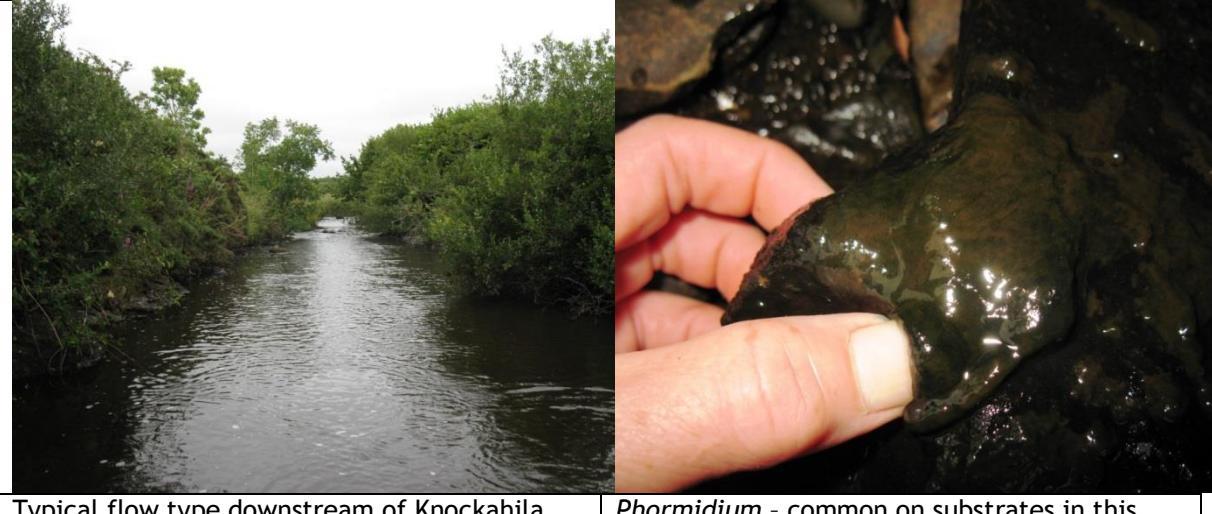
| Location | Reach downstream of Knockahila Bridge |
|---|--|
| Habitat | Glide/run sequence, with limited rapid/riffle. Historically drained with spoil heap/embankment at TR bank and evidence that bed level was incised into bedrock. 5m width, mean 0.35m depth (at low flow). Slight-moderate water colour (humic), slight turbidity. Substrates in reach comprised mainly of bedrock and larger cobble with very limited fine interstitial material. Layer of fine silt/detritus on substrates in slow flows, but clean in fast flowing riffles. <i>Phormidium</i> common, <i>Myriophyllum</i> and <i>Fontanalis antipyretica</i> present. but generally free of algae otherwise. |

Typical flow type downstream of Knockahila Bridge (11/8/16)

Phormidium - common on substrates in this reach (11/8/16)

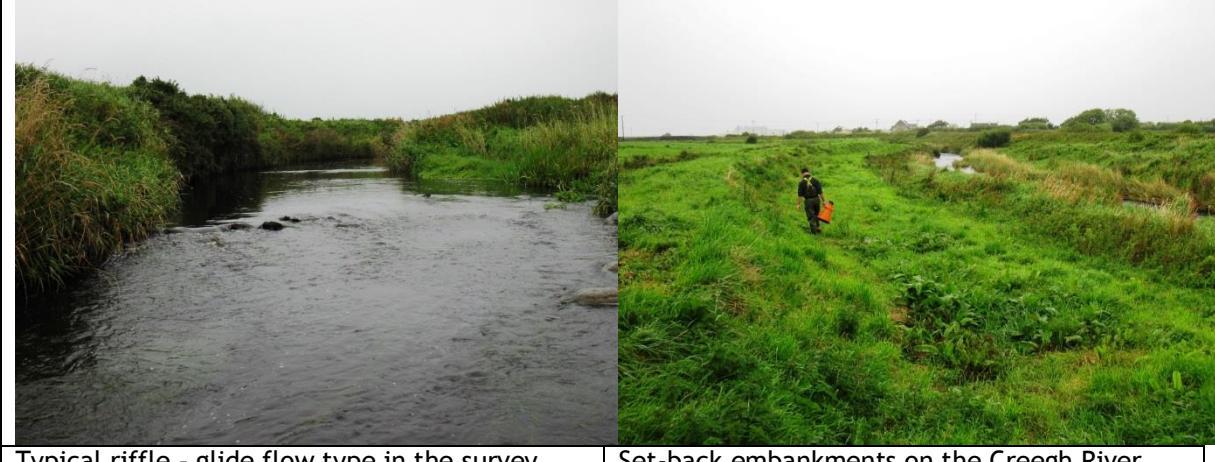
| | Very limited patches of finer bed material suitable for |
|---|---|
| Evidence of Mussels | None |

Typical riffle - glide flow type in the survey reach. No mussels (1/9/16).

Set-back embankments on the Creegh River near Mount Rivers Bridge (1/9/16).

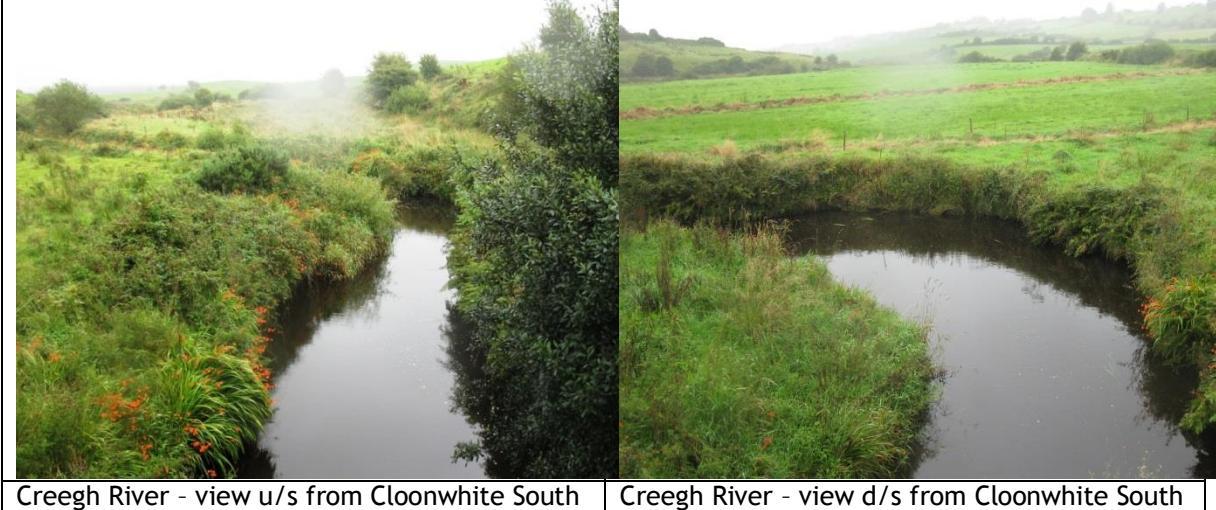
| Location | Bridge near townland of Cloonwhite South |
|---|--|
| Habitat | Habitat similar to the reach at Cloonenagh (above). The river has been historically drained in this part of the catchment also, as evidenced by steep uniform bank slopes and limited riparian tree cover. Given that mussels were absent from parts of the river with much more ideal habitat, and were absent from similar drained habitat c.2km downstream, this upstream reach was not surveyed. |

bridge (1/9/16)

Creegh River - view d/s from Cloonwhite South bridge (1/9/16)
